IMPORTANT SAFETY RECALL

NHTSA Recall Number: 25V250

Altec Identifier: CSN-3215

Mounting Frame Inspection

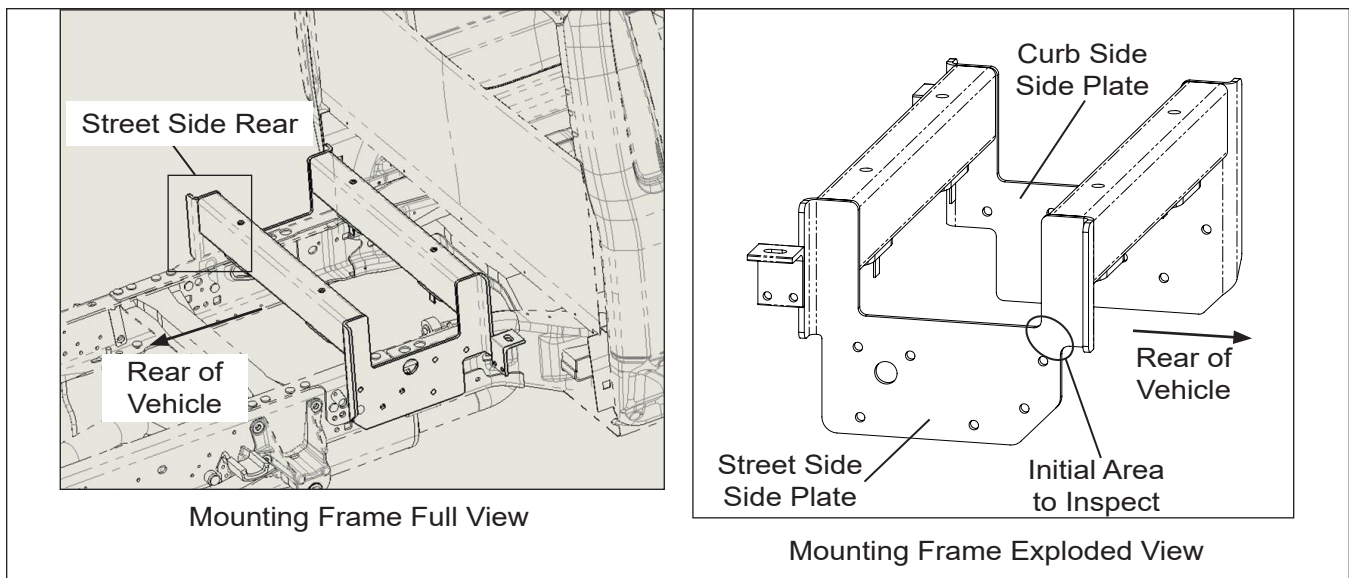
Figure 1 – Mounting Frame Initial Inspection

3. Find the mounting frame under the vehicle (refer to Figure 1). Determine the orientation of the mounting frame.
4. Inspect the narrow section at the rear portion of the side plate on the street side of the mounting frame. Use a wire brush to remove any paint and rust from this area.

5. Using a flashlight, inspect the outer surface and the upper and lower rounded corners of the narrow section of the side plate (refer to Figure 1) for the extent of any cracking in the steel plate.

6. Review the inspection results, and take the specified action based on the initial inspection area.
 - If there is **no cracking**, put the unit back into service. Order the Mounting Frame Reinforcement Kit, part number 991832504, and install it within one year of the inspection. Do not perform Inspection Procedures B. Inspect this area regularly as outlined in the Preventive Maintenance and Inspection Checklist in the appendix of the unit's Maintenance and Parts Manual.

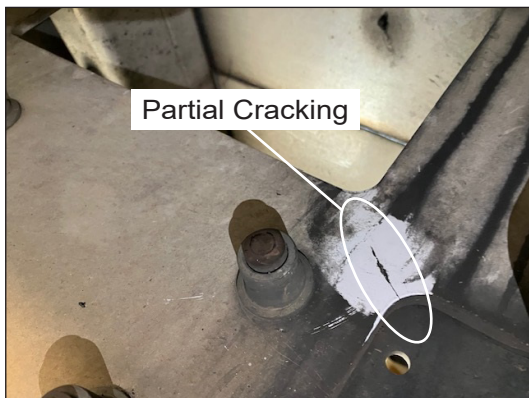
Figure 2 – Partial Cracking Example

- No cracking means no visible cracking at all in the plate.
 - Partial cracking means a visible crack anywhere in the narrow section that extends only part way across the width or part way through the thickness of the plate (refer to Figure 2).

- If there is **partial cracking**, put the unit back into service. Order the Mounting Frame Reinforcement Kit, part number 991832504, and install it within 60 days of the inspection. Do not perform Inspection Procedures B. Inspect this area regularly as outlined in the Preventive Maintenance and Inspection Checklist in the appendix of the unit's Maintenance and Parts Manual.

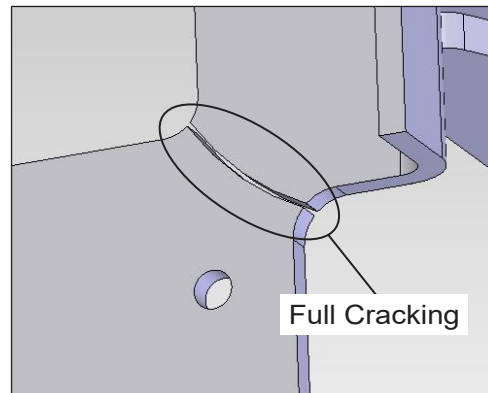
Figure 3 – Full Cracking Example

- Full cracking means a visible crack across the full width of the narrow section extending through the full thickness of the plate and causing the complete separation of the material (refer to Figure 3).

- If there is **full cracking**, take the unit out of service. The vehicle can still be driven, but the aerial device cannot be used until it is repaired. Proceed to Inspection Procedure B to determine the necessary repair procedure.

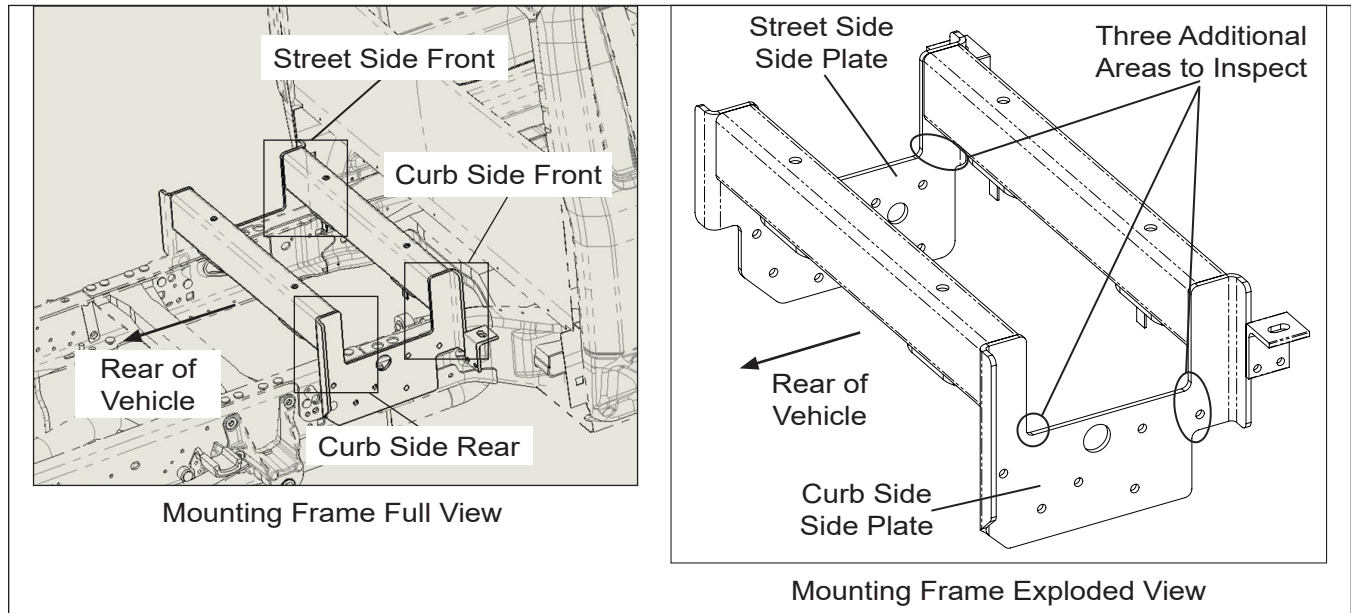
Figure 4 – Mounting Frame Additional Inspection B

7. Keep the unit set up as in Inspection Procedure A step 1.
8. Use a wire brush to remove any paint and rust from the other three corners of the mounting frame (refer to Figure 4).

9. Using a flashlight, inspect the outer surface and the rounded corners of the other three corners of the mounting frame as shown in Figure 4 for the extent of any cracking in the steel plate.
 - If there is no cracking in any of these three areas, order the Mounting Frame Reinforcement Kit, part number 991832504, and install it before putting the unit back into service.
 - If there is cracking in any of these three areas, call 1-270-505-1532 to speak to Telecom Product Support or email Telecom.Product.Support@altec.com to obtain further direction on repair.
