IMPORTANT SAFETY RECALL

NHTSA Recall Number: 25V651
Altec Identifier: CSN-3253

Boom Tip Mounting Fastener Torque Check

Units Affected: Certain Altec A-Class models built from January 2024 through September 2025. Verify your unit is affected by reviewing the attached list or accessing Altec Connect.

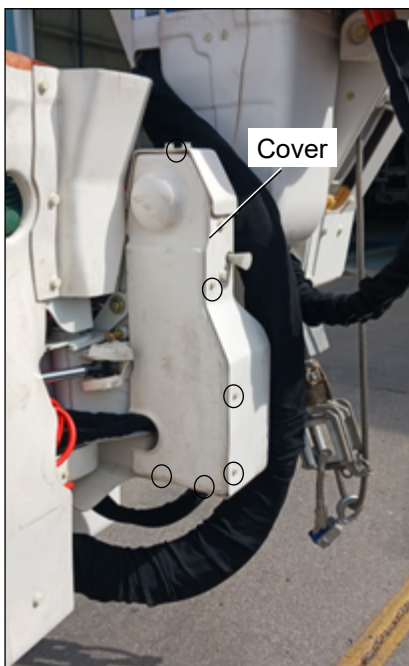
Figure 1 — Cover to Remove

1. Read and understand all steps of the instructions before beginning the procedure. Wear appropriate personal protective equipment (PPE) following your employer's requirements.
2. Position the unit on a level surface, apply the parking brake, and engage the power take-off (PTO) . Chock the wheels, and properly set the outriggers.
3. Use the lower controls to place the boom in a position that allows the platform to be rotated out 90 degrees and safe access to the boom tip for a person on the ground.
4. Rotate the platform out 90 degrees.
5. Disengage the PTO, and turn off the engine. Remove the key from the ignition, and secure it following your employer's vehicle lockout/tagout procedure.
6. Remove the platform pivot arm cover (refer to Figure 1). Keep the hardware and cover for re-installation.

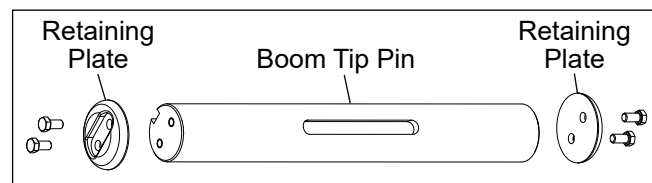
Figure 2 — Inspection Area

7. Behind the pivot arm cover will be the retaining plate (part number 071810016) and cap screws (refer to Figure 2). This procedure is also found in Section 4 of the Maintenance Manual under Boom Tip Pin Retaining Plates.
 - a. Visually inspect fasteners and retaining plate.
 - b. Perform a 90% torque check (28 ft-lbs) of the normal installation torque value (31 ft-lbs) with a calibrated torque wrench to ensure the connection is secure. If any are loose, torque to 31 ft-lbs.
 - c. If fasteners are missing or damaged, they require replacement.

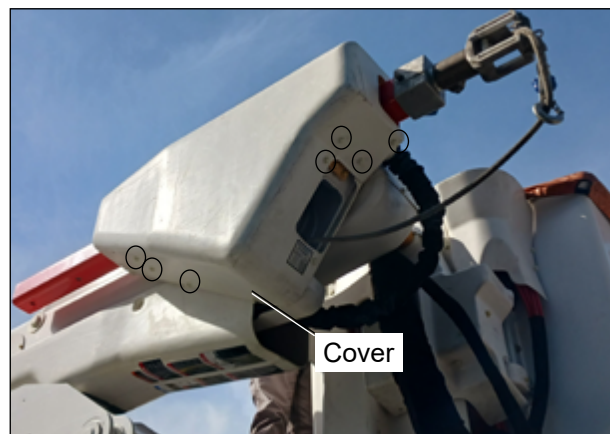
Figure 3 — Second Cover to Remove

8. Replace the cover.
9. Inspect the opposite side of the boom tip pin retaining plate (part number 071810016) and cap screws. Remove the outer jib cover (refer to Figure 3). Keep the hardware and cover for re-installation.

- a. Visually inspect fasteners and retaining plate.
 - b. Perform a 90% torque check (28 ft-lbs) of the normal installation torque value (31 ft-lbs) with a calibrated torque wrench to ensure the connection is secure. If any are loose, torque to 31 ft-lbs.

- c. If fasteners are missing or damaged, they require replacement.
10. Replace the cover.
11. Review the inspection results.
 - If all fasteners and the retaining plate are in place and not damaged, the torque inspection is complete no repair is required. Proceed to step 12.
