Remedy available for  
2017-2019 (KL) Jeep Cherokee

# SAFETY RECALL

## Two Speed PTU Failure

Reference: 01C / NHTSA 25V-011

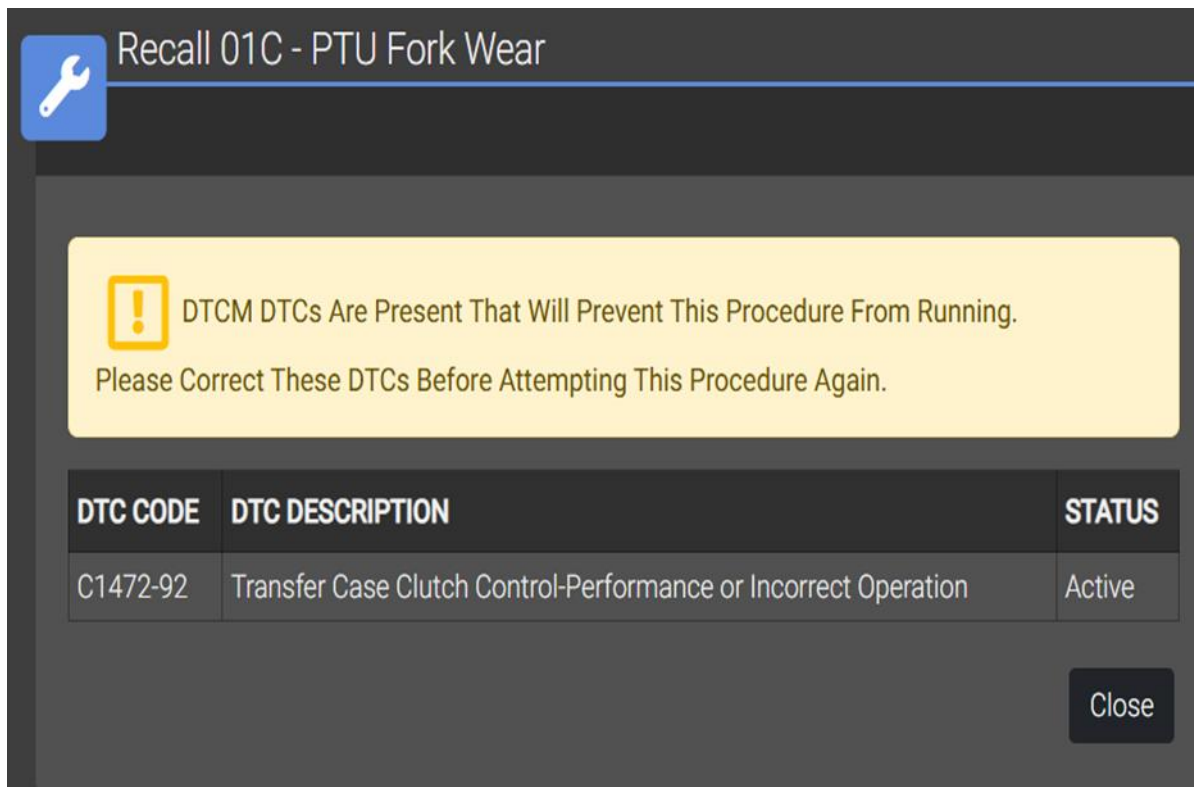
**Example of an error message with a possible DTC. Actual DTC may be different.**

**NOTE:** If the above message is displayed, reference the service library for the appropriate diagnostic and repair procedures to resolve the issue before proceeding. Service repair LOP(s) and a description of the additional repair(s) should be included in the 01C recall claim submission to ensure reimbursement for the additional diagnostic and repair time.

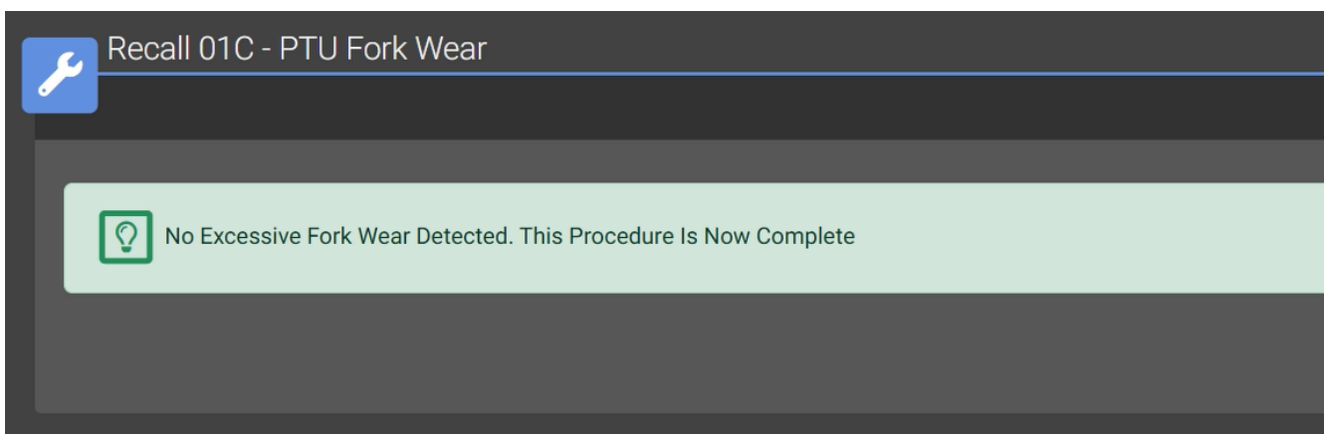
**Passes Test – No Excessive Wear Detected**

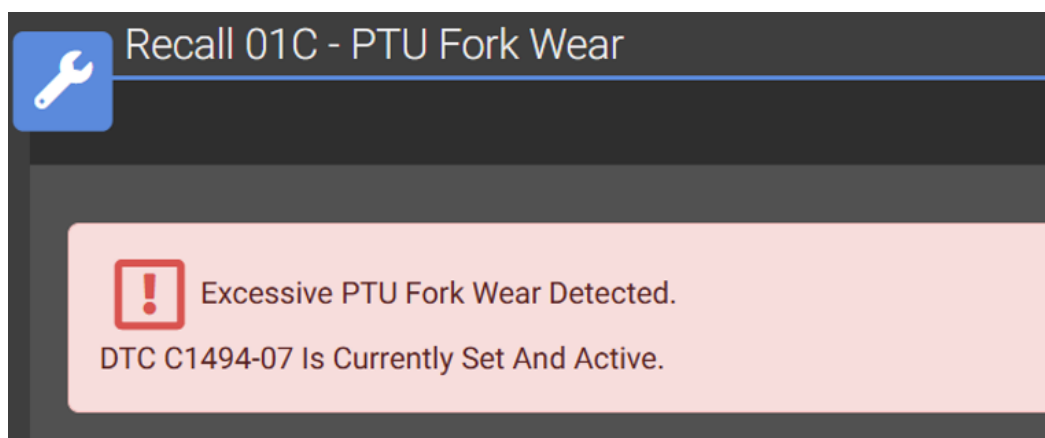
**Failed Test – Excessive Wear Detected**

- 
2. Check for DTC C1494-07 (PTU Fork).
    - If C1494-07 is set, replace the PTU using the following procedures.
    - If no code C1494-07 is set, return the vehicle to the customer.
