Safety Recall

N242481530 Adaptive Cruise Control May Not Stop Vehicle

Release Date: January 2025

Revision: 01

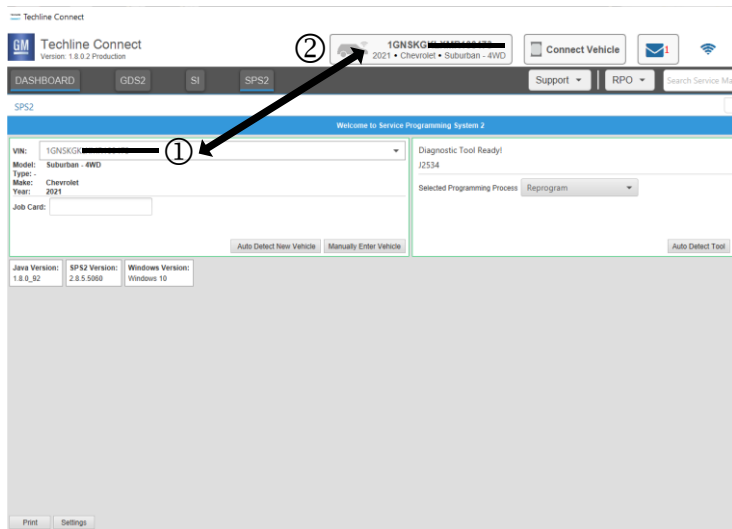
5743643

Caution: Be sure the VIN selected in the drop down menu (1) is the same as the vehicle connected (2) before beginning programming.

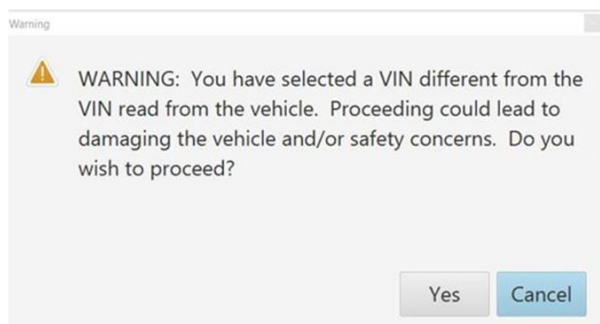
5877000

Important: If the vehicle VIN DOES NOT match, the message below will be shown.

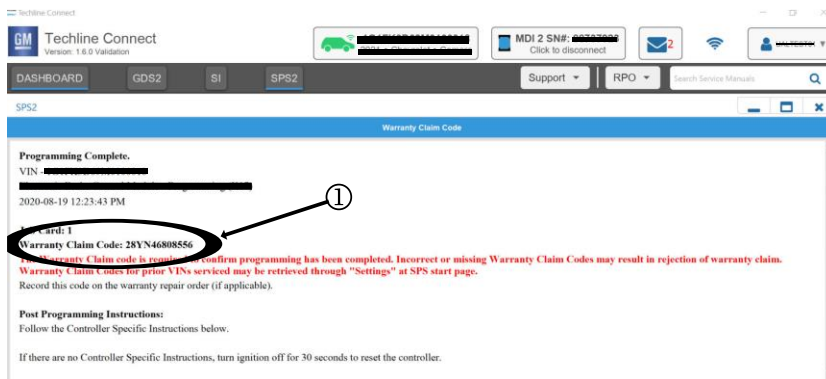
5644478

Note: The screenshot above is an example of module programming and may not be indicative of the specific module that is being programmed. Module selection and VIN information have been blacked out.

1. Reprogram the Brake System Control Module. Refer to *K160 Brake System Control Module: Programming and Setup* in SI.

Important: To avoid warranty transaction rejections, you **MUST** record the warranty claim code provided on the Warranty Claim Code (WCC) screen shown above on the job card. Refer to callout 1 above for the location of the WCC on the screen.
