# SAFETY RELATED RECALL

Global Recall Action  
Number: H535

<b>Subject:</b>  <b>Loss of Rear View Camera Image</b>	Publication No.: H535
	Model: XE (X760)
	Model Year: 2019 - 2020
	Date of Issue: 09 December 2025

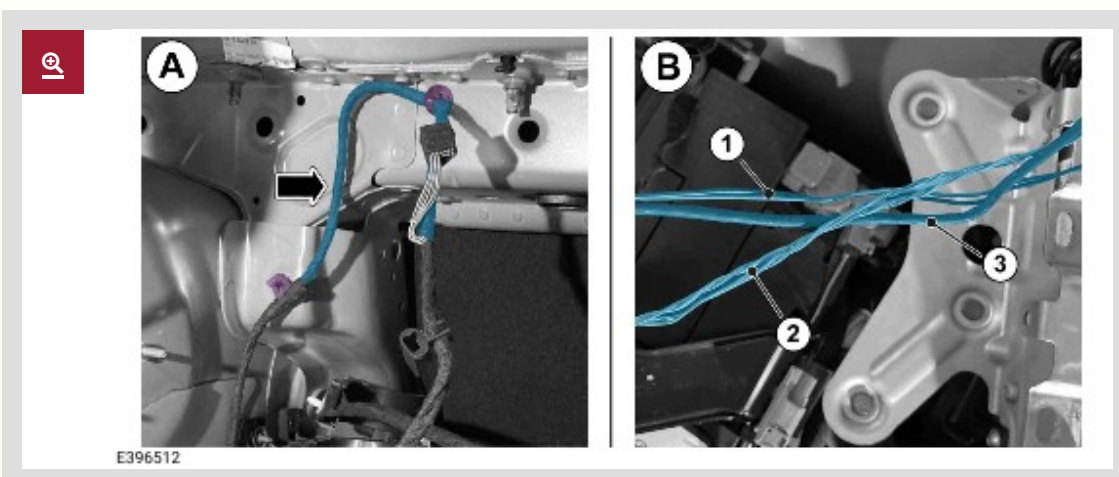
7 wires / cables will be exposed when removing the anti-abrasion tape from the wiring harness. 2 sets of twisted wires (all twisted wires are the same color) for the block connector. 1 black (BK) wire and 1 blue/green (BU/GN) wire (to be spliced). 1 coaxial cable for the rear view camera.

1. 1 black (BK) wire and 1 blue/green (BU/GN) wire. Wire to be spliced.
2. 2 sets of twisted wires.
3. Rear view camera coaxial cable.

Remove the wiring harness anti-abrasion tape from the area marked in (A) in the illustration and expose the wires (B).

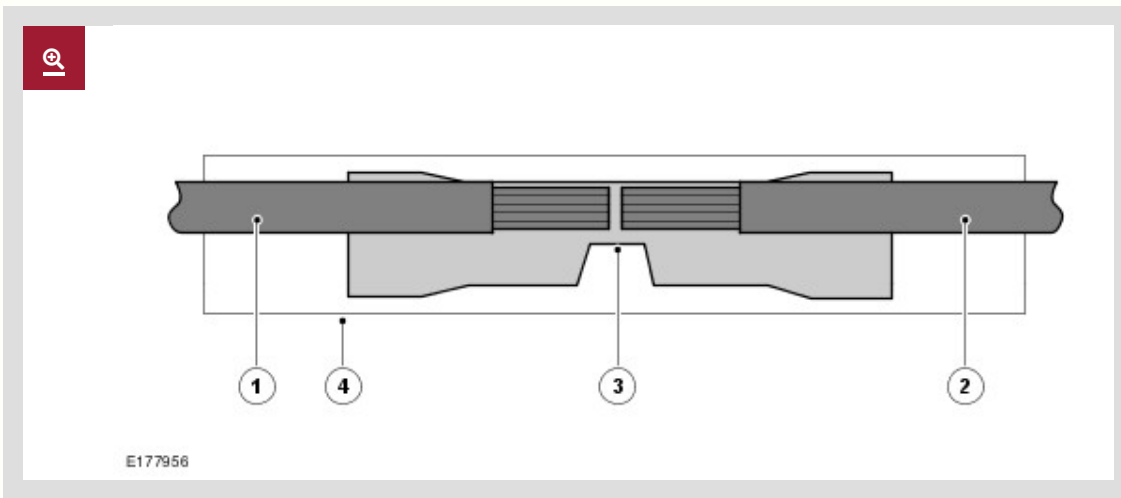
1. Original wire
2. New wire
3. Splice connector
4. Heat shrink sleeve

Place the wiring harness wire and appropriate wiring harness overlay wire into the splice with the splice connector. The wiring harness cable must be against the stop in the splice, crimp the splice connector to the wiring harness wire.
