GROUP	MODEL
Safety Recall Campaign	2023-2025MY Niro HEV, PHEV and EV (SG2 P/HEV, SG2 EV)
NUMBER	DATE
SC332 (Rev 1, 07/02/2025)	January 2025

SAFETY RECALL CAMPAIGN

FLOOR HARNESS INSPECTION AND

PROTECTIVE COVERING INSTALLATION (SC332)

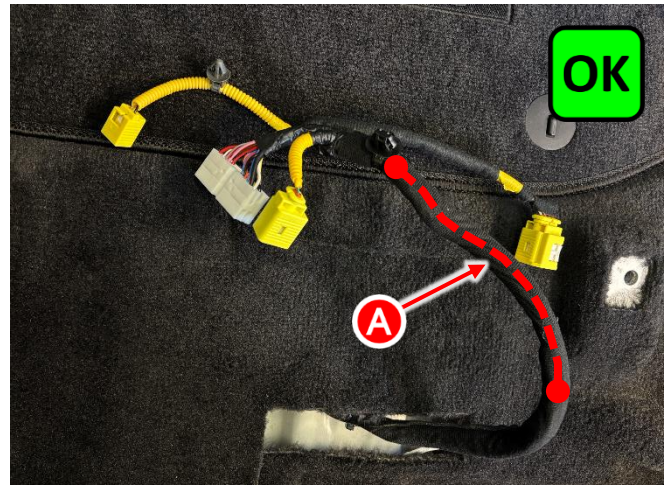
4a. Inspect the seat wiring (A) coming from under the floor carpet for damage (red outlined area). There should be no damage (OK) to the protective wiring cloth insulation.

4b. **OK Condition** - Proceed to the protective covering installation instructions for the applicable model:

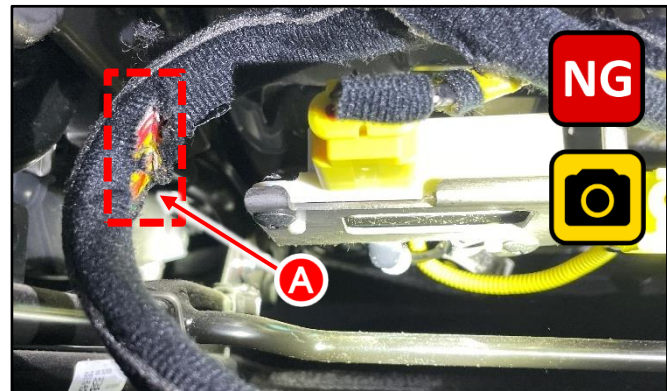
5a. The (NG) wiring sample shown was rubbing against the steel ODS module retaining bracket and caused damage to the wiring insulation.

5b. **NG Condition** - Take a clear photo of the NG condition using the KDS Warranty Claim Attachment tab and then refer to the floor wiring harness replacement (Page 8) and then install the protective covering (Page 5 or 6) for the applicable model.
