GROUP	MODEL
Safety Recall Campaign	2023-2025MY Niro HEV, PHEV (SG2 P/HEV) and Niro EV (SG2 EV)
NUMBER	DATE
SC332	January 2025

FLOOR HARNESS INSPECTION AND

PROTECTIVE COVERING INSTALLATION (SC332)

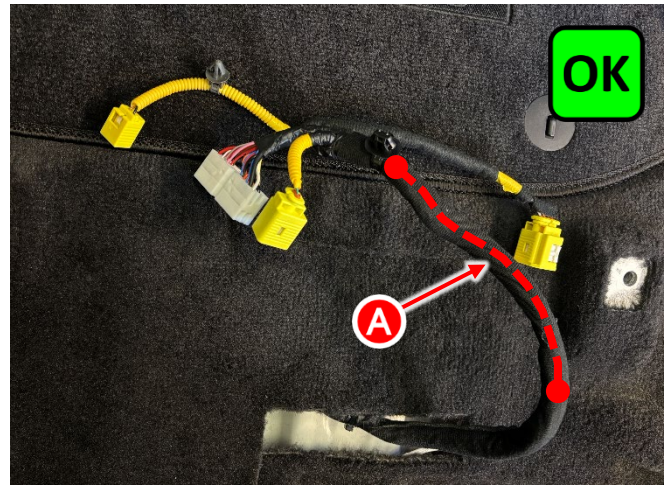
4a. Inspect the seat wiring (A) coming from under the floor carpet for damage (red outlined area). There should be no damage (OK) to the protective wiring cloth insulation.

4b. **OK Condition - Proceed to the protective covering installation instructions for the applicable model:**

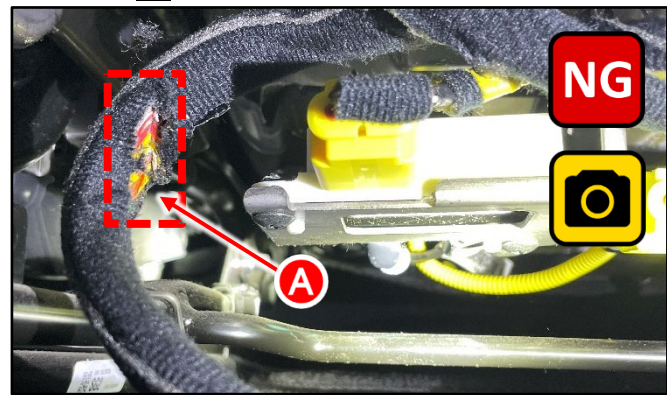
5a. The (NG) seat wiring (A) sample shown was rubbing against the steel ODS module retaining bracket and caused damaged to the wiring insulation.

5b. **NG Condition - No Remedy Available at this time, the vehicle will need to be parked.**

Take a photo of the damaged wiring.
