TECHNICAL INSTRUCTIONS

SAFETY RECALL 25LA02

DRIVER AIRBAG MAY NOT DEPLOY

CERTAIN MODEL YEAR 2023-2024 NX AND 2023 RX

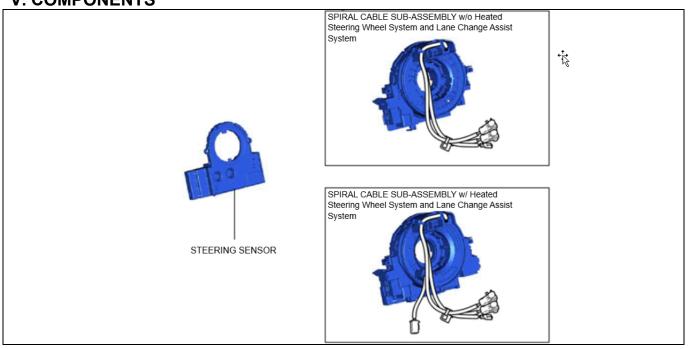
V. COMPONENTS

The affected vehicles may not have been correctly inspected in a prior recall to determine if a replacement of the spiral cable assembly in the steering column that controls the driver's side airbag was needed. A loose connection in the spiral cable can cause the airbag warning light to illuminate, and the driver's airbag may not deploy in a crash. As a result, the vehicle will not comply with a federal safety standard and may increase the risk of injury to the driver in the event of a crash.

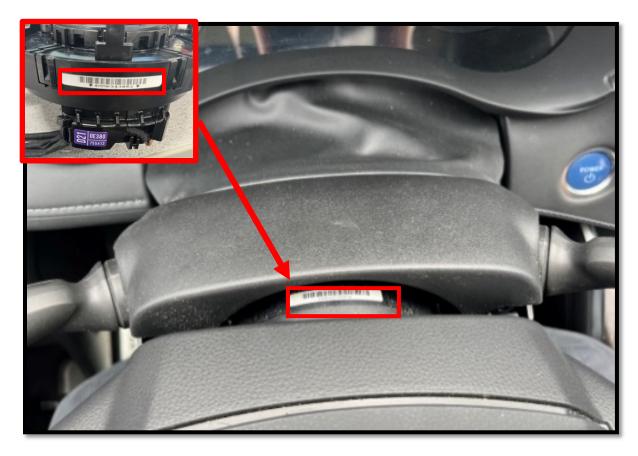
1. Remove upper steering column cover to access spiral cable serial number.

Follow steps 5 and 6 in the Repair Manual to remove the upper steering column cover. **DO NOT REMOVE THE LOWER STEERING COLUMN COVER TO ACCESS THE SERIAL NUMBER.**

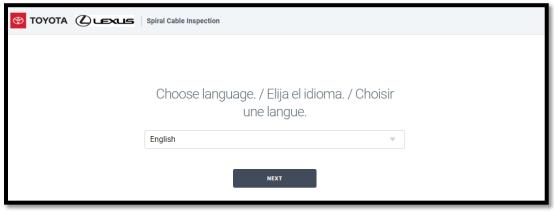
a. The serial number is located on top of the spiral cable. Confirm the spiral cable installed on the vehicle falls within the affected part range by logging onto https://SpiralCableInspection.imagespm.info
