February 6, 2025

Version 1

Safety Recall: 2025 Pilot 3rd Row Seat Belt Routing Inspection

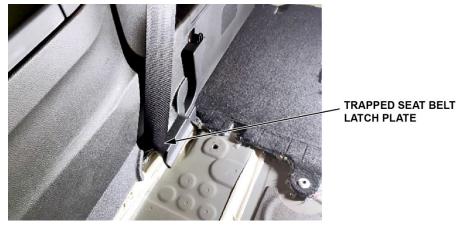
The passenger side 3rd row seat belt may have been improperly routed, trapping and hiding the seat belt latch plate and seat belt webbing behind the rear side liner panel.

15. Reroute the trapped latch plate and seat belt webbing from behind the rear side liner panel.

- Inspect the location of 3rd row right passenger seat belt latch plate and seat belt webbing, and ensure proper seat belt functionality
- Reroute the 3rd row right passenger seat belt latch plate and seat belt webbing, if necessary
