# Safety Recall

## N242490120 Chrome Grille Deflector May Detach

**Release Date:** March 2025

<b>Condition</b>	General Motors has decided that a defect which relates to motor vehicle safety may exist in certain 2022 model year GMC Sierra 1500 vehicles equipped with chrome front grille deflectors. One or more of the attachments that hold the front upper grille deflector in place may fracture over time. If all eight attachment points break, the deflector may detach from the vehicle while driving. If a front grille deflector detaches unexpectedly while driving, there is increased risk of a crash.
<b>Correction</b>	Dealers will reinforce or repair all attachment points on the chrome front grille deflector.

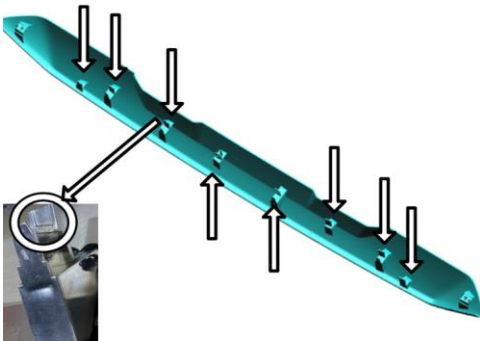
6833961

**Note:** The graphic above points to the locations of the “detents” on the deflector retainers. Refer back to this graphic to aid in releasing the retainers from their housings on the Front Grille.

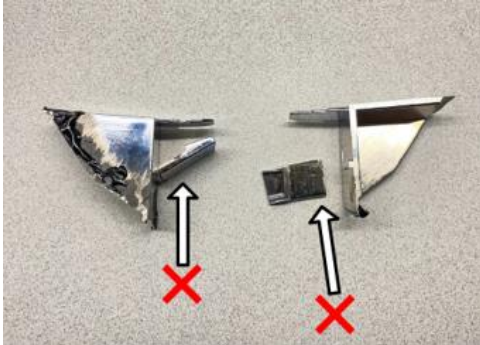
6850620

**Note:** **DO NOT** attempt to repair the Deflector if any of the retainer detent tabs are damaged or missing.

- If **ANY** of the retainer detent tabs are damaged (cracked, broken off, missing), proceed to Step 13.

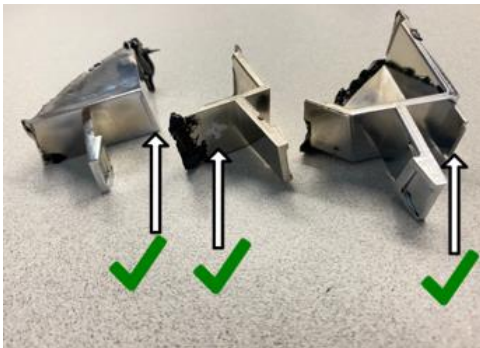
6850621

**Note:** The locating tabs do not affect the performance of the retainers. **DO NOT REPLACE THE FRONT GRILLE IF THE LOCATING TABS ARE DAMAGED OR MISSING.**

- If **NONE** of the retainer attachment detent tabs are damaged but the retainer locating tabs are damaged or missing, the retainer is OK – proceed to Step 12.

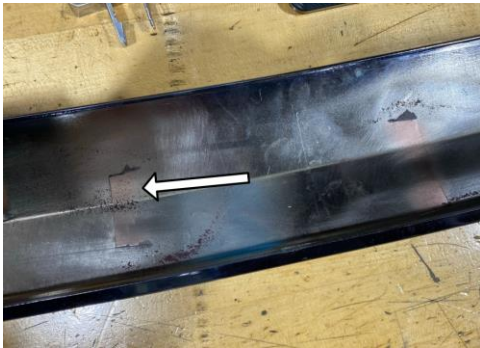
6833959

**Note:** It is not necessary to remove the retainers from the Deflector if they remained attached during removal. Sand and prep the area around where the retainer sits for good adhesion between the epoxy and the retainer.

14. Prep the surface and remove the chrome coating from ALL of the contacting surfaces of the retainers and Deflector using a rotary tool, 80-grit abrasive paper, or 3M Scotch-Brite pad or equivalent.

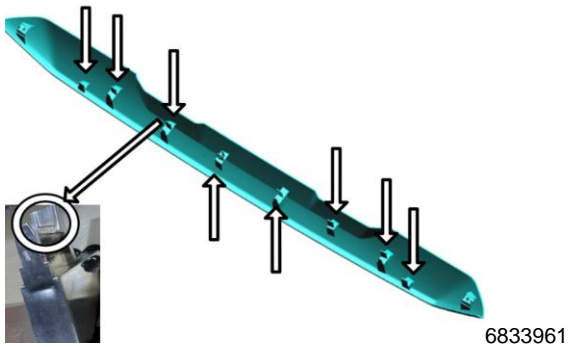
**Note:** The graphic above points to the locations of the “detents” on the deflector retainers. If any of the retainers detached from the Deflector during removal, use this graphic to properly orient the retainer so the detent is facing the correct position.

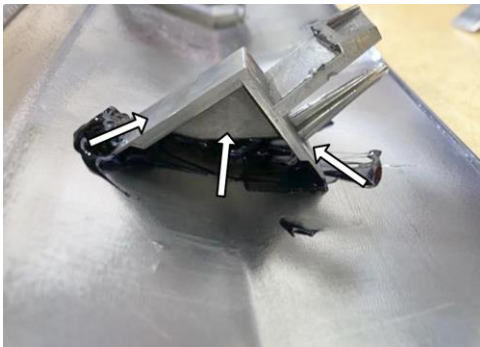
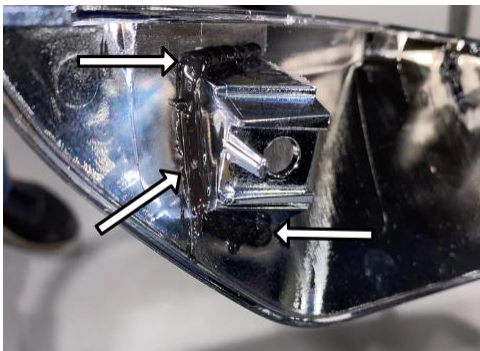
**Important:** If epoxying any separated retainers back onto the Deflector, ensure the direction of the detent on the end of the retainer is correctly positioned.

**Important:** Ensure that the ALL of the retainers receive a generous amount of epoxy around the entire base (both sides of each retainer) and extend up the body of the retainer. FAILURE TO DO SO COULD RESULT IN AN INSUFFICIENT BOND BETWEEN THE RETAINER AND THE DEFLECTOR.

18. Using the FUSOR-133 epoxy or equivalent, apply a generous amount on and around ALL of the retainers, including any retainers that may have separated from the Deflector. Ensure that the epoxy is applied around all base areas and extends up the body of the retainer. A minimum of 50ml of epoxy should be used to repair the deflector.
