# Safety Recall

## N242490120 Chrome Grille Deflector May Detach

**Release Date:** June 2025

<b>Condition</b>	General Motors has decided that a defect which relates to motor vehicle safety may exist in certain 2022 model year GMC Sierra 1500 vehicles equipped with chrome front grille deflectors. One or more of the attachments that hold the front upper grille deflector in place may fracture over time. If all eight attachment points break, the deflector may detach from the vehicle while driving. If a front grille deflector detaches unexpectedly while driving, there is increased risk of a crash.
<b>Correction</b>	Dealers will reinforce or repair all attachment points on the chrome front grille deflector.

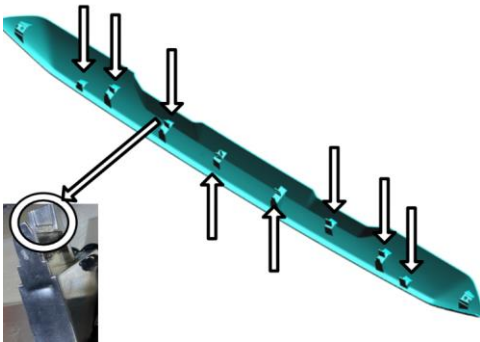
6833961

**Note:** The graphic above points to the locations of the “detents” on the deflector retainers. Refer back to this graphic to aid in releasing the retainers from their housings on the Front Grille.

3. Remove the two fasteners on the outer edge of the Upper Grille Deflector. Do not discard.

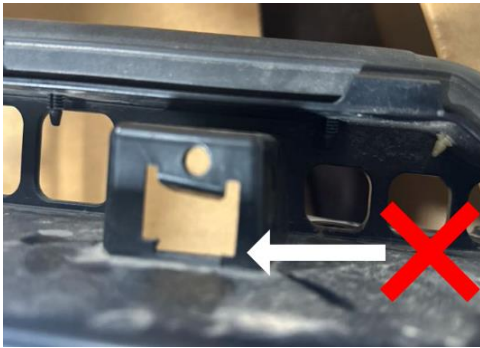
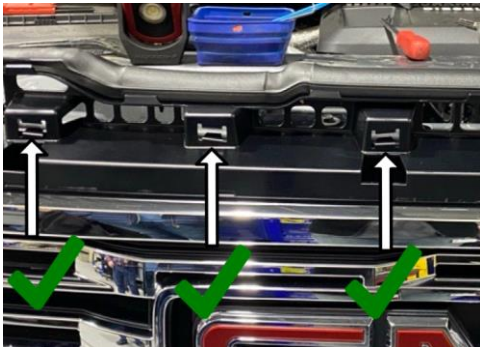
**Important: DO NOT replace the Front Grille unless it fails this inspection step.**

11. Inspect **ALL** Deflector retainer housings on the Front Grille for any damage, such as cracked, missing or broken attachment points, etc.
  - If **NONE** of the Deflector retainer housings on the Front Grille are damaged, and the Deflector is not missing from the vehicle, proceed to Step 13.

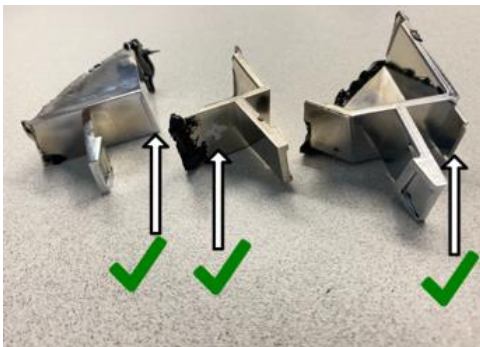
6850621

**Note: DO NOT REPLACE THE FRONT GRILLE OR UPPER DEFLECTOR IF THE LOCATING TABS ARE DAMAGED OR MISSING. The locating tabs do not affect the performance of the retainers.**

- If **NONE** of the retainer housings on the Front Grille are damaged, and the Deflector is missing from the vehicle, proceed to Step 20 to replace the Upper Deflector.
  - If **ANY** of the retainer housings on the Front Grille are damaged, proceed to Step 12.
12. Replace the Front Grille. Refer to *Front Grille Replacement* in SI. No further action is required after replacement.
  13. Inspect ALL of the Deflector retainer “Detent Tabs” for damage.

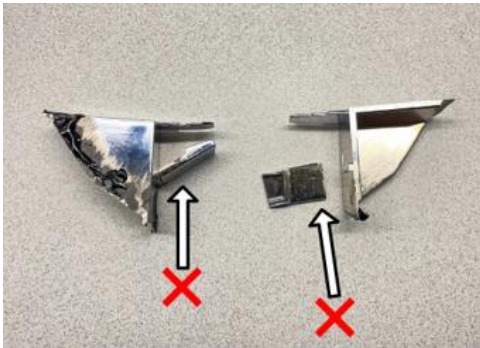
**Note:** **DO NOT** attempt to repair the Deflector with epoxy if any of the retainer detent tabs are damaged or missing.

- If **ANY** of the retainer detent tabs are damaged (cracked, broken off, missing), proceed to Step 20 to replace the Upper Deflector.

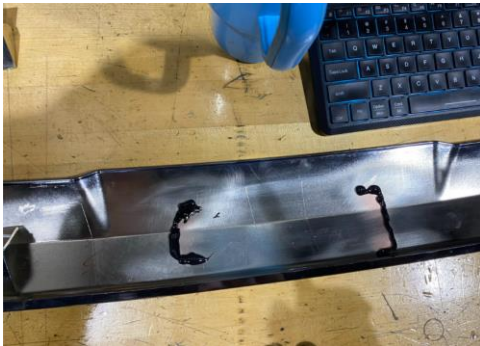
6833963

**Note:** To prevent the epoxy from drying too quickly, epoxy each retainer one at a time repeating Steps 17 and 18.

17. Using the FUSOR-133 epoxy or an equivalent fast setting, plastic safe repair adhesive, apply in the mounting location of any detached retainers, as shown above.

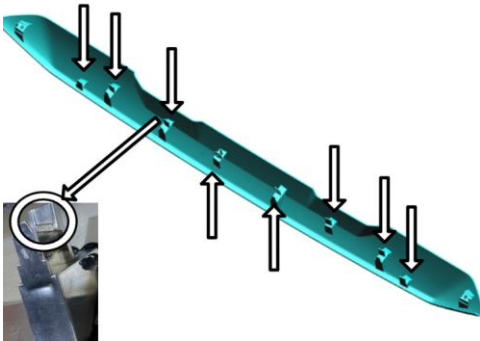
6833961

**Note:** The graphic above points to the locations of the “detents” on the deflector retainers. If any of the retainers detached from the Deflector during removal, use this graphic to properly orient the retainer so the detent is facing the correct position.

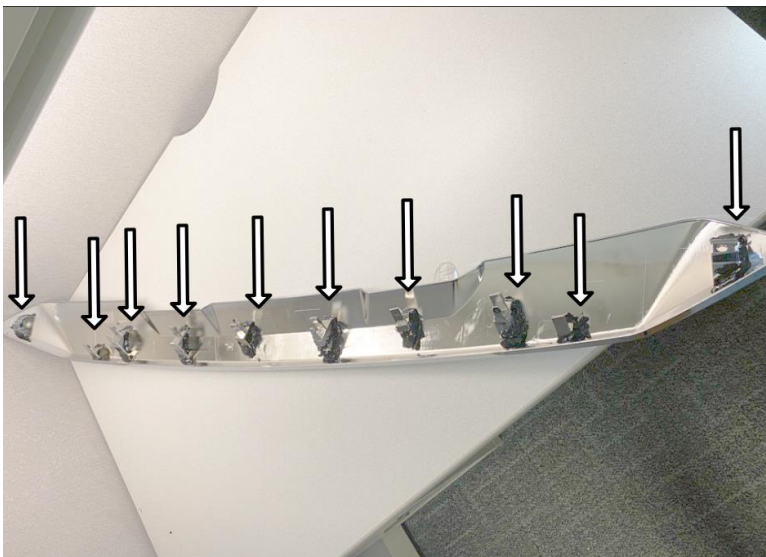
6957838

- When finished, all 10 retainers, including the 2 far outside retainers, should have a generous amount of adhesive covering all sides and extending up the body of the retainers and look like the above graphic.

18. Epoxy ALL Retainer Areas (Attached & Unattached) using FUSOR-133 epoxy or an equivalent fast setting, plastic safe repair adhesive.
  - Apply a generous amount on and around ALL of the retainers, including any retainers that may have separated from the Deflector.
  - Ensure that the adhesive is applied around all base areas and extends up the body of the retainer. A minimum of 50ml of adhesive should be used to repair the deflector.
