**HYUNDAI**
Technical Service Bulletin

GROUP RECALL	NUMBER 25-01-014H
DATE FEBRUARY 2025	MODEL(S) IONIQ 5 (NEA EV)

SUBJECT: REAR SEAT FLOOR WIRING HARNESS CONNECTOR TERMINALS
INSPECTION/HARNESS REPLACEMENT (RECALL 274)

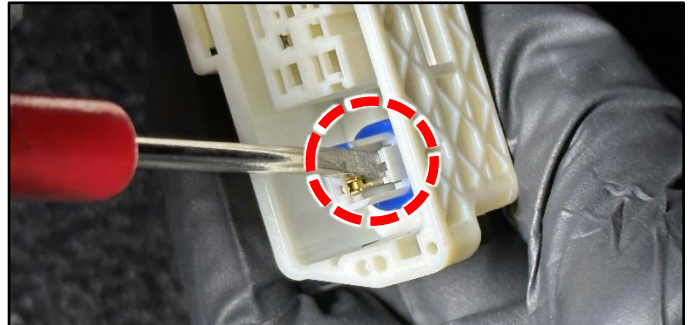
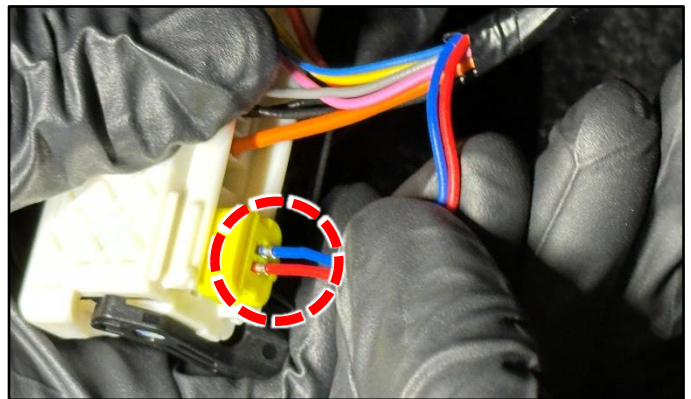
7. With the LH connector, lift the indicated locking part with the terminal tool and pull pin 29 (blue wire) and pin 30 (red wire) out through the back.

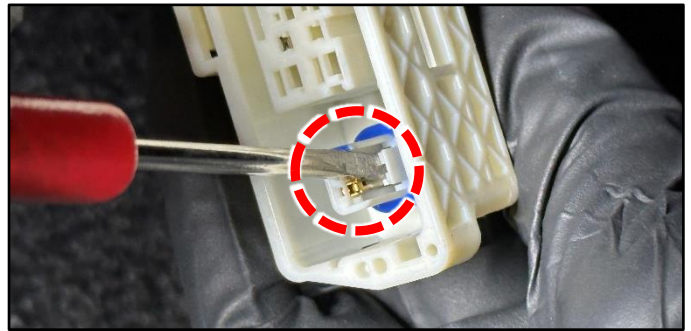
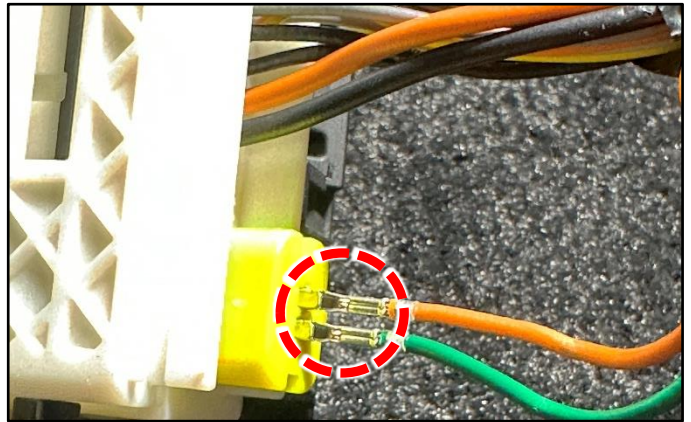
8. With the RH connector, lift the locking part with the terminal tool and pull pin 29 (orange wire) and pin 30 (green wire) out through the back.

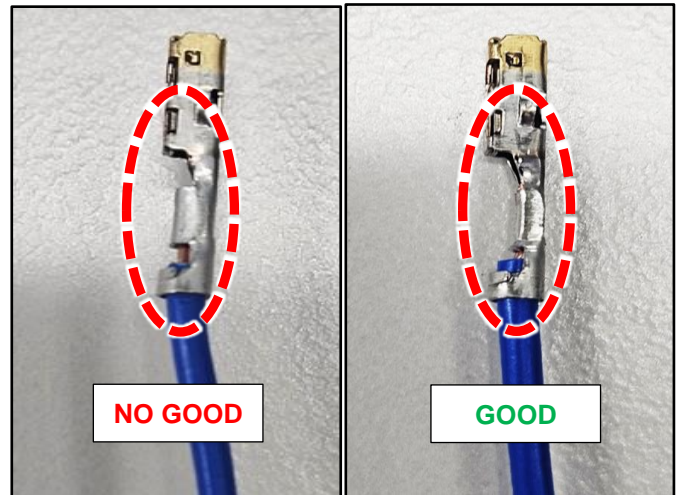
9. Inspect LH and RH pin 29 and 30 terminals. Terminals with insufficient crimping in the area marked in the photo are **NO GOOD**.

- If **ALL** of the terminals are **GOOD**, proceed to **step 10**.
- If **ONE OR BOTH** of the terminals is **NO GOOD**, proceed to **step 10** and upload the picture to STUI. HMA will release the parts when pictures have been reviewed. Proceed to the **Rear Floor Wiring Harness Replacement Procedure** when the part is received.

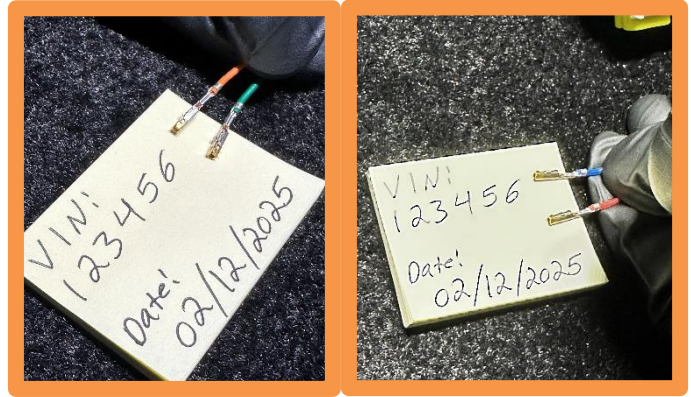
Using STUI, take two close-up photos, one of LH terminals and one of RH terminals with the last 6 digits of the VIN and the date of repair on a piece of paper.

Once you have taken a picture of the improper crimps and uploaded to STUI, place an order for the specific part number listed in the Web Parts Catalog for the harness. Ensure you provide the VIN when ordering the harness.
