Priority Field Campaign

Modification Bulletin

60-0011 - MB - EUR - YTxx3 - CAM0175 steering arm bolts

**Steering arm bolt undertorqued
YTxx3 with mechanical steering**

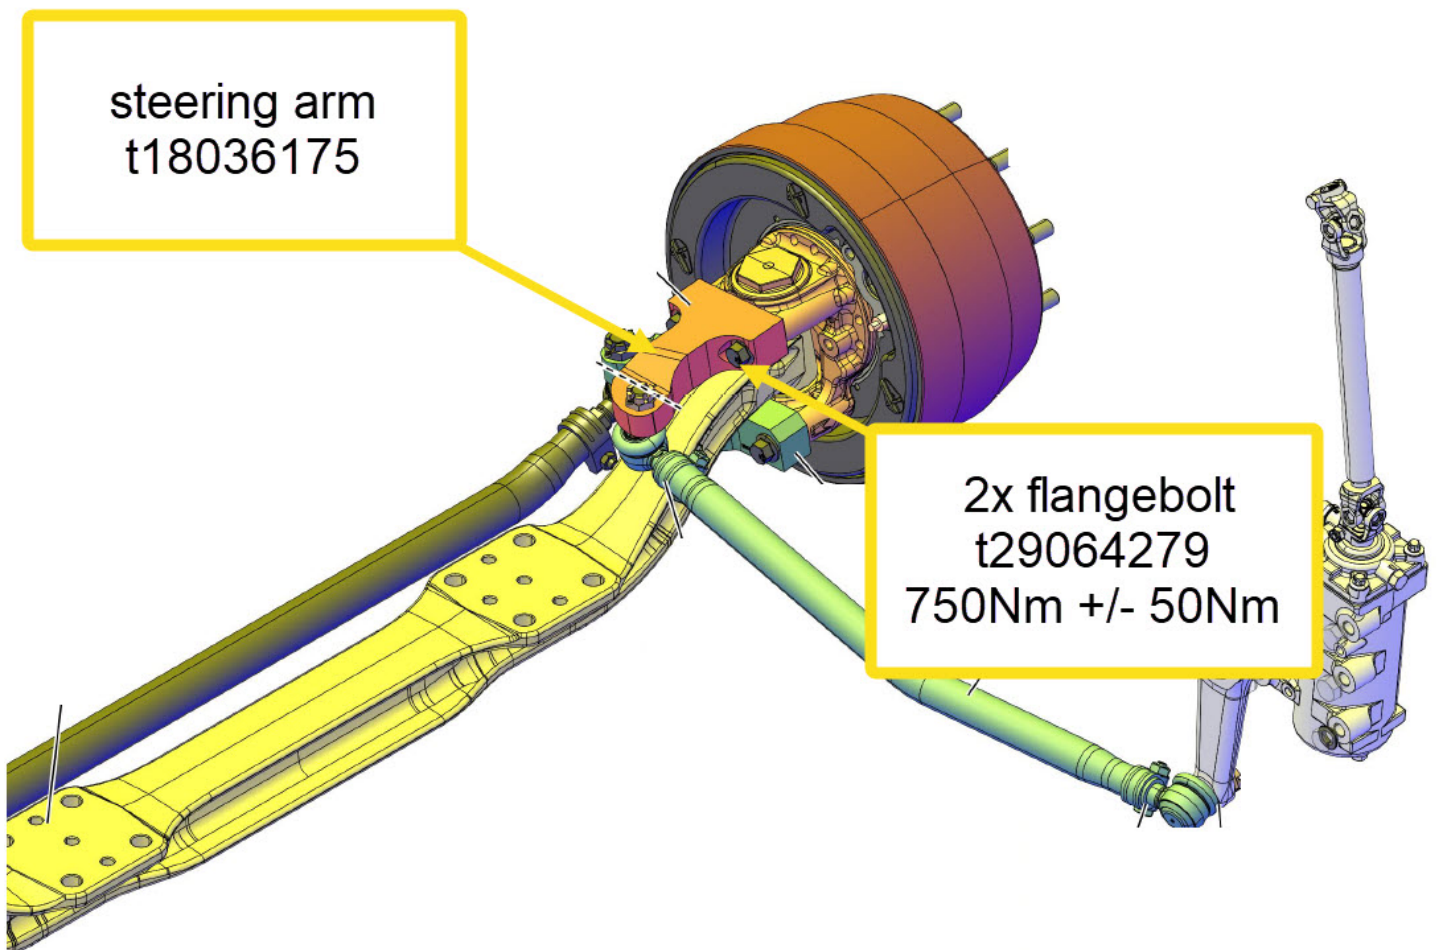
During a production assessment it was found that a bolt in the steering system was undertorqued (300 Nm instead of 750 Nm). This can result in an insecure connection of the upper steering arm to the left steering knuckle.

figure 1, steering arm and bolt positions

To address this issue, the steering arm bolts must be removed, the holes cleaned, and new bolts installed and torqued to the specified requirements.

6. Remove plastic mudguard over left hand front wheel.
7. Remove the 2 bolts that connect the upper steering arm, see figure 1, to the left hand side steering knuckle.

10. Install the steering arm, using 2 new bolts t29064280. No threadlock has to be applied as the bolts come with threadlock applied.
11. Torque bolts between 700 Nm and 800 Nm.
