ASAO – Check Rear Seat Belt Buckles and Rework if necessary (Stop Delivery / Recall Campaign)

Model Line: **911 (992)**

Model Year: **As of 2023 up to 2025**

Concerns: **Rear seat belt buckles**

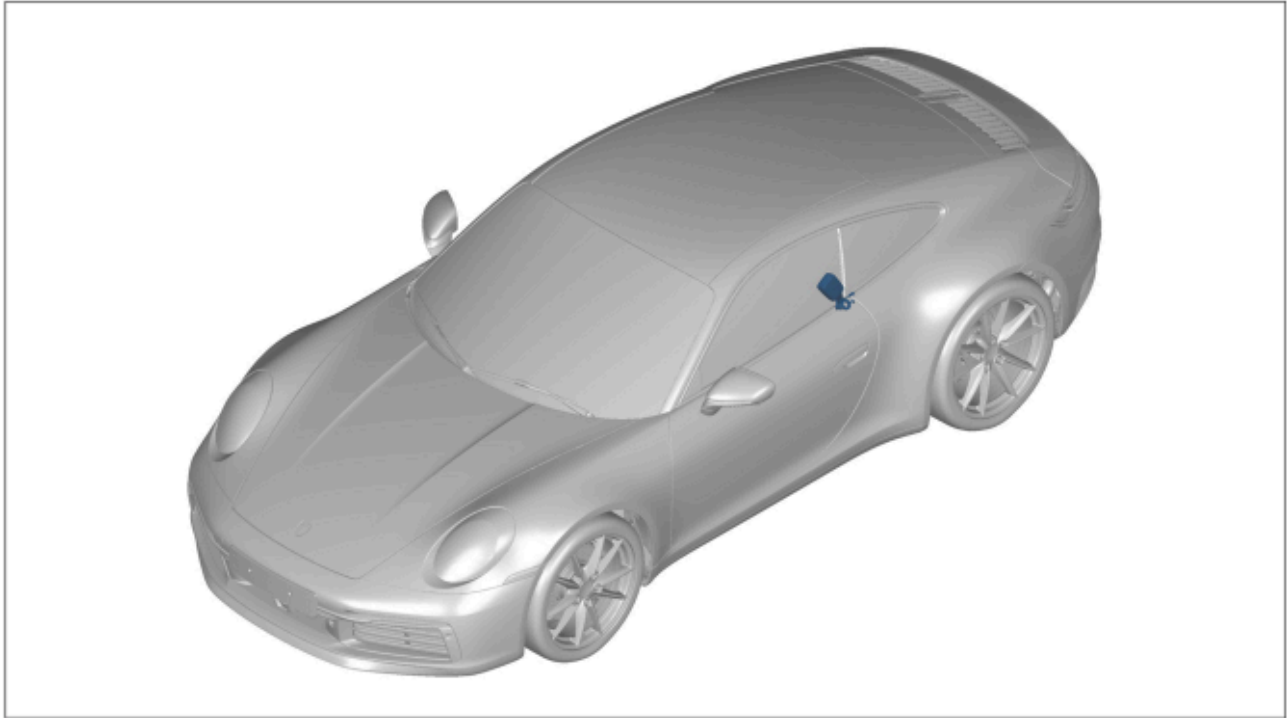
Installation position of rear seat belt buckle

Cause: **Due to a process error in the production process, an aluminium butyl mat was incorrectly positioned and consequently the screw connection of the rear left and right seat belt buckle was potentially not designed according to the specifications.**

If this is the case, the correct screw connection of the seat belt buckle would not be ensured. In this case, it cannot be ruled out that the rear seat belt buckles will be loosened in the event of an accident or full braking. This could increase the associated risk of injury.

Action: Check rear seat belt buckles and rework if necessary.

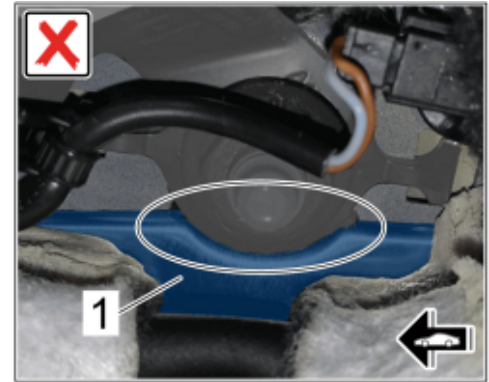
Checking rear seat belt buckle

The aluminium butyl mat must **not** be located below the seat belt buckle. Furthermore, there must be a **minimum distance of 10 mm / 0.39 in** from this.

Assessment		Action
(✓)	The aluminium butyl mat is not located below the seat belt buckle and complies with the minimum distance on both sides .	Continue with Step 3. [Warranty processing: Scope 1]
(✗)	The aluminium butyl mat is located below the seat belt buckle or does not comply with the minimum distance on one or both sides .	Continue ⇒ <i>Technical Information 'to rework the seat belt buckle'</i> One side: [Warranty processing: Scope 2] Both sides: [Warranty processing: Scope 3]

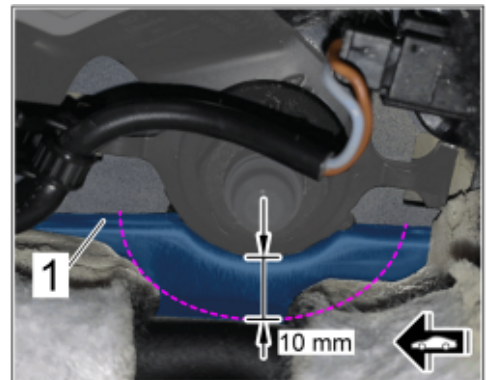
Fresh cut on aluminium butyl mat

In order to ensure the correct fastening of the belt buckle, the aluminium butyl mat below must be cut free correspondingly with a distance of 10 mm/ 0.39 in.

2 Mark fresh cut on aluminium butyl mat ⇒ *Fresh cut on aluminium butyl mat -1-* with suitable means.
