# Compliance Recall

## Code: 90AV

#### Camera Control Unit

**Subject: Compliance Recall 90AV - Camera Control Unit**

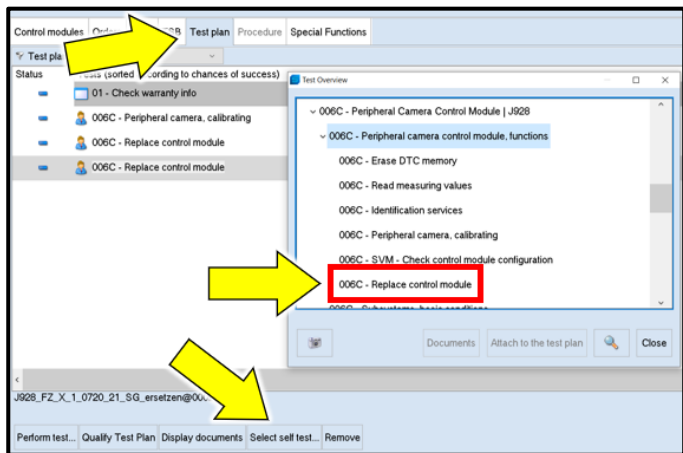
### Replace Peripheral Camera Control Module -J928-

- Customer concern may be, “no camera images are displayed”.
- DTC U104C00: “Rear view camera system control module no communication” is stored in the Gateway (DA 0019).
- J928 may be offline when vehicle is scanned.

- See ELSA Repair Manual: *Repair Manual > Electrical System > Driver Assistance Systems > 98 Assistance Systems > Sensors and Control Modules > Peripheral Camera Control Module J928, Removing and Installing*
- **The new control module does not require the software update.**
