# Thor Motor Coach Recall Repair Instructions

Recall #	<b>25V-097 2025-093</b>		
Description/Title:	<b>Solar Panel</b>		
Affected Product Line(s):	<b>Certain MY 2023 Gemini and Compass motorhomes</b>		
Service Campaign # :	<b>RC000322</b>		
Repair Code:	<b>Inspect with Repair: TMCRC80599J</b>	Document Date:	<b>2/13/2025</b>
Time Allowed:	<b>Inspect with Repair: 0.5 hr</b>	Document Revision:	<b>A</b>

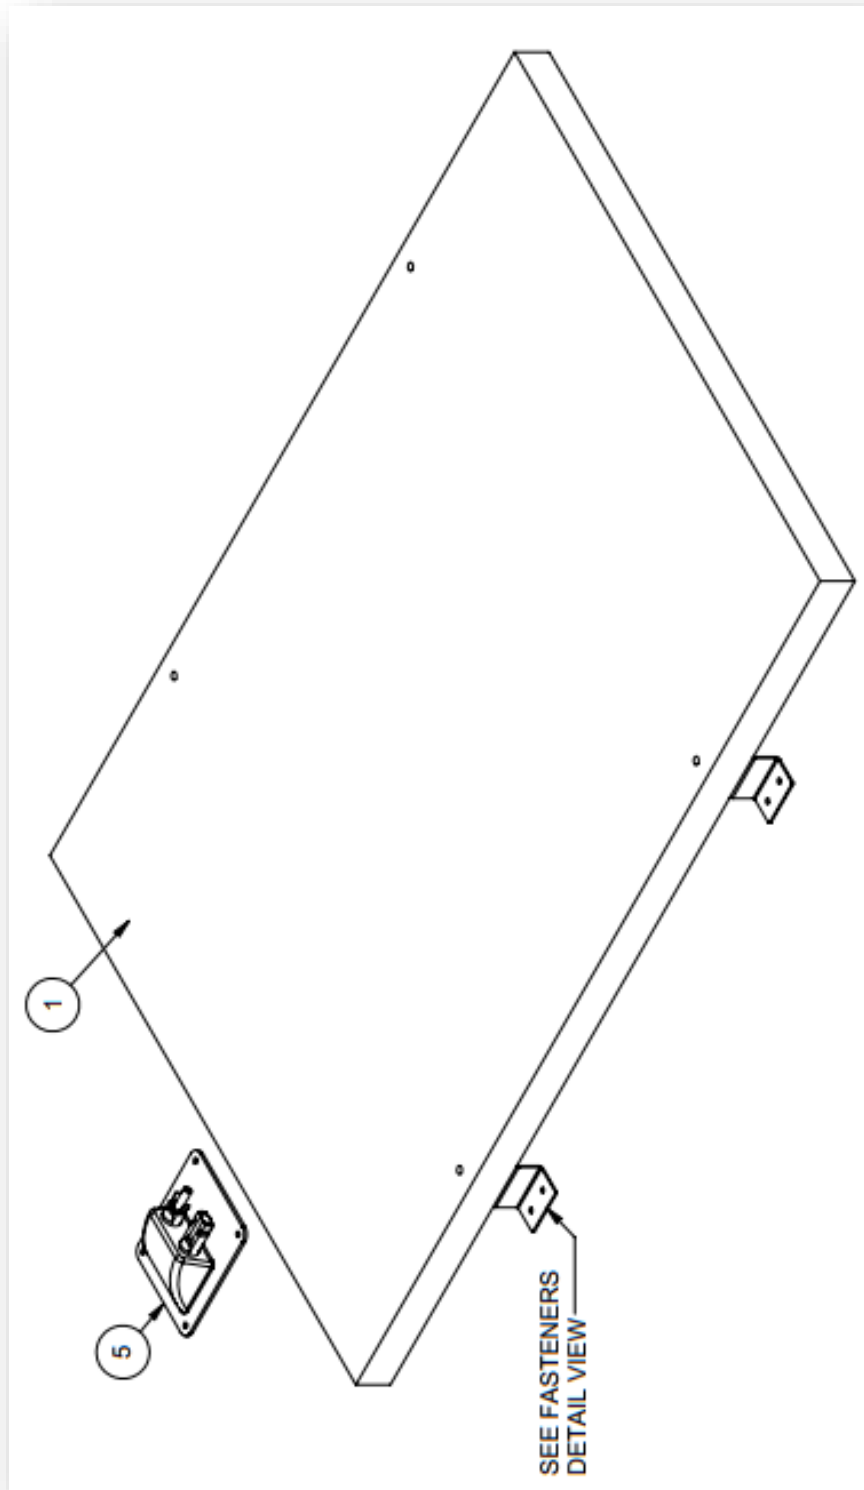
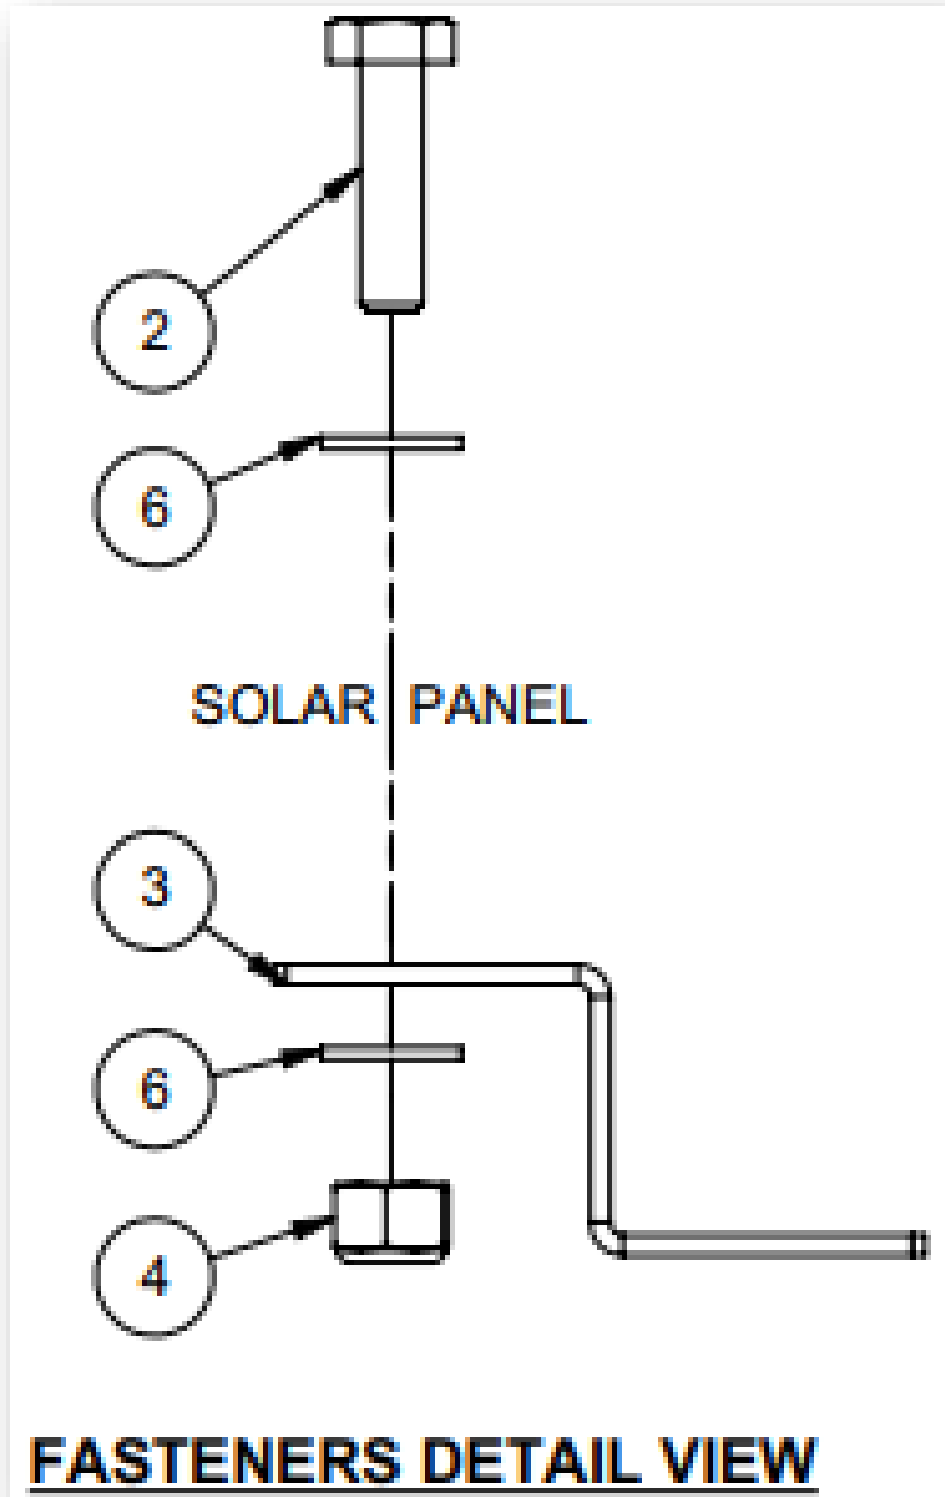
Solar panels were not installed properly on the roof. The washers to be used in conjunction with the bolts for the mounting brackets are missing.

1. Inspect each bracket (#3) for any damage and missing washers (#6).
2. If no bracket (#3) damage is present and washers (#6) are installed per fasteners detail view, no further action required.
3. If bracket (#3) is damaged, replace bracket (#3) and reassemble according to the fasteners detail view.
4. If no bracket (#3) damage is present, but washers (#6) are missing, reassemble according to the fasteners detail view.
- 5. Verify EACH Solar Panel hardware shown in FASTENERS DETAIL VIEW is torqued to 8-12 FT-LBS**
