## Customer Legal Recall

### MAS004603\_B (CLR 25-03)

## Customer Legal Recall # 740 – U.S. MY21 - MY25 Ghibli, Quattroporte , Levante, Grecale, GT/GC, MC20 and MC20 Cielo – ETM SW UPDATE

### Description of Vehicle Safety Recall # 740

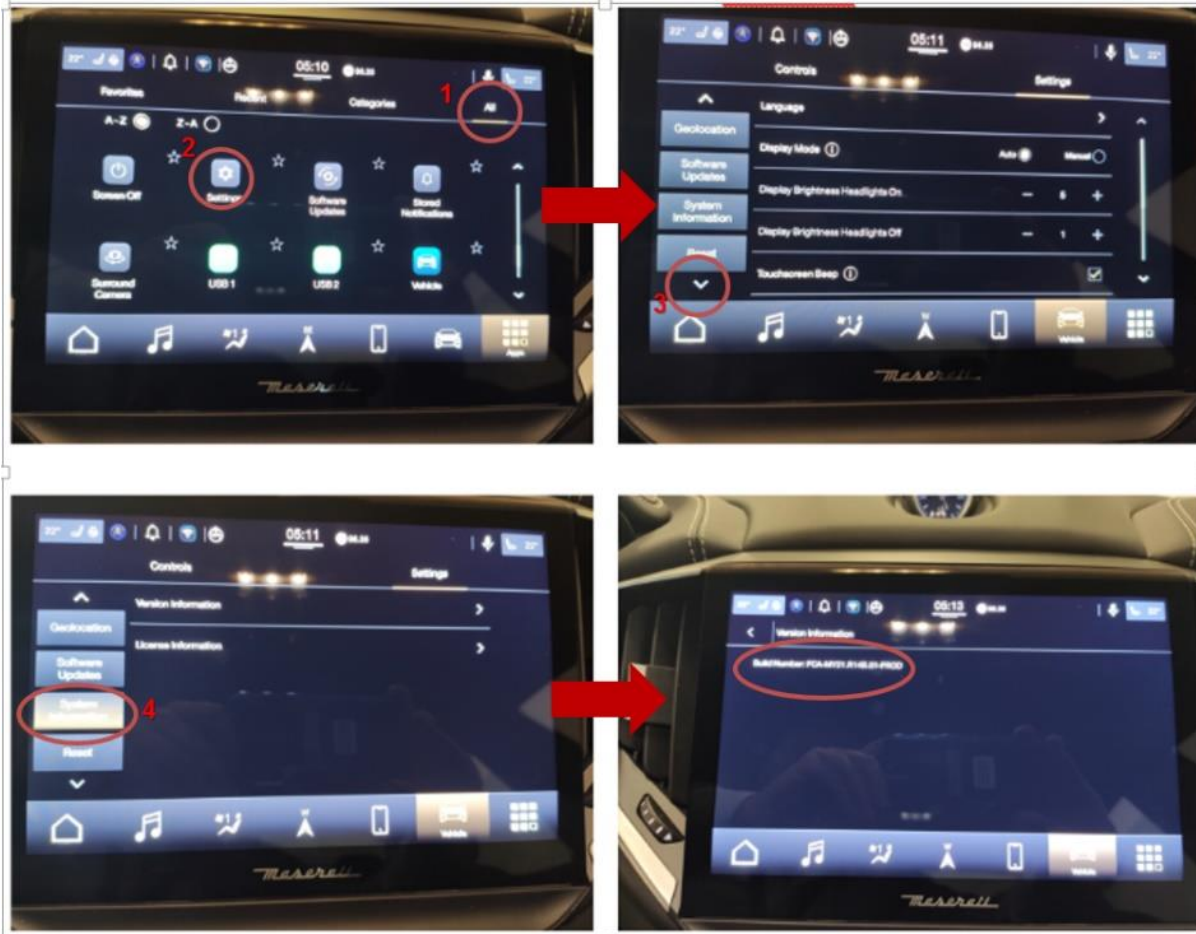
1. Check the actual software version on the vehicle:

2. Compare the software level of the vehicle with the SW listed in **TABLE 2** below:
3. If the actual software level in the vehicle is the same as the “**SW Target**”, No further action is needed.
4. However, if the software level is lower than the “**SW Target**”, the USB update is mandatory. Use “**TABLE 2**” to determine which SW update to perform and which steps.

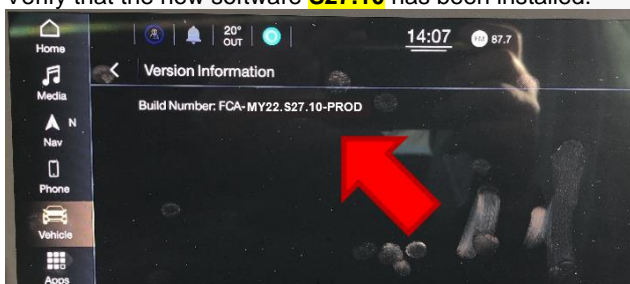
8. Verify that the new software **S27.10** has been installed:

9. Perform the “factory reset, radio sleep, and restart” procedure outlined on page 8. **Afterward, continue to step 10 below.**

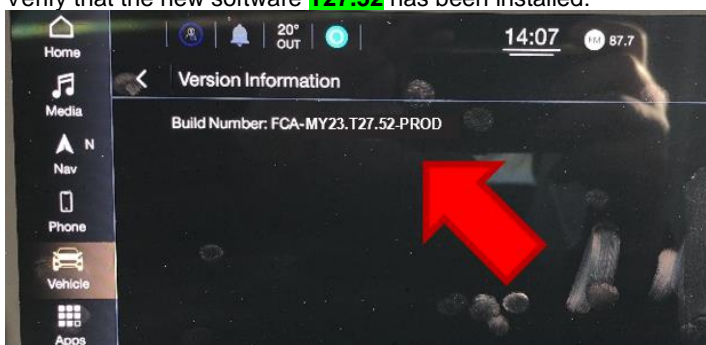
11. Use another USB FLASH DRIVE and format it to NTFS.
12. Copy the zip file to the USB FLASH DRIVE. (DO NOT UNZIP THE FILE!)
13. With the engine running, insert the USB FLASH DRIVE into the vehicle’s USB port.
14. A pop-up will appear on the radio display, press “Update Now” and “Continue”.
15. This step will take approx. 1 hour and 30 minutes without any action being carried out by the operator.
16. After the system reboots automatically, press “Accept” and remove the USB FLASH DRIVE from the vehicle.
17. Verify that the new software **T27.52** has been installed:

18. Perform the “factory reset, radio sleep, and restart” procedure outlined on page 8.
19. **Procedure complete.**

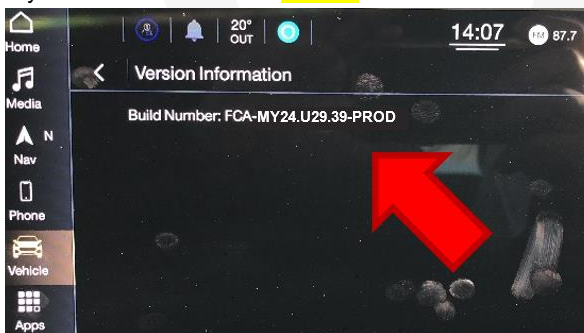
1. Download “R1\_U29.39\_M18X\_NAFTA\_NO\_NAV” from MODIS.
2. Format the USB FLASH DRIVE to NTFS file system.
3. Copy the zip file to the USB FLASH DRIVE. (DO NOT UNZIP THE FILE!)
4. With the engine running, insert the USB FLASH DRIVE into the vehicle’s USB port.
5. A pop-up will appear on the radio display, press “Update Now” and “Continue”.
6. This step will take approx. 30 minutes without any action being carried out by the operator.
7. After the reboot of the system, press “Accept” and remove the PEN Drive.
8. Verify that the new software **U29.39** has been installed:

9. Perform the “factory reset, radio sleep, and restart” procedure outlined on the page. **Afterwards, continue to step 10.**

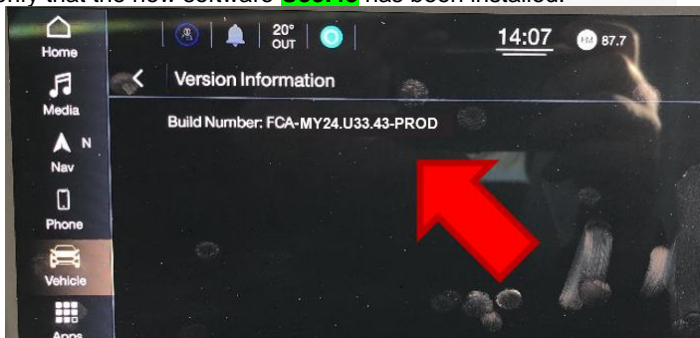
11. Use another USB FLASH DRIVE and format it to NTFS.
12. Copy the zip file to the USB FLASH DRIVE. (DO NOT UNZIP THE FILE!)
13. With the engine running, insert the USB FLASH DRIVE into the vehicle’s USB port.
14. A pop-up will appear on the radio display, press “Update Now” and “Continue”.
15. This step will take approx. 1 hour and 30 minutes without any action being carried out by the operator.
16. After the system reboots automatically, press “Accept” and remove the USB FLASH DRIVE from the vehicle.
17. Verify that the new software **U33.43** has been installed:

18. Perform the “factory reset, radio sleep, and restart” procedure outlined on **page 8**.
19. **Procedure complete.**

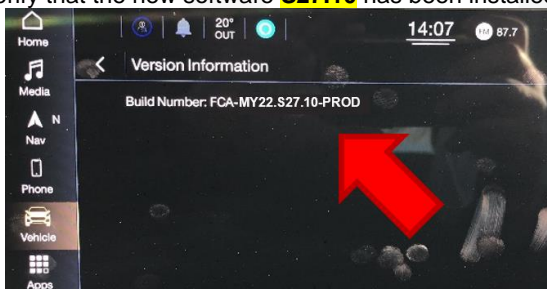
1. Download “R1\_S27.10\_M240\_NAFTA\_NO\_NAV” from MODIS.
2. Format the USB FLASH DRIVE to NTFS file system.
3. Copy the zip file to the USB FLASH DRIVE. (DO NOT UNZIP THE FILE!)
4. With the engine running, insert the USB FLASH DRIVE into the vehicle’s USB port.
5. A pop-up will appear on the radio display, press “Update Now” and “Continue”.
6. This step will take approx. 30 minutes without any action being carried out by the operator.
7. After the reboot of the system, press “Accept” and remove the PEN Drive.
8. Verify that the new software **S27.10** has been installed:

9. Perform the “factory reset, radio sleep, and restart” procedure outlined on page 8. **Afterwards, continue to step 10.**

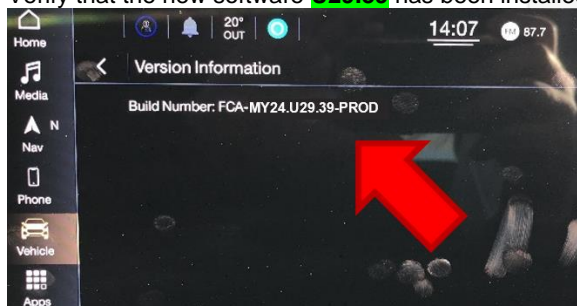
11. Use another USB FLASH DRIVE and format it to NTFS.
12. Copy the zip file to the USB FLASH DRIVE. (DO NOT UNZIP THE FILE!)
13. With the engine running, insert the USB FLASH DRIVE into the vehicle’s USB port.
14. A pop-up will appear on the radio display, press “Update Now” and “Continue”.
15. This step will take approx. 30 minutes without any action being carried out by the operator.
16. After the system reboots automatically, press “Accept” and remove the USB FLASH DRIVE from the vehicle.
17. Verify that the new software **U29.39** has been installed:

18. Perform the “factory reset, radio sleep, and restart” procedure outlined on page 8. **Afterwards, continue to step 10.**

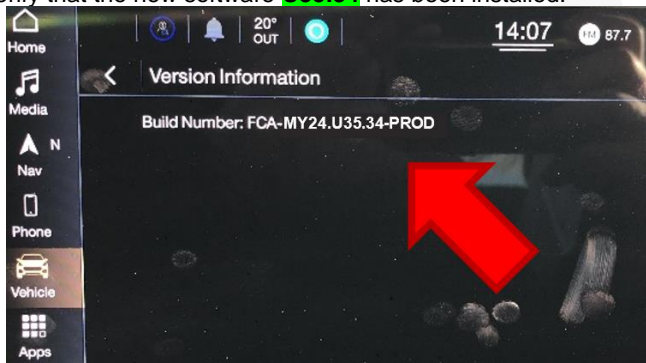
26. Verify that the new software **U35.34** has been installed:

27. Perform the **“factory reset, radio sleep, and restart”** procedure outlined below.

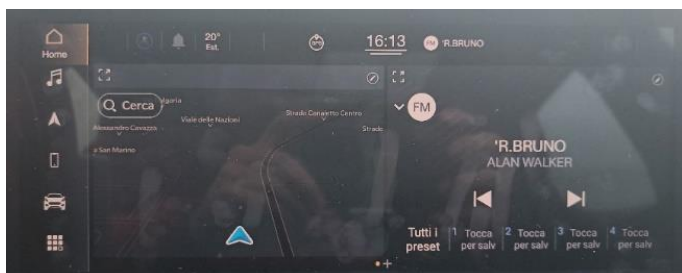
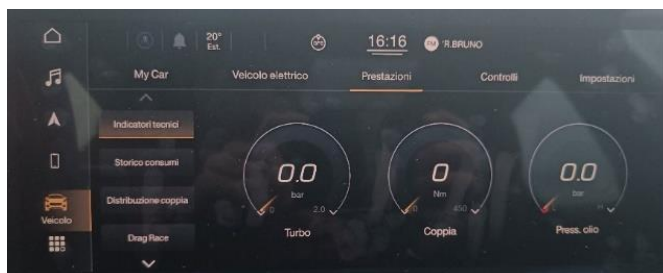
5. Check configuration and ensure that all widgets and screens have the correct theme according to the following slides (No Blue theming should be visible).
