GROUP	MODEL
Safety Recall Campaign	2021-2023MY Soul (SK3) <u>and</u> Seltos (SP2) w/2.0L Nu MPI Engine
NUMBER	DATE
SC336 (Rev 6, 10/21/2025)	April 2025

ENGINE INSPECTION/REPLACEMENT AND ECM LOGIC IMPROVEMENT (SC336)

This bulletin provides information 1) to perform an engine vibration inspection and, if necessary, replace the engine long block, and 2) to install the Piston Ring Noise Sensing System software in the Engine Control Module (ECM) on certain 2021-2023MY Soul (SK3) produced from July 2, 2020 through April 19, 2022 and certain 2021-2023MY Seltos (SP2) produced from July 2, 2020 through July 1, 2022 vehicles equipped with 2.0L Nu MPI (Atkinson) Engine. The piston oil ring(s) in the subject vehicles may, over time, damage the surface of the engine cylinder wall. This may lead to increased oil consumption which will eventually result in abnormal noise from the engine and/or illumination of the oil pressure warning light. If the vehicle is continually operated in this condition, engine damage and/or seizure can occur, resulting in loss of motive power. In limited cases, a fire may occur from engine oil leaking onto a hot exhaust component due to a hole in the engine block. Lo

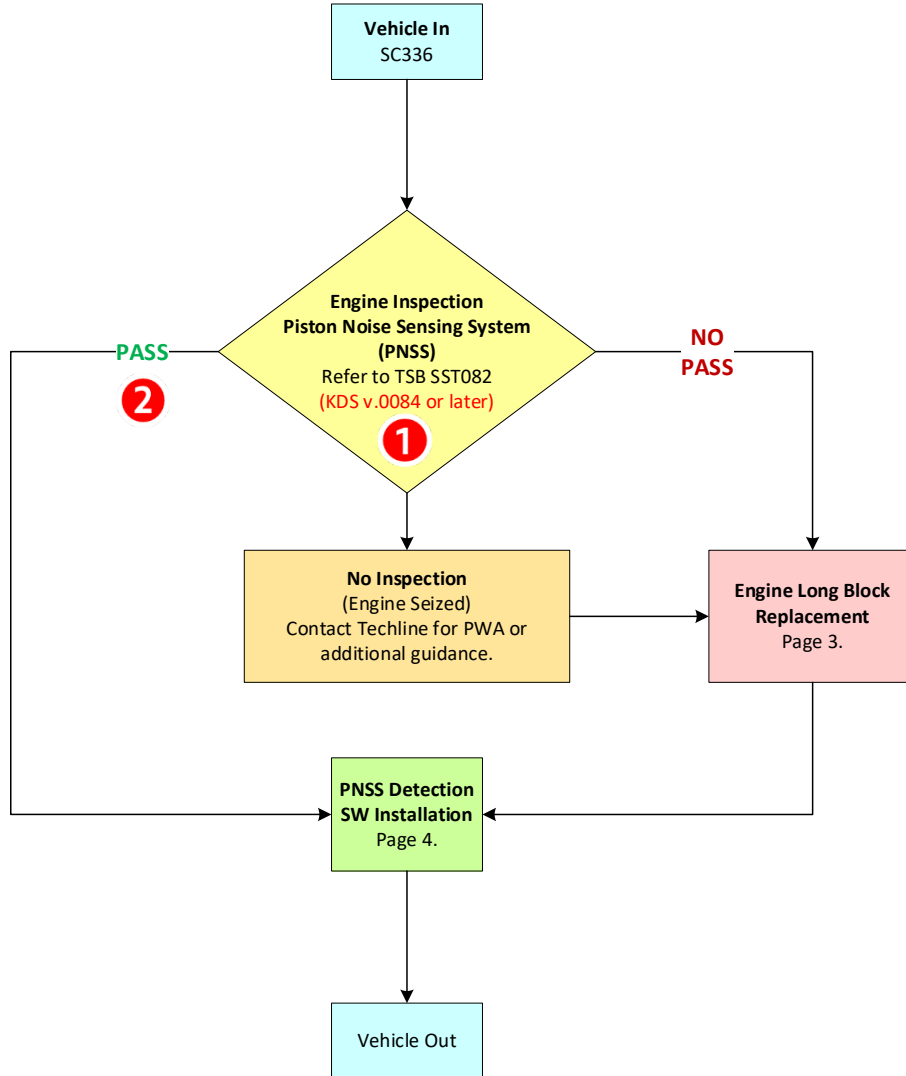
Flowchart:

DO NOT install the PNSS Detection Software BEFORE performing the Engine Inspection (Piston Noise Sensing Sensor)

1. RETEST: If there's an error on the measured engine vibration test, check the jack input (microphone) and knock sensor connection and perform measuring test again. If the results keep displaying 'RETEST' (more than 2 times), open a Techline case online for further instructions.

2. PASS (Engine Noise): If engine noise is present and the Engine Vibration Inspection results in a PASS, then open a Techline case for further instructions.
