GROUP	MODEL
Safety Recall Campaign	2025MY EV9 (MVa)
NUMBER	DATE
SC337	February 2025

SAFETY RECALL CAMPAIGN

REAR MOTOR AND REDUCTION GEAR DRIVE ASSEMBLY REPLACEMENT (SC337)

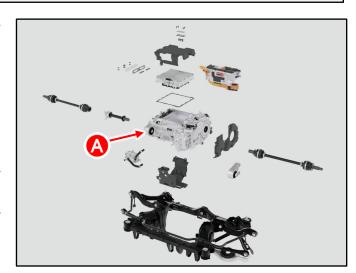
Note: The Shift by Wire (SBW) actuator assembly will need to be reused and transferred to the 'new' GDU/Rear Motor and Reduction Gear Assembly.

Remove the Rear Motor and Reduction Gear Assembly (GDU) (A) by referring to "Motor and Reduction Gear System → Rear Motor and Reduction Gear Assembly → Removal → Installation" in the applicable Shop Manual on KGIS.

- 2a. Loosen the three (3) SBW actuator assembly(B) retaining bolts and remove it from the existing GDU.
- 2b. Install the removed SBW actuator assembly (B) onto the 'new' GDU.
- 3. Install the new GDU and all other removed parts in reverse order of removal.
