# Recall Bulletin 250221REV

**RECALL BULLETIN:**  
**250221REV**  
**NHTSA #25V121**  
**TC #2025-107**

**FLEETWOOD BOUNDER, FLAIR FLEX, FORTIS SOUTHWIND**

**SUBJECT:**  
**Engine Exhaust Tips**

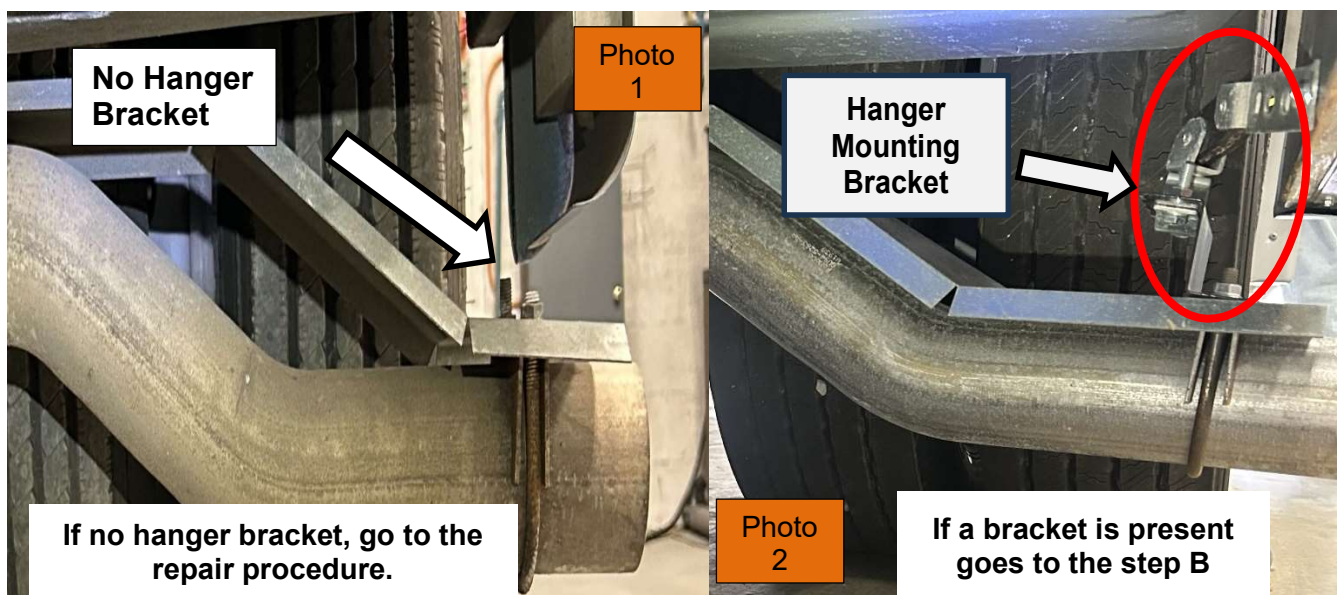
- A.** Inspect to determine if the main exhaust has a hanger mounting bracket as outlined in photo 2, if no bracket exists go to the repair procedure. See photo 1. Note: The bracket is not required but just assists with identifying if a repair is needed. However, if the **main exhaust hanger mounting bracket does exist** as shown in photo 2, go to Step B for further validation.

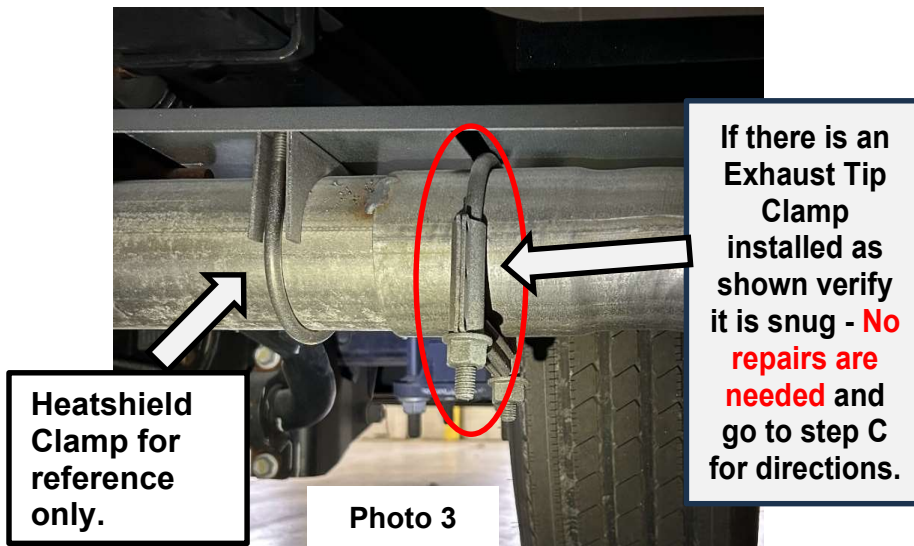
- B. Look where the exhaust tip connects to the main exhaust pipe. Determine if there is a clamp attaching the exhaust pipe to the exhaust tip. If the clamp is missing, go directly to the repair procedure in the next section. **Note: Do not be confused with the clamp adhering the main exhaust pipe to the heat shield. The heatshield clamp is important but is not the primary focus of this repair procedure.**

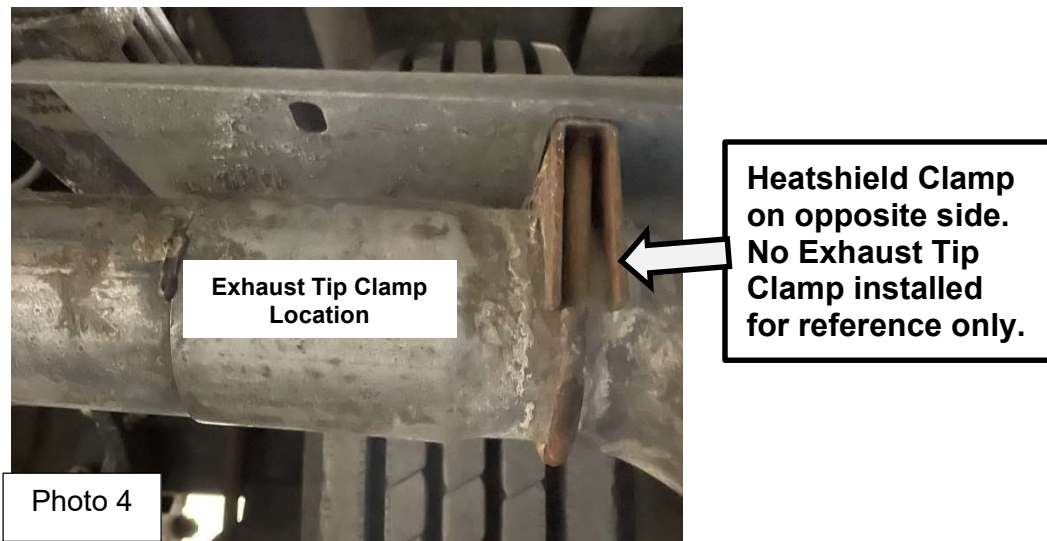
Variation: On some models the Heatshield Clamp may be on the opposite side of where the exhaust tip clamp is or needs to be installed. See photo 4.

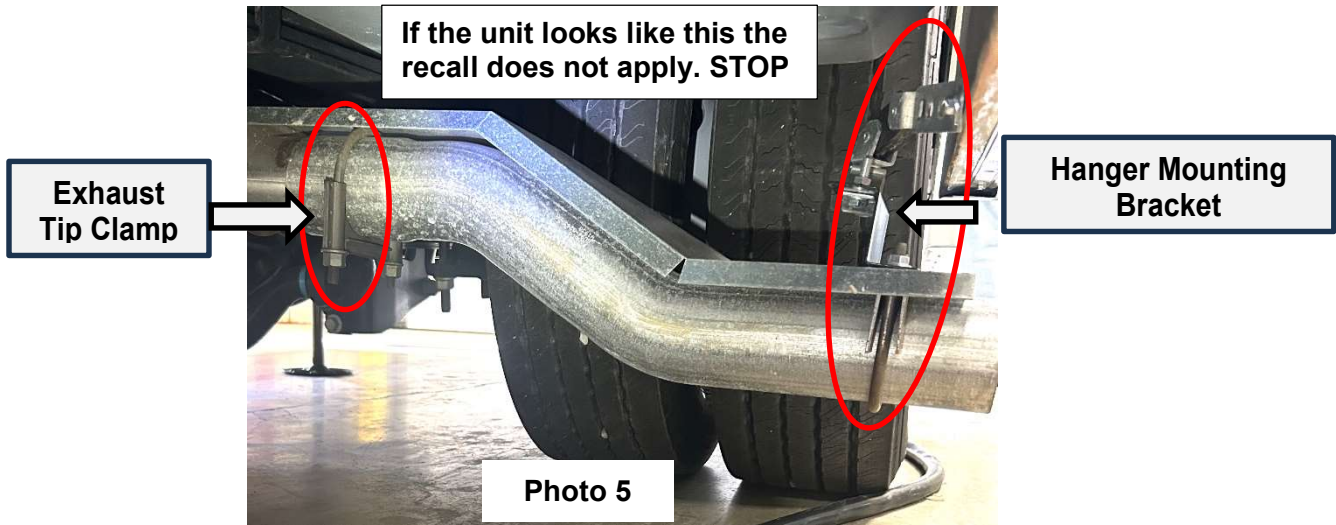
- C. If **both** the hanger mounting bracket and the clamp are installed as shown in photo 5 below, file a warranty request for inspected and found **NOT** defective and use Flat Rate **Code 6320 11. No other work is required.**

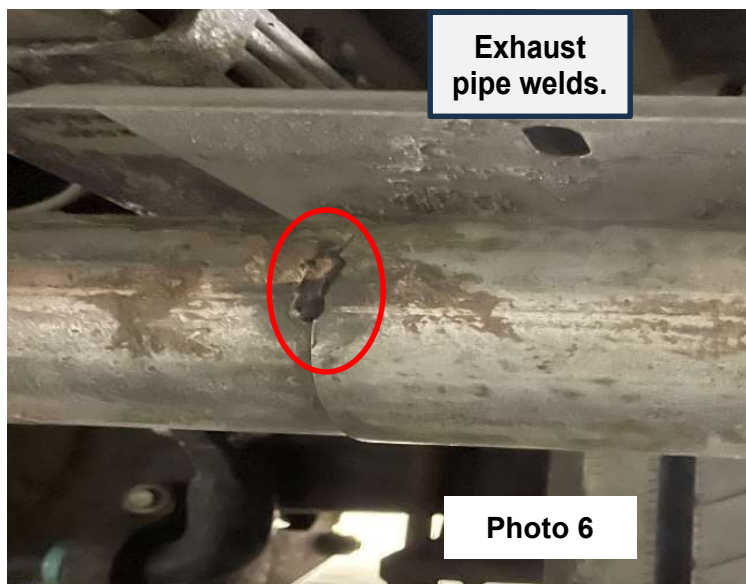
1. Inspect the welds on the main exhaust pipe where the tip attaches. See photo 6. If they are intact, proceed to step 3. If it is not intact, proceed to step 2.

2. If the welds are broken, make sure to reorient the exhaust pipe tip by hand, to ensure it properly extends beyond the outer edge of the sidewall vertical plane, so gases discharge away from the vehicle.

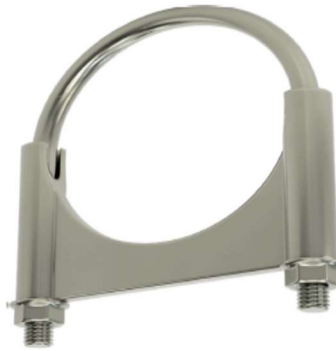
**Clamping U-Bolt Steel, 3/8"-16 Thread Size, 3-5/8" ID**

**PART NEEDED - # 10908195 ordered from [revrvparts.com](http://revrvparts.com) OR Call REV Parts (800) 509-3417 or ordered from McMaster-Carr Part #3042T21**
