Keystone RV Company

3/18/25

SAFETY ADVISORY 25-463

7-Way Cord and 12V Distribution Box Wiring

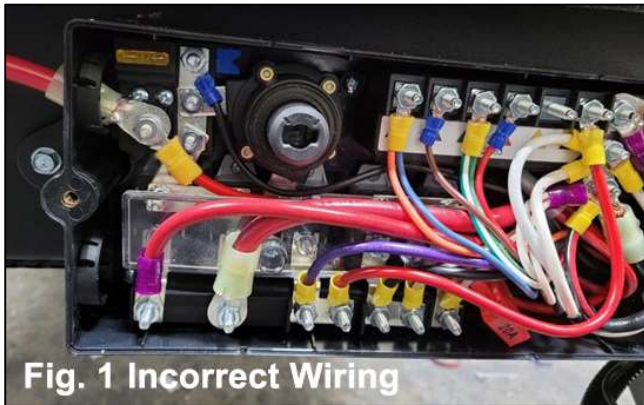
Fig. 1 Incorrect Wiring

Keystone is conducting a voluntary RECALL notification campaign in accordance with the National Highway Transportation and Safety Act. It has been decided the 7-way cord and 12V distribution box wiring may have been hooked up incorrectly. Under certain conditions during travel, the charge line may not be properly protected leading to an increased risk of fire. The following procedure describes how to identify and repair wiring.

Inspect wiring at 12V Distribution box. See **Figure 1** incorrect location of wiring. If correct according to **Figure 2** correct location of wiring, proceed to claim inspection. No further action is required. If incorrect proceed to **Step 4**.

The remedy is to relocate 7-way 12V distribution box wires to correct location as outlined below:

Repair wiring according to **Figure 2**.

- Starting by moving wire from slot 22 to slot 1, which is the battery terminal.
- Ensure that slot 5 is connected to the red wire.
- Ensure that slot 6 is empty.
- Ensure slot 7 has the red wire.
- Ensure slot 9 has the purple wire as well as black wire.
- Next ensure slot 10 is the brown wire and brown/ white wire, one side of the red jumper.
- Slot 17 is the other end of the red jumper wire.
