Safety Recall – 2024-2025MY CX-50 Trailer Hitch Bolts Improperly Torqued PLEASE READ THE ENTIRE DOCUMENT

REPAIR OUTLINE: This repair is to re-torque the 8 Trailer Hitch Mounting Bolts to 87 ft-lbs (118 N-m)

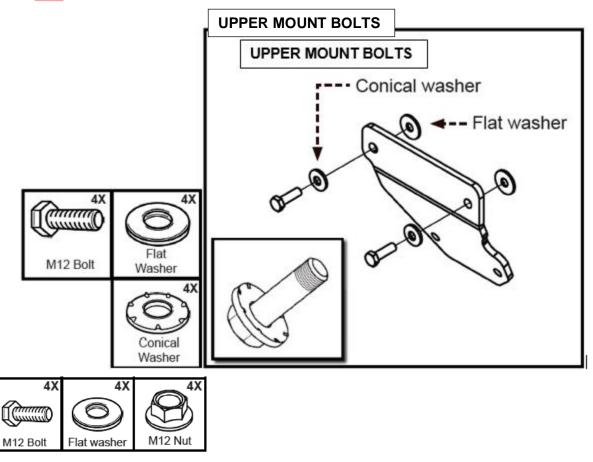
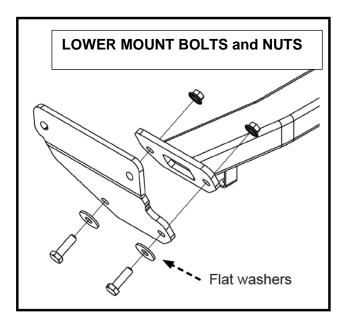
NOTE: The Upper bolts are M12 with 2 flat washers and 2 Conical (serrated) washers per side. The Lower bolts are M12 with 2 flat washers and 2 flange nuts requiring a 19mm wrench per side. Pictures below on next page for reference.

Do not remove any of the bolts to complete the recall. This is a re-torque of bolts already installed on the car.
