# SAFETY RECALL

## Headlamp Aim Plugs

Reference: 23C / NHTSA 25V-174

Remedy available for  
2024-2025 (KM) Wagoneer S

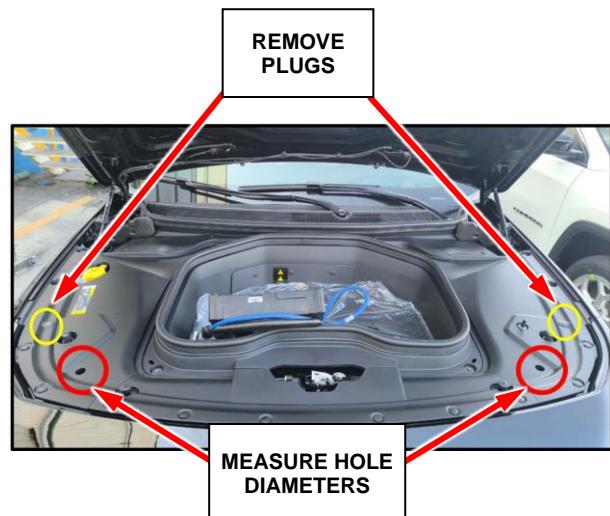
Figure 1 – Hole and Plug Locations

1. Open the hood.
2. Inspect both cowl side panel covers for plugs in the vertical alignment holes. Remove and discard if present (Figures 1 and 2).
3. Measure the size of the horizontal alignment holes in both cowl side panels (Figure 1). It is possible for only one panel to require service.
  - Hole is 10mm in size, no further action needed.
  - Hole is 20mm in size, install rubber plug(s) (see parts section of this recall) (Figures 1 and 3).
