SIB 12 03 25

RECALL 25V-202: STARTER GENERATOR

This Service Information Bulletin (Revision 1) replaces SI B12 03 25 **dated April 2025**.

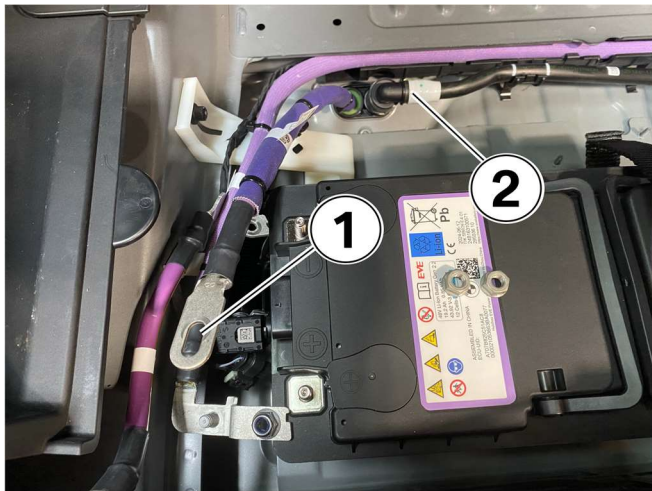
Disconnect the 48V SGR cable (1) from the B+ terminal of the 48V battery.

Disconnect the coolant line at the access point to the body (2)

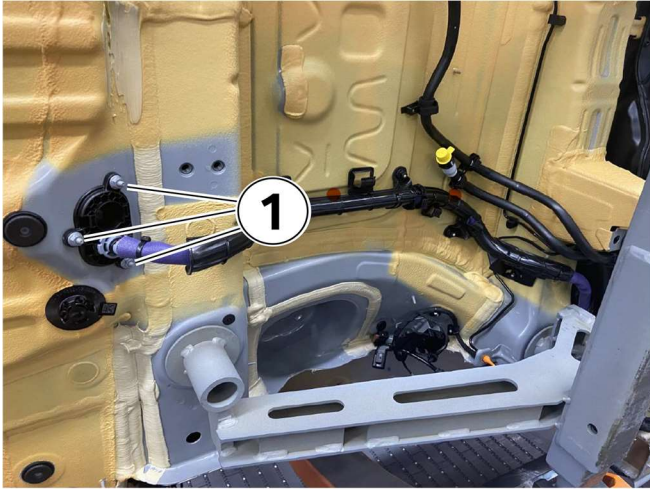
Remove the nuts (1) holding the SGR B+ cable to the trunk. (Replace nuts during reassembly and tighten to 9 Nm)

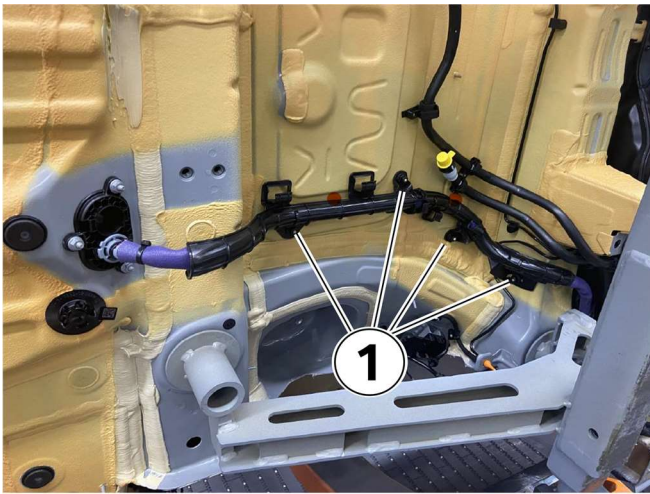
Remove all plastic nuts (and feed the cable out of the trunk. (replace all plastic nuts during assembly and torque to 2.3 Nm)

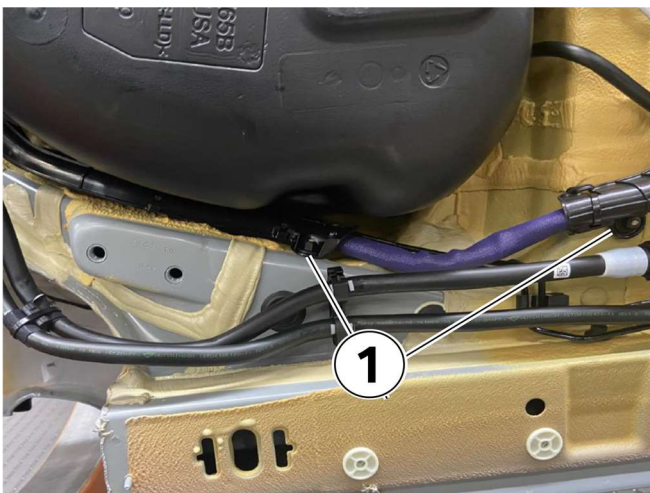
Continue removing plastic nuts and feed out cable (1).

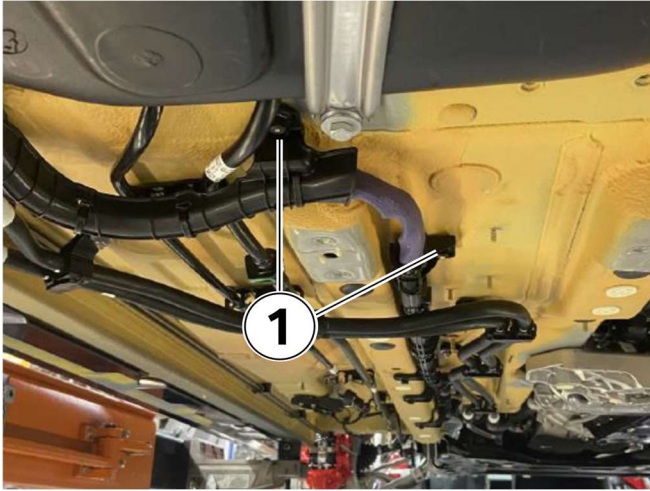
Continue removing plastic nuts and feed out cable (1).

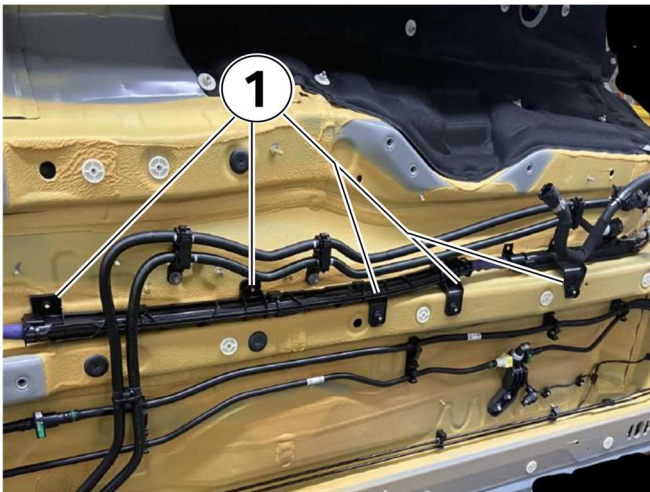
Continue removing plastic nuts and feed out cable (1).

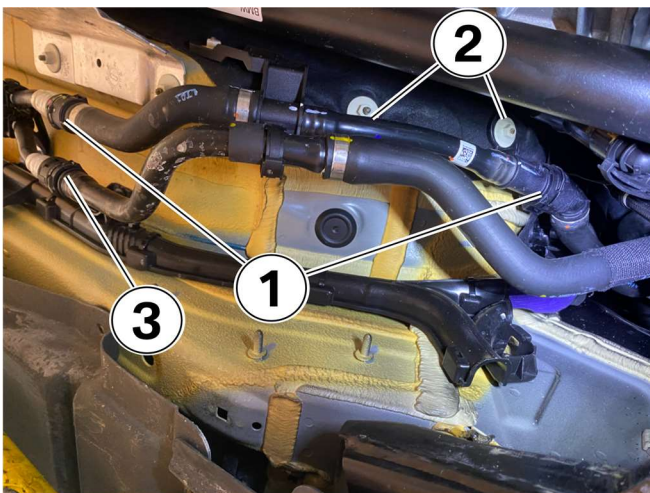
Disconnect low temperature coolant circuit's coolant hose (1) from both ends and remove coolant pipe with bracket (2). (Replace the plastic nuts during assembly and tighten to 2.3 Nm).

Disconnect coolant hose (3) and move hose away from the 48V B+ cable for better access to the cable.

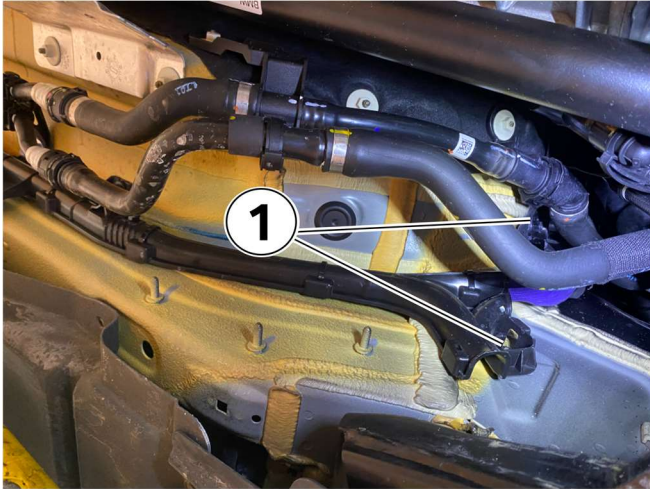
Continue removing plastic nuts and feed out cable (1).

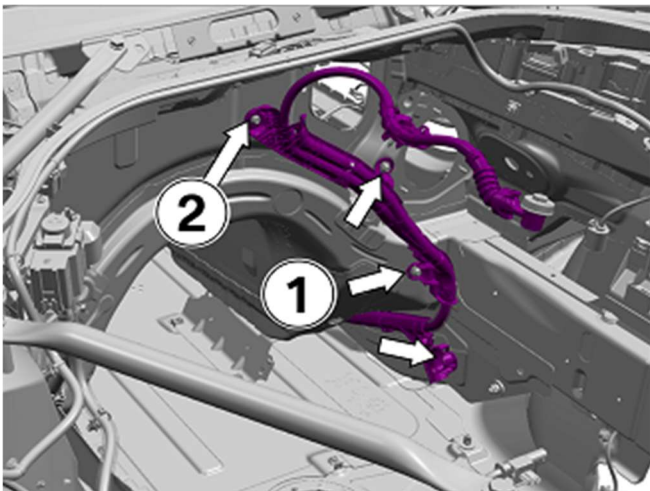
G45: There are three plastic nuts (1) (see previous photo) and one metal nut (2) (next step photo) that need to be removed.

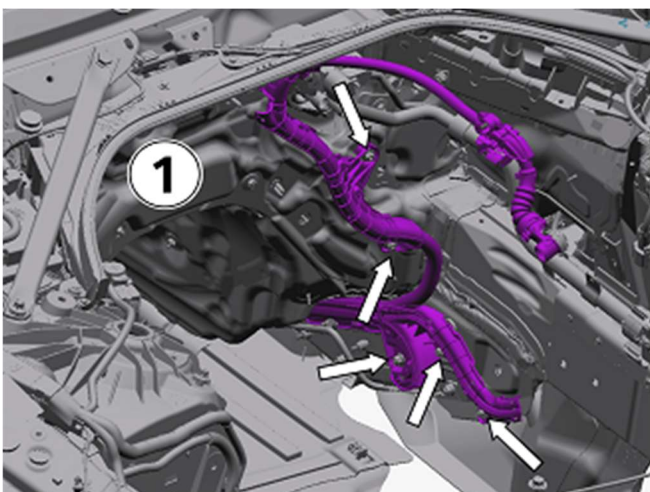
G60: Layout of cable in the engine compartment

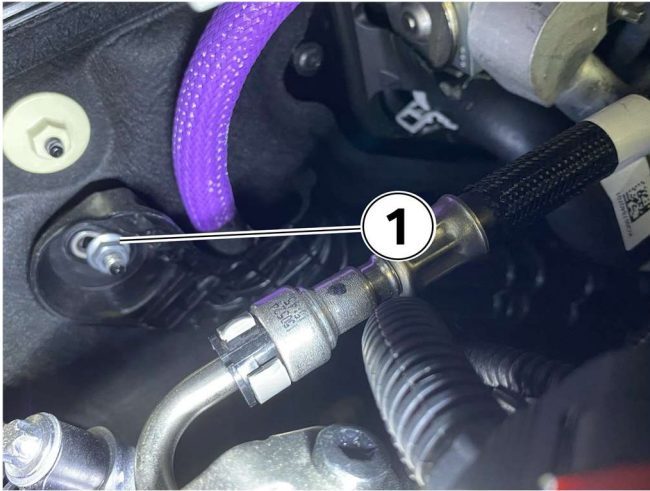
Remove nut from firewall and feed the 48V B+ cable out from under the vehicle (cable is disconnected from SGR). (Tighten nut to 9 Nm during assembly)

Install the new 48V SGR cable and continue with SGR replacement. Reinstall all removed components (rear axle carrier, covers, etc).
