Technical Service Bulletin

25-01-027H

IONIQ 5 N (NE EV N)

SUBJECT: **MULTI-EVENT UPDATE: IEB SOFTWARE INSPECTION & VCU SOFTWARE LOGIC IMPROVEMENT (RECALL 277)**

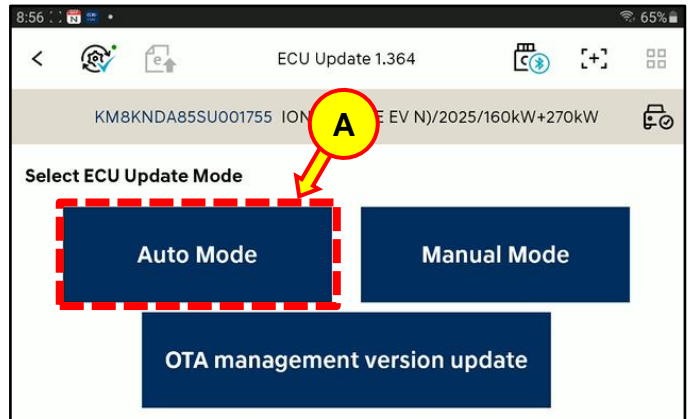
1. After selecting **Auto Mode (A)**, please check control unit ROM IDs.

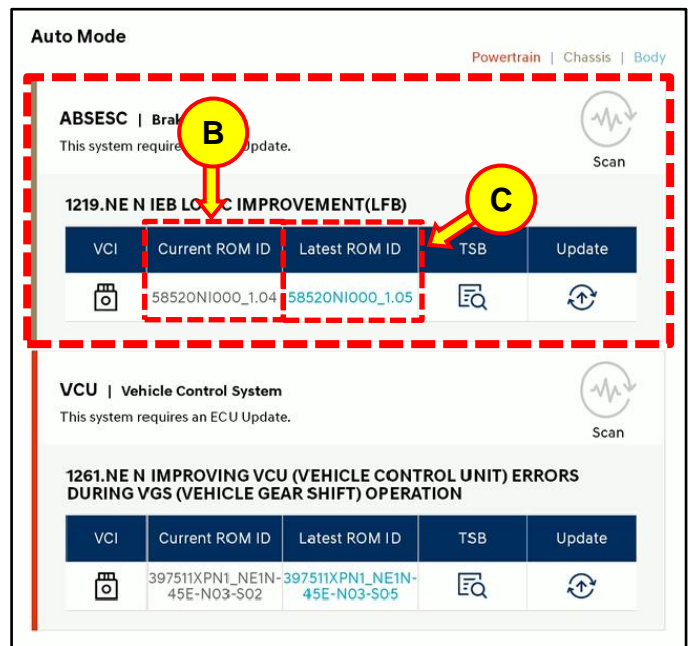
2. Verify the ROM ID listed under the **ABSESC** system.

- If the IEB **Current ROM ID (B)** and **Latest ROM ID (C)** do **NOT** match, proceed to [ECU Update Procedure: Event 1219](#) section on page 7, followed by [ECU Update Procedure: Event 1261](#) on page 11.

- If the IEB **Current ROM ID** and **Latest ROM ID** match, proceed to [ECU Update Procedure: Event 1261](#) section on page 11.

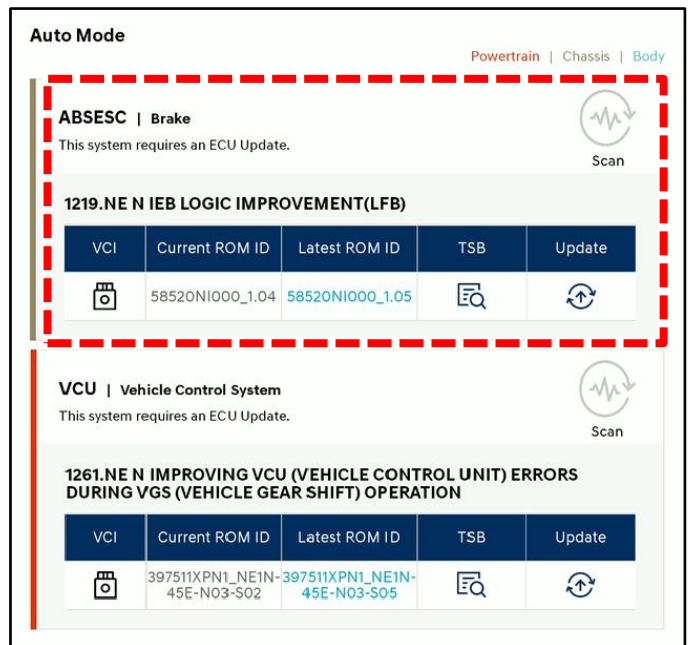
Select the **ABSESC** system to scan the vehicle’s current ROM ID, and then begin the update.

If the update fails, remove the power connector from the indoor fuse box for at least **5 seconds** then reconnect it. Retry the update.

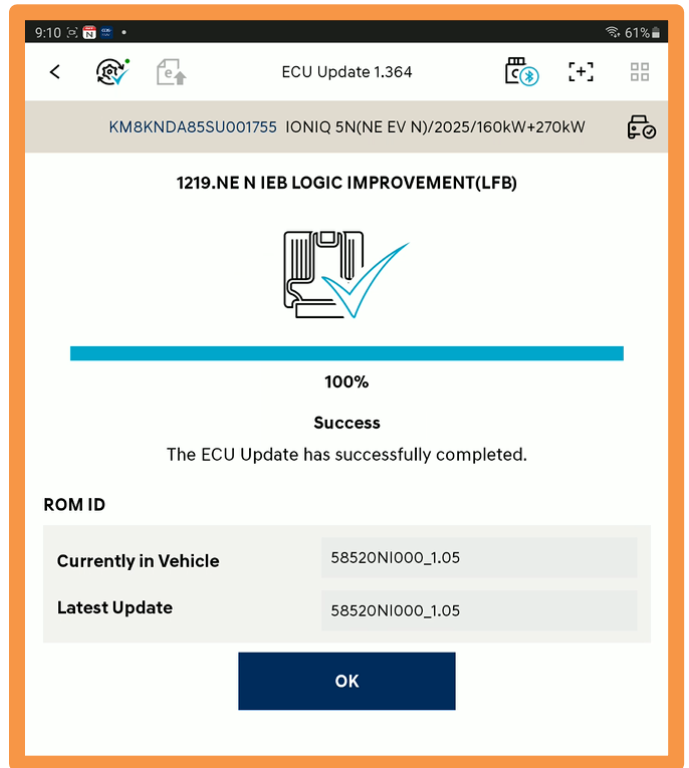
Take a screenshot of the IEB ECU update complete screen using your tablet and upload to STUI.

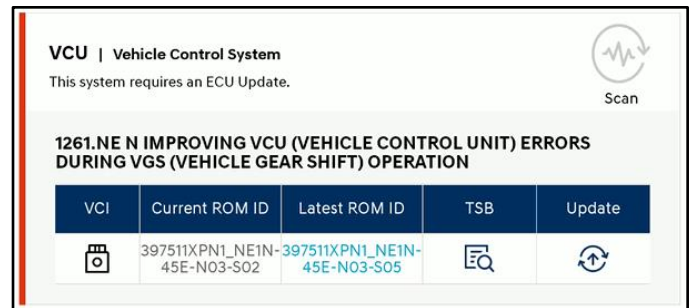
Select the **VCU** system to scan the vehicle's current ROM ID and then begin the update.

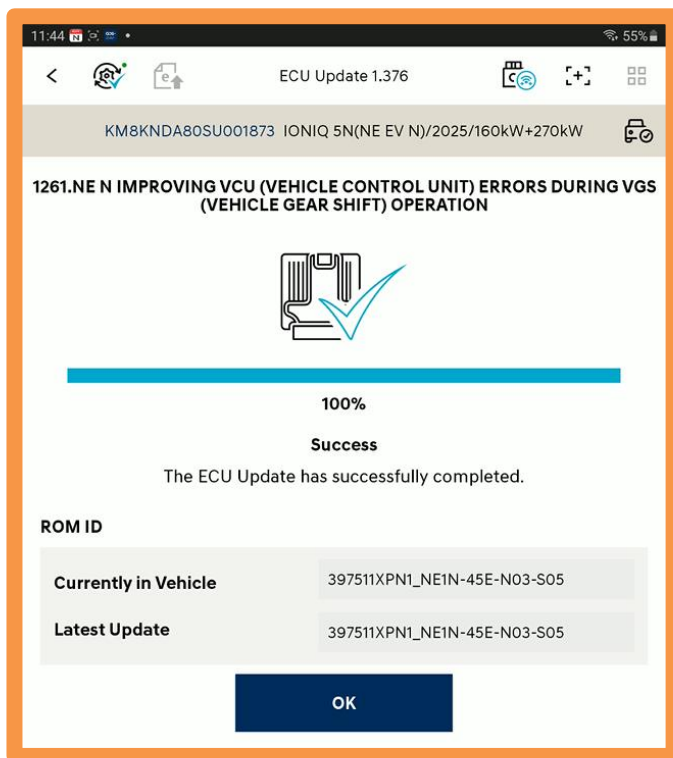
Take a screenshot of the VCU ECU update complete screen using your tablet and upload to STUI.
