Recall Campaign Bulletin

CAMPAIGN NO.	2025040007
CAMPAIGN DESC.	25P5491321
NHTSA ID	25V240
SUBJECT	Check Bolting of the Ground Connections
MODEL(S)	E-Class (214 platform)
MODEL YEAR(S)	2024
CAMPAIGN POPULATION	14

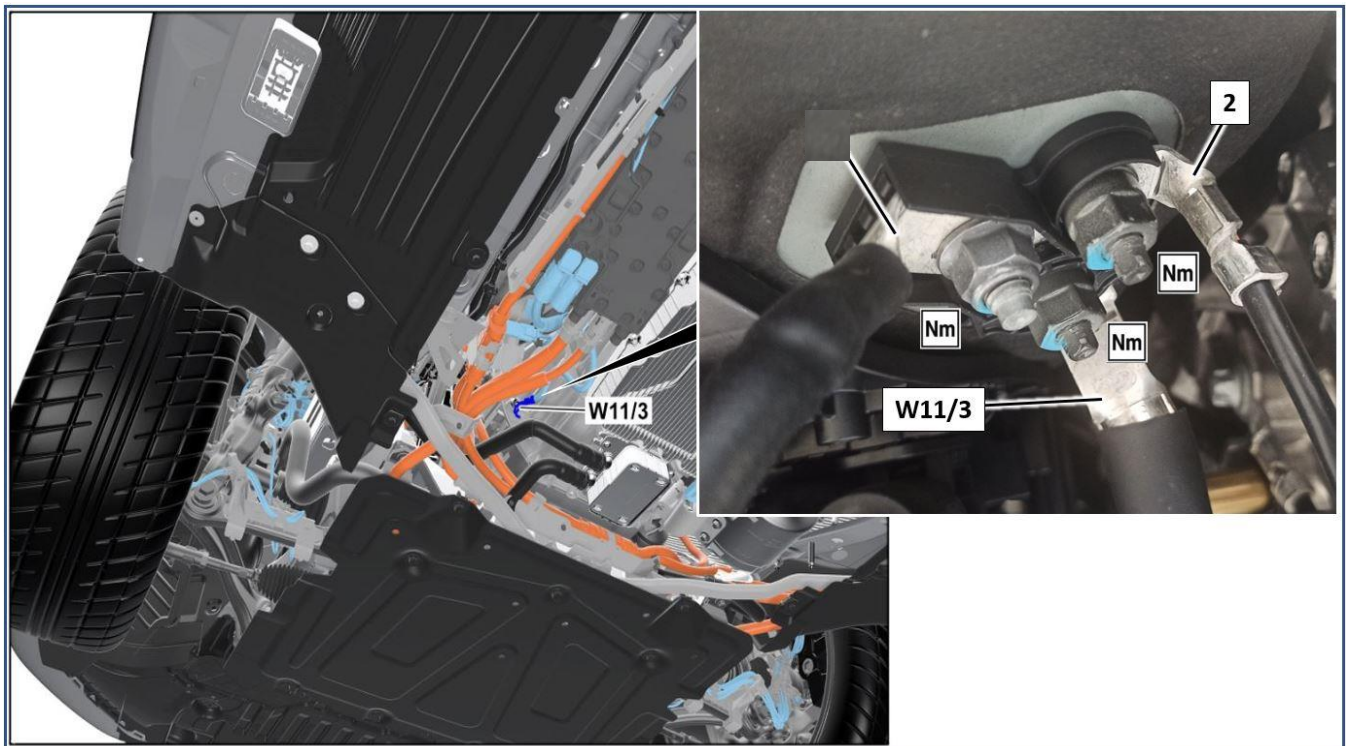
Figure 1

For basic information on model 214 see **AR61.20-P-1105WT**.
- Unscrew nuts on ground points (**Figure 1, W11/3 & 2**).

The number of ground points can vary depending on the engine involved.
 - Ground point for combustion engine, left (**Figure 1, W11/3**)
 - Ground point for circuit 31, with code B01 (48 V technology) (**Figure 1, 2**)

3. Perform a visual check on all detached electrical lines, the associated contact surfaces and the weld stud on the ground point:
 - a. If electrical lines, contact surfaces and/or weld studs **are damaged (such as signs of arching, welding, etc.)**: Take descriptive pictures and clarify further repair procedure by opening a TIPS case and referencing code **25P5491321**.
 - b. If electrical lines, contact surfaces and weld studs are **not damaged**: **Continue with Work Procedure Step 4**.
4. **Replace** nuts on ground points (**Figure 1, W11/3 or 2**) and tighten to specified torque.
 - Left combustion engine ground point (**Figure 1, W11/3**): **20 Nm**
 - Ground point for circuit 31, with code B01 (48 V technology) (**Figure 1, 2**): **20 Nm**
5. Assemble in reverse order.
