Safety Recall

N252494000 L87 Engine Loss of Propulsion

Release Date: May 2026

Revision: 13

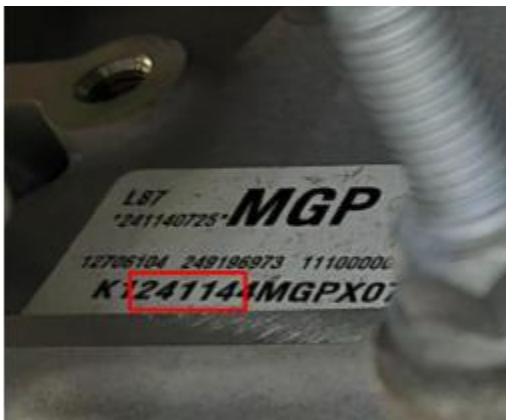
6908278

- For Replacement Engines: Looking upwards from under the vehicle towards the rear of the Left Hand cylinder head, inspect the digits indicated on the sticker above to determine the build date of the engine. The first two digits circled are the build year ('24 in this example), and the next three digits are the build day (day 114 in this example).

- If the engine was built ON or BEFORE day 153 or 6-1-2024, proceed to Step 3.
- If the engine was built AFTER day 153 or 6-1-2024 no further action is required. Submit inspect-only labor operation 9107967. **BE SURE TO RECORD THE NEW ENGINE SERIAL NUMBER IN THE CORRECTION FIELD OF THE REPAIR.** The new engine serial number MUST be included in the warranty information.

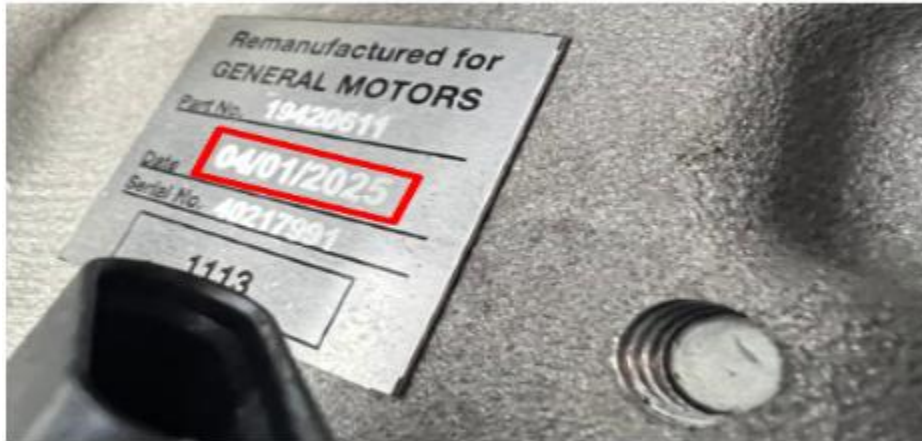
6953960

- For Remanufactured Engines: Looking upwards from under the vehicle towards the lower left side of the engine block, inspect the date indicated on the remanufactured engine tag pictured above.
