# Safety Recall

## N252494000 L87 Engine Loss of Propulsion

**Release Date:** May 2026

**Revision:** 13

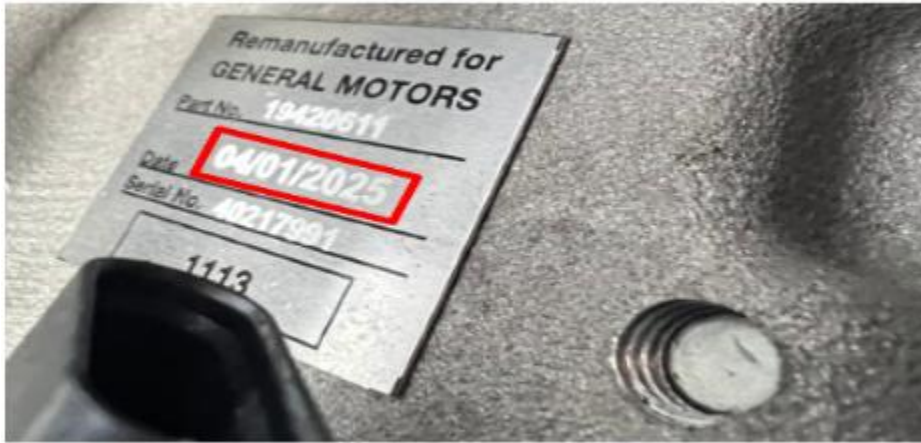
6953960

- For Replacement Engines: Looking upwards from under the vehicle towards the rear of the Left Hand cylinder head, inspect the digits indicated on the sticker above to determine the build date of the engine. The first two digits circled are the build year ('24 in this example), and the next three digits are the build day (day 114 in this example).

- For Remanufactured Engines: Looking upwards from under the vehicle towards the lower left side of the engine block, inspect the date indicated on the remanufactured engine tag pictured above.

- If the engine was built ON or BEFORE day 153 or 6-1-2024, proceed to Step 3.
- If the engine was built AFTER day 153 or 6-1-2024 no further action is required. Submit inspect-only labor operation 9107967. **BE SURE TO RECORD THE NEW ENGINE SERIAL NUMBER IN THE CORRECTION FIELD OF THE REPAIR.** The new engine serial number MUST be included in the warranty information.

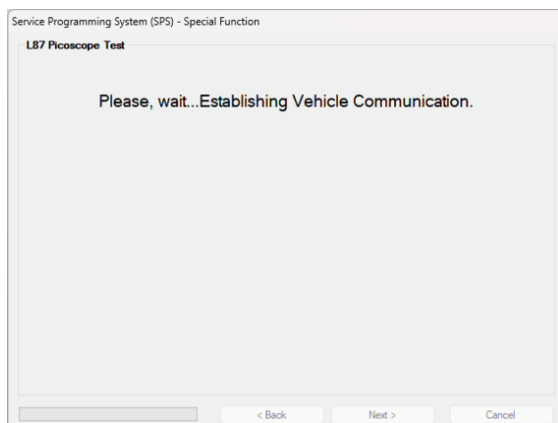
7058428

11. The above screen will pop up, indicating the procedure has been initiated.
12. The next screens will instruct you to connect the Picoscope to the vehicle and to start the engine, please follow the instructions as they are displayed.

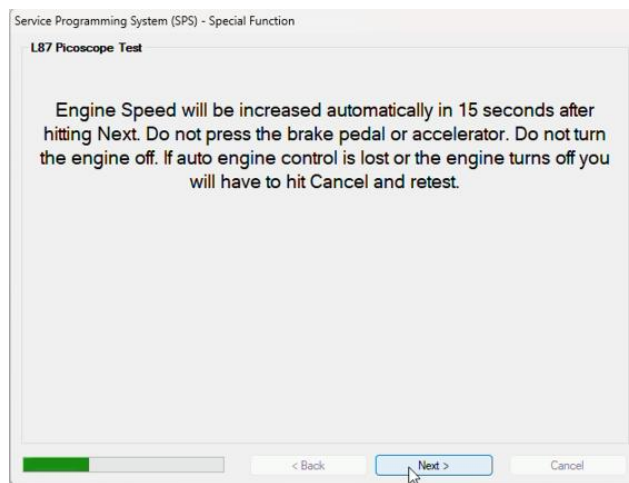
7058429

13. The above screen will display when the PicoScope is connected, engine is running, and after pressing next. 15 seconds after clicking "Next", engine speed will be increased automatically to 2000 RPMs.

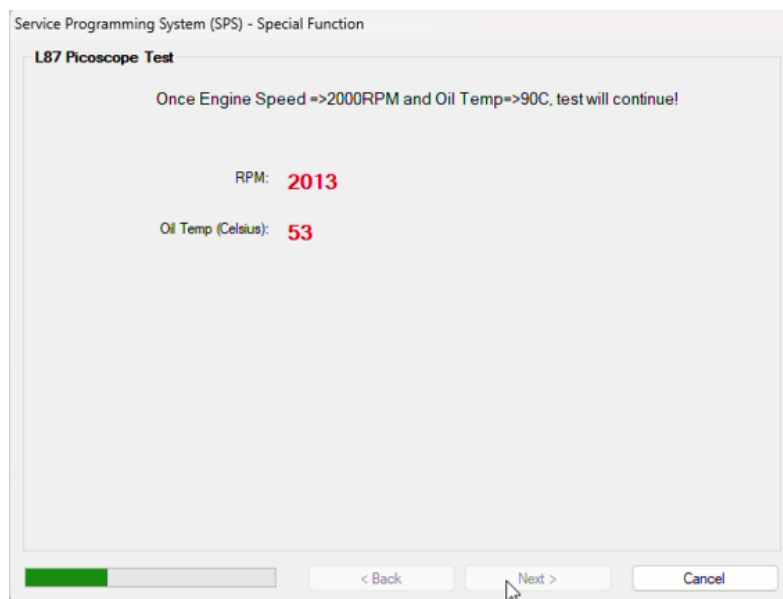
7058430

14. The above screen will display until the listed parameters are met. Engine Speed must be 2000 RPM and Oil Temp must reach 90 degrees Celsius. Please do not touch the accelerator pedal during the procedure.

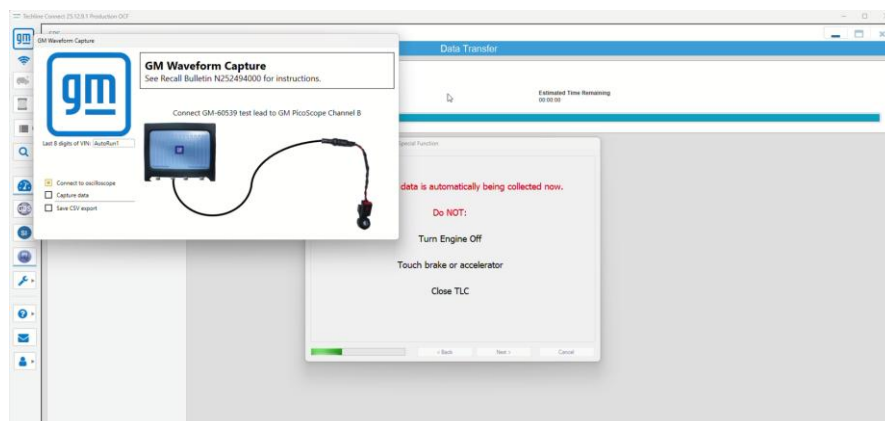
7058431

15. After the parameters have been met, the screen will change and GM Waveform Capture will open. No action needs to be completed at this time. The program will automatically record and capture the required data.

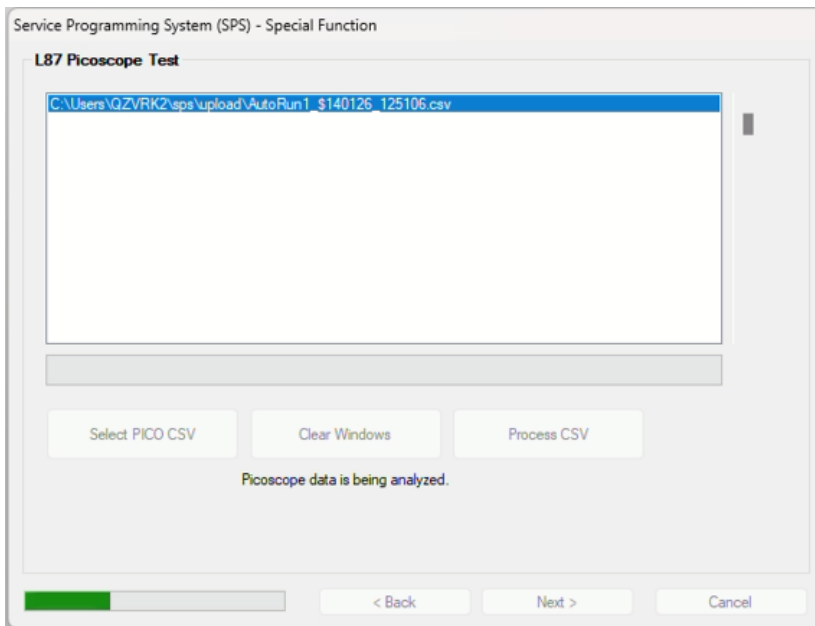
7058432

16. When GM Waveform Capture has completed its sequence, the program will automatically save and upload the captured data.
17. The next screen will automatically populate with a PASS or FAIL result. After recording the result, press “Next” on the following screens to retrieve the Warranty Claim Code and exit the procedure.

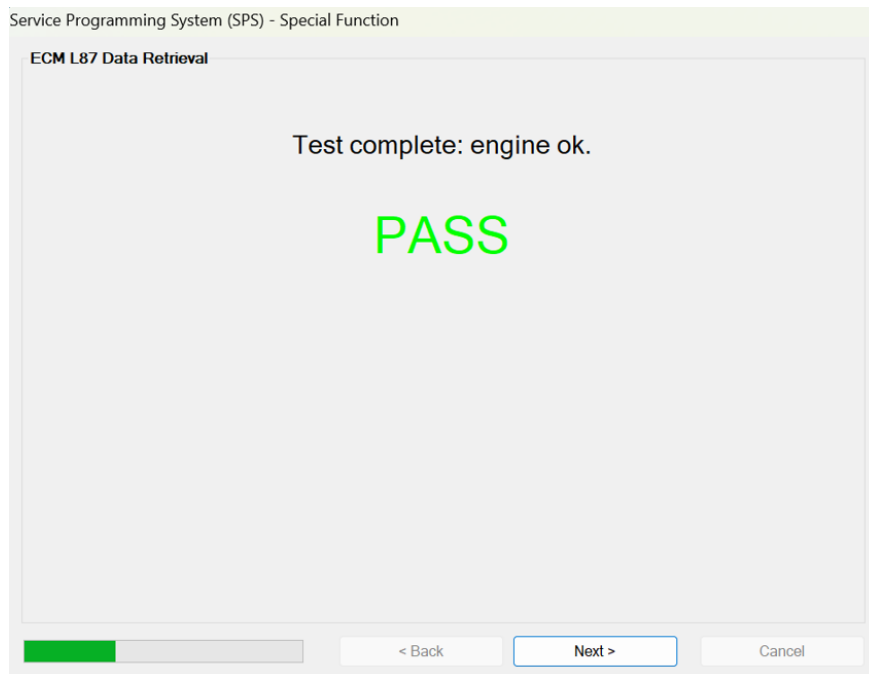
6932384

- If the engine PASSES the test, proceed to the next step.

18. FOR ENGINES THAT PASS: Perform an oil change to 0W-40 Oil, *Refer to Engine Oil and Oil Filter Replacement* in SI. Install a NEW engine oil cap and place the owner's manual insert(s) in the glovebox.
