# Safety Recall

## N252494000 L87 Engine Loss of Propulsion

**Revision:** 09

<b>Condition</b>	General Motors has decided that a defect which relates to motor vehicle safety may exist in certain 2021 – 2024 model year Cadillac Escalade and Escalade ESV, Chevrolet Silverado 1500, Suburban, and Tahoe, and GMC Sierra 1500, Yukon, and Yukon XL vehicles equipped with the 6.2L V8 gas engine (RPO L87). The connecting rod and/or crankshaft engine components in these vehicles may have manufacturing defects that can lead to engine damage and engine failure. If the engine fails during vehicle operation, the vehicle will lose propulsion, increasing the risk of a crash.
<b>Correction</b>	Dealers will inspect the engine. If the vehicle fails the inspection procedure, the engine will be repaired or replaced. Vehicles that pass inspection will be provided a higher viscosity oil, which will also require a new oil fill cap identifying the new required oil grade, an oil filter replacement, and an owner's manual insert free of charge.

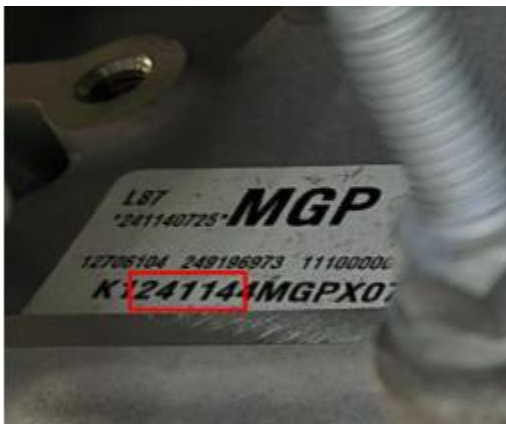
6908278

- For Replacement Engines: Looking upwards from under the vehicle towards the rear of the Left Hand cylinder head, inspect the digits indicated on the sticker above to determine the build date of the engine. The first two digits circled are the build year ('24 in this example), and the next three digits are the build day (day 114 in this example).
- For Remanufactured Engines: Looking upwards from under the vehicle towards the lower left side of the engine block, inspect the date indicated on the remanufactured engine tag pictured above.

- If the engine was built ON or BEFORE day 153 or 6-1-2024, proceed to Step 3.
  - If the engine was built AFTER day 153 or 6-1-2024 no further action is required. Submit inspect-only labor operation 9107967. **BE SURE TO RECORD THE NEW ENGINE SERIAL NUMBER IN THE CORRECTION FIELD OF THE REPAIR.** The new engine serial number MUST be included in the warranty information.
3. Download and install the GM PicoScope NVH analysis software, if you do not already have it installed. It is available through <https://gmglobaltools.com/gmsoftware.aspx>. Select PicoScope NVH and Scope Software.
    - If your software is older than version 7, it is *essential* you update it or the test may not complete.
  4. Lift the vehicle. Refer to *Lifting and Jacking the Vehicle* in SI.

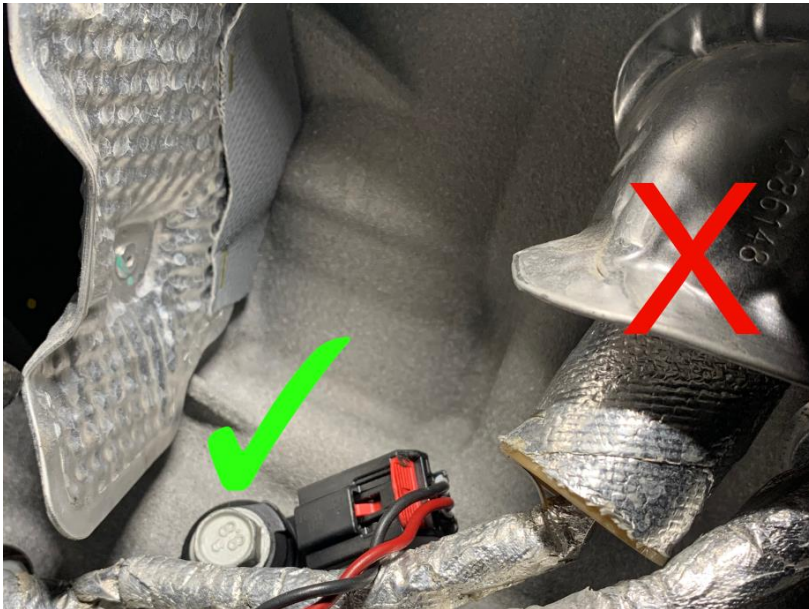
7003965

**Caution:** Using compressed air, blow out the M8 boss in which the test sensor is installed in the above picture.

5. Install the test sensor into the unused M8 boss on the left-hand side of the engine directly above and in front of the engine oil cooler line junction block. **DO NOT USE THE FACTORY KNOCK SENSOR, OR THE FACTORY KNOCK SENSOR LOCATION.** Torque the M8X1.25X35 bolt to 16 lb-ft/22 N-m.
6. Route the test sensor harness in a manner in which it is not contacting any hot components of the vehicle and which allows the harness to reach your laptop or PC.
