Safety Recall

N252494000 L87 Engine Loss of Propulsion

Release Date: January 2026

Revision: 10

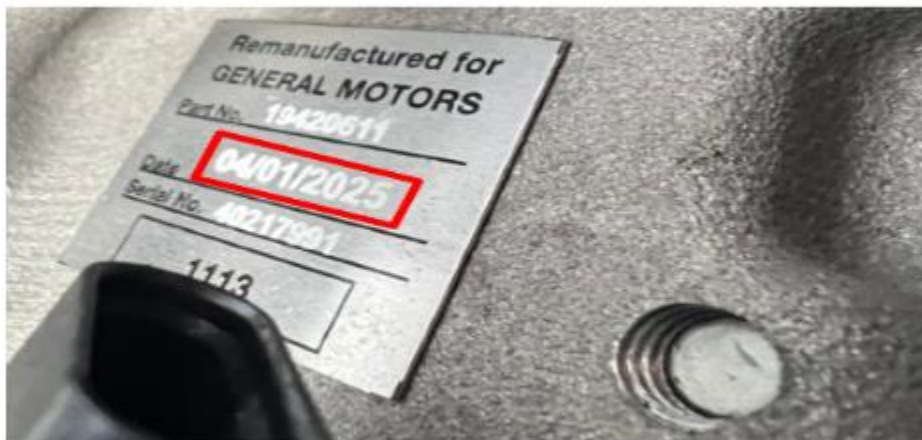
6953960

- For Replacement Engines: Looking upwards from under the vehicle towards the rear of the Left Hand cylinder head, inspect the digits indicated on the sticker above to determine the build date of the engine. The first two digits circled are the build year ('24 in this example), and the next three digits are the build day (day 114 in this example).

- For Remanufactured Engines: Looking upwards from under the vehicle towards the lower left side of the engine block, inspect the date indicated on the remanufactured engine tag pictured above.

- If the engine was built ON or BEFORE day 153 or 6-1-2024, proceed to Step 3.
 - If the engine was built AFTER day 153 or 6-1-2024 no further action is required. Submit inspect-only labor operation 9107967. **BE SURE TO RECORD THE NEW ENGINE SERIAL NUMBER IN THE CORRECTION FIELD OF THE REPAIR.** The new engine serial number MUST be included in the warranty information.
