Safety Recall

N252494000 L87 Engine Loss of Propulsion

Release Date: June 2025

Revision: 06

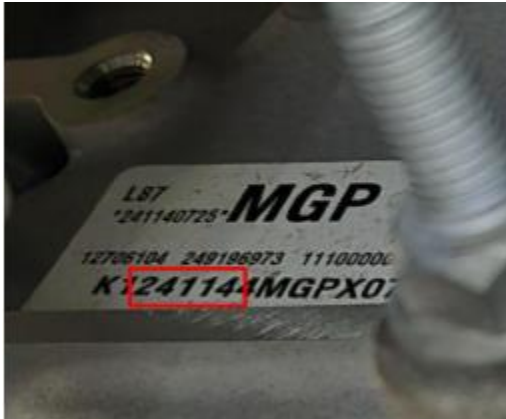
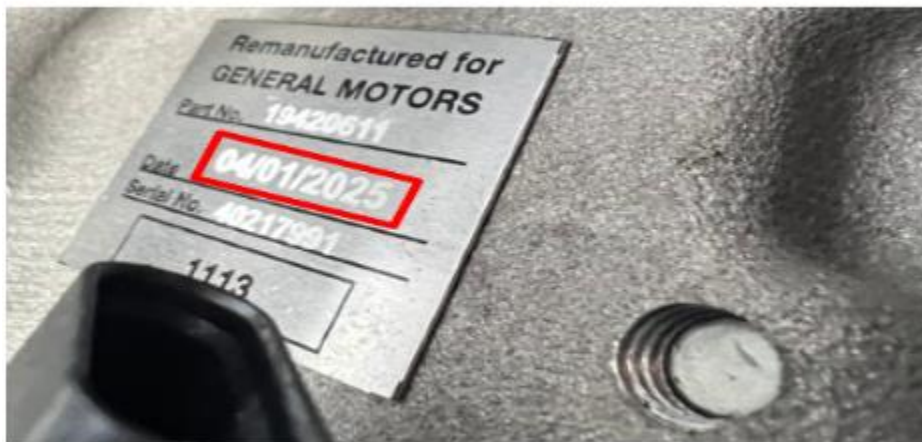
- For Replacement Engines: Looking upwards from under the vehicle towards the rear of the Left Hand cylinder head, inspect the digits indicated on the sticker above to determine the build date of the engine. The first two digits circled are the build year ('24 in this example), and the next three digits are the build day (day 114 in this example).

- For Remanufactured Engines: Looking upwards from under the vehicle towards the lower left side of the engine block, inspect the date indicated on the remanufactured engine tag pictured above.

- If the engine was built ON or BEFORE day 153 or 6-1-2024, proceed to Step 3.
- If the engine was built AFTER day 153 or 6-1-2024 no further action is required. Submit inspect-only labor operation 9107967. **BE SURE TO RECORD THE NEW ENGINE SERIAL NUMBER IN THE CORRECTION FIELD OF THE REPAIR.** The new engine serial number MUST be included in the warranty information.
