# Safety Recall

## N252494000 L87 Engine Loss of Propulsion

**Release Date:** October 2025

**Revision:** 08

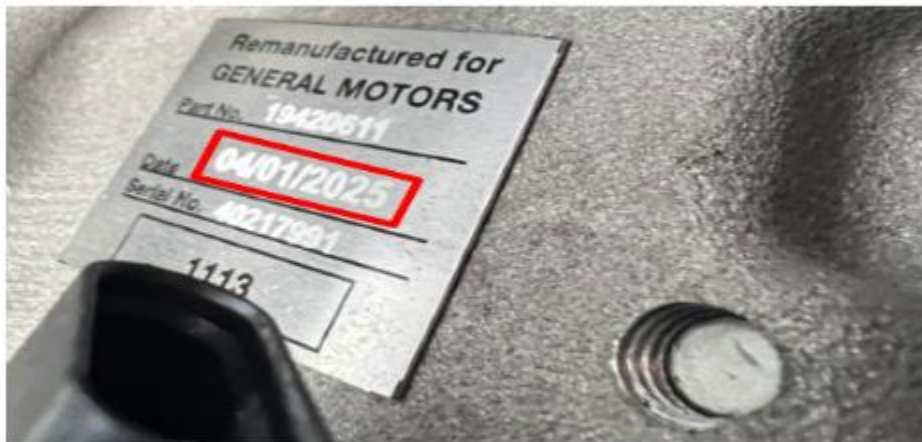
- For Replacement Engines: Looking upwards from under the vehicle towards the rear of the Left Hand cylinder head, inspect the digits indicated on the sticker above to determine the build date of the engine. The first two digits circled are the build year ('24 in this example), and the next three digits are the build day (day 114 in this example).
- For Remanufactured Engines: Looking upwards from under the vehicle towards the lower left side of the engine block, inspect the date indicated on the remanufactured engine tag pictured above.

- If the engine was built ON or BEFORE day 153 or 6-1-2024, proceed to Step 3.
  - If the engine was built AFTER day 153 or 6-1-2024 no further action is required. Submit inspect-only labor operation 9107967. **BE SURE TO RECORD THE NEW ENGINE SERIAL NUMBER IN THE CORRECTION FIELD OF THE REPAIR.** The new engine serial number MUST be included in the warranty information.
3. Download and install the GM PicoScope NVH analysis software, if you do not already have it installed. It is available through <https://gmglobaltools.com/gmsoftware.aspx>. Select PicoScope NVH and Scope Software.
    - If your software is older than version 7, it is *essential* you update it or the test may not complete.
  4. Lift the vehicle. Refer to *Lifting and Jacking the Vehicle* in SI.

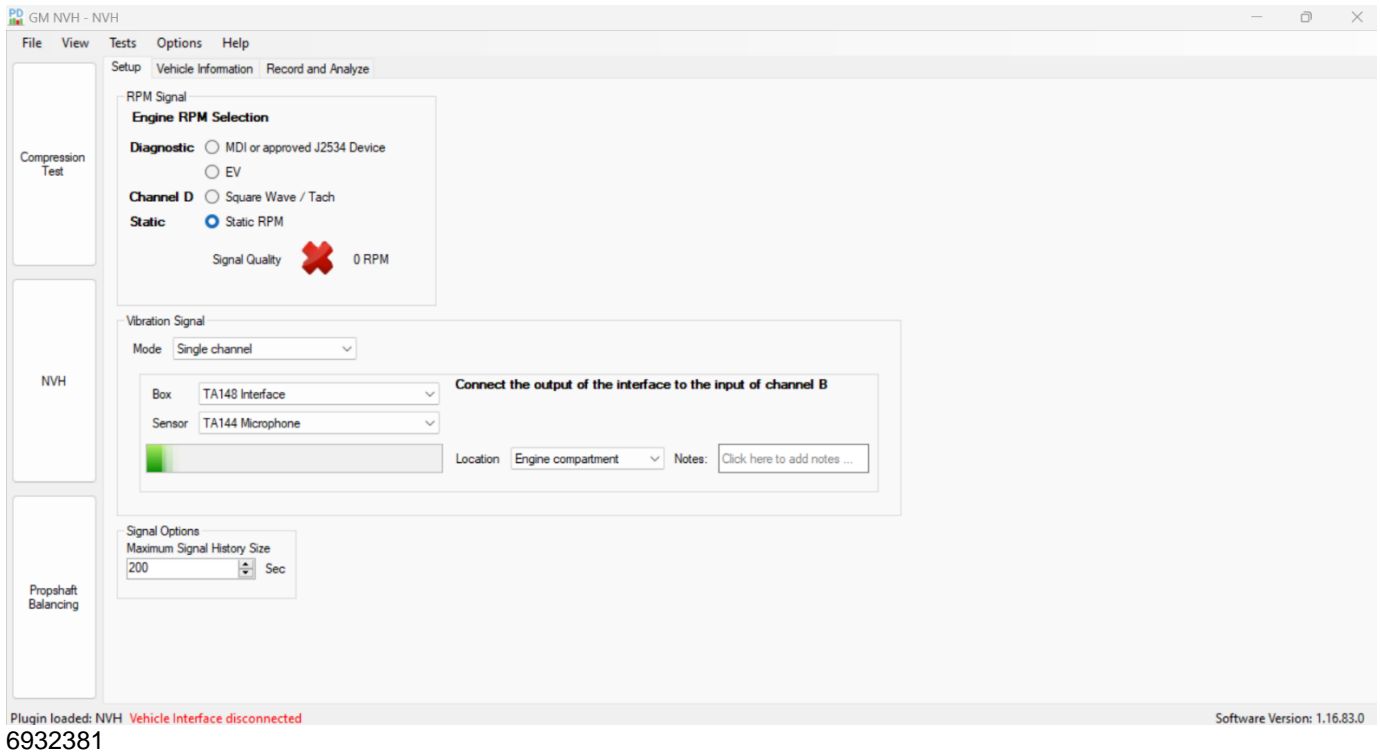
**IMPORTANT:** It is extremely important that ALL settings are configured exactly as shown above or the test will not work.

23. Click on the “setup” tab located at the top of the screen and confirm that your GM NVH software is configured EXACTLY as shown in the above screenshot, with the following options.
