Safety Recall

N252494000 L87 Engine Loss of Propulsion

Release Date: February 2026

Revision: 12

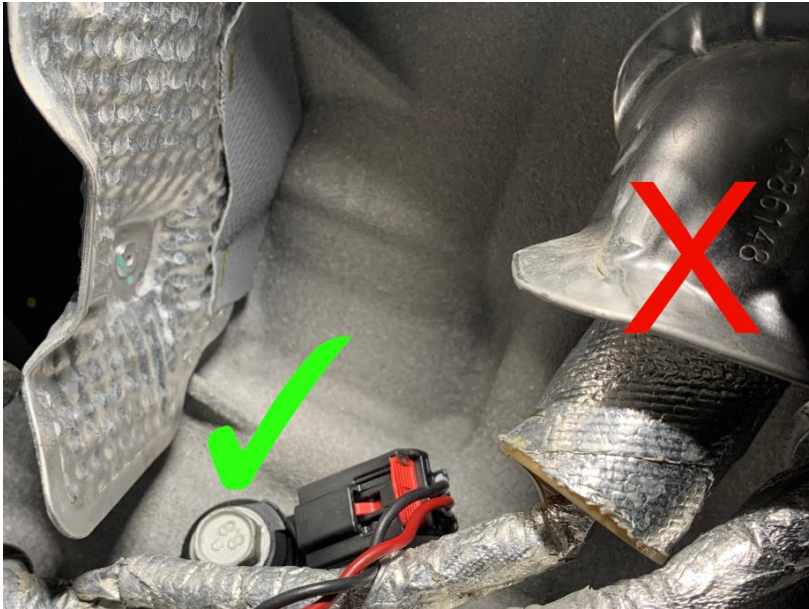
7003965

Caution: Using compressed air, blow out the M8 boss in which the test sensor is installed in the above picture.

4. Install the test sensor into the unused M8 boss on the left-hand side of the engine directly above and in front of the engine oil cooler line junction block. **DO NOT USE THE FACTORY KNOCK SENSOR, OR THE FACTORY KNOCK SENSOR LOCATION.** Torque the M8X1.25X35 bolt to 16 lb-ft/22 N-m.
5. Route the test sensor harness in a manner in which it is not contacting any hot components of the vehicle and which allows the harness to reach your laptop or PC.
