Safety Recall

N252494000 L87 Engine Loss of Propulsion

Release Date: May 2025

Revision: 01

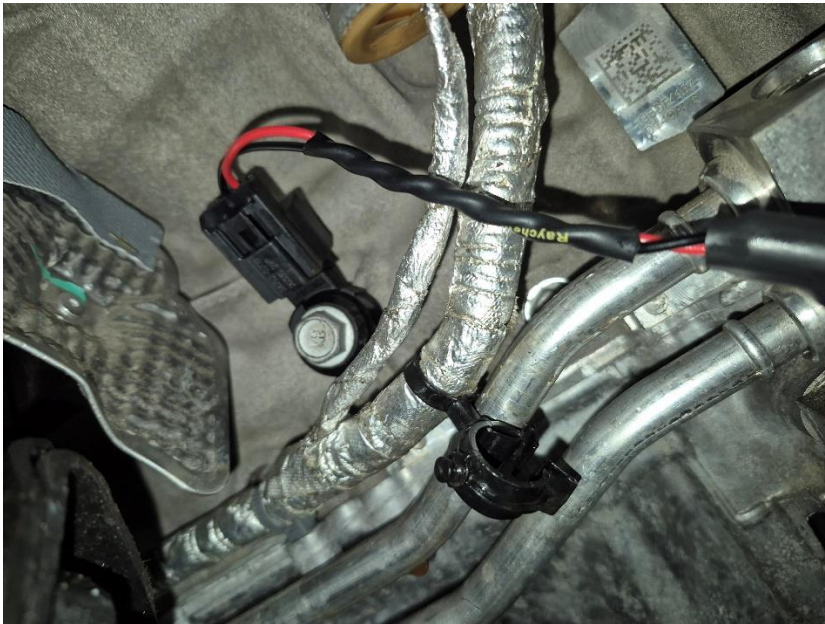
6932366

Caution: Using compressed air, blow out the M8 boss in which the knock sensor is installed in the above picture.

4. Install the knock sensor into the M8 boss on the left-hand side of the engine directly above and in front of the transmission oil cooler line junction block. Torque the M8X1.25X35 bolt to 16 lb-ft/22 N-m.
5. Route the knock sensor harness in a manner in which it is not contacting any hot components of the vehicle and which allows the harness to reach your laptop or PC.

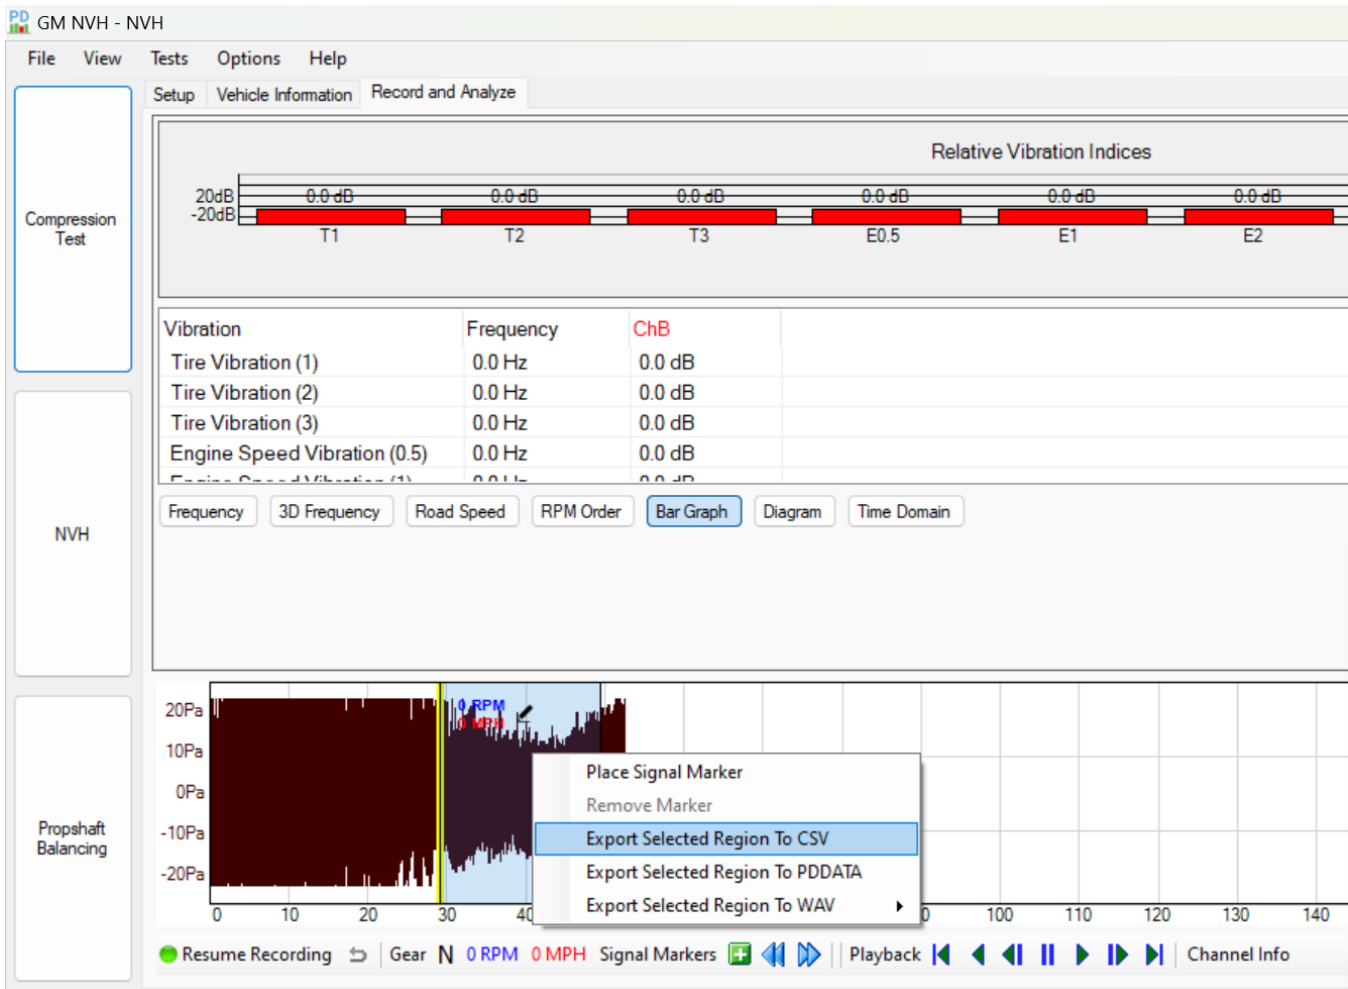
6932383

27. Switch back to the GM NVH software and select a roughly 20-second-long clip of the data displayed at the bottom, as shown above. You may select data by clicking and dragging the vertical bars. Then, right click it and hit “export selected region as CSV” as shown above. Note where the file is saved to, or save it to an easy to find location such as ‘my documents’ or your desktop. It may be helpful to name the file with the last 8 of the VIN if you will be running a lot of these tests.
28. Return to TLC and hit “Select Pico CSV” then navigate to the folder where you exported the CSV file in the previous step and open it.
29. Select “Process CSV.” An automated diagnostic will run, which will give you a result at the end determining whether the engine has passed or failed the test. The example shown above is a fail.

- If the engine FAILS the test, refer to *Engine Replacement* in SI. Transfer the engine oil cap from the original engine to the replacement engine and fill the engine with the oil grade that is indicated on the cap.
