Safety Recall

N252494000 L87 Engine Loss of Propulsion

Release Date: January 2026

Revision: 11

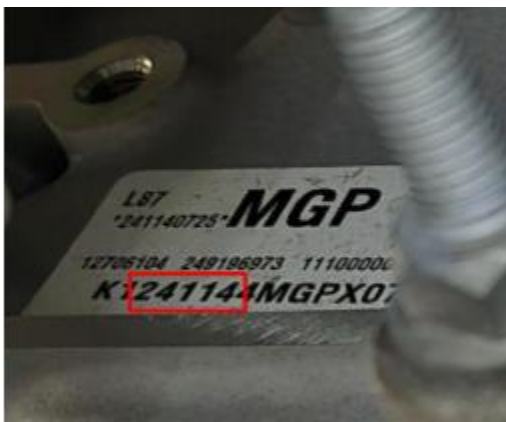
6908278

- For Replacement Engines: Looking upwards from under the vehicle towards the rear of the Left Hand cylinder head, inspect the digits indicated on the sticker above to determine the build date of the engine. The first two digits circled are the build year ('24 in this example), and the next three digits are the build day (day 114 in this example).

- If the engine was built ON or BEFORE day 153 or 6-1-2024, proceed to Step 3.
- If the engine was built AFTER day 153 or 6-1-2024 no further action is required. Submit inspect-only labor operation 9107967. **BE SURE TO RECORD THE NEW ENGINE SERIAL NUMBER IN THE CORRECTION FIELD OF THE REPAIR.** The new engine serial number MUST be included in the warranty information.

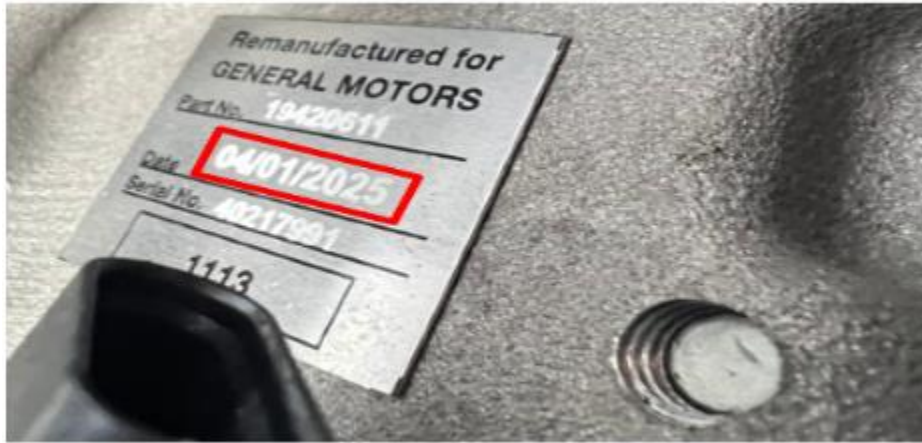
6953960

- For Remanufactured Engines: Looking upwards from under the vehicle towards the lower left side of the engine block, inspect the date indicated on the remanufactured engine tag pictured above.
