Safety Recall

Code: 15ZK

Subject: Safety Recall 15ZK - Cylinder Head Cover Screws

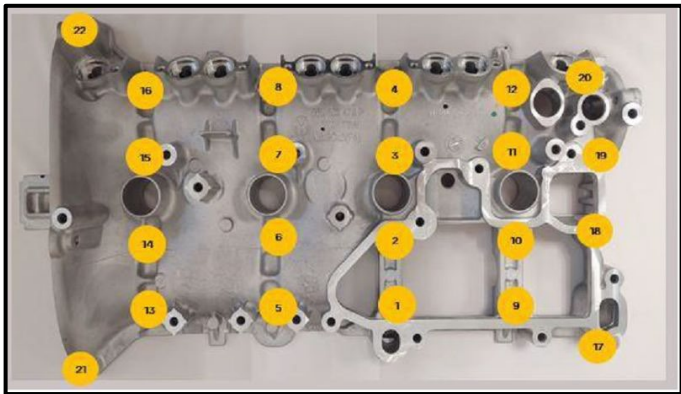
Repair Overview

Over time, the cylinder head cover screw(s) may loosen. If this occurs, engine oil may leak from the cylinder head cover screw hole(s). If the engine oil were to come into contact with certain hot parts of the engine, increasing the risk of a fire.

- Check torque on all cylinder head cover bolts, and replace bolts, if necessary.

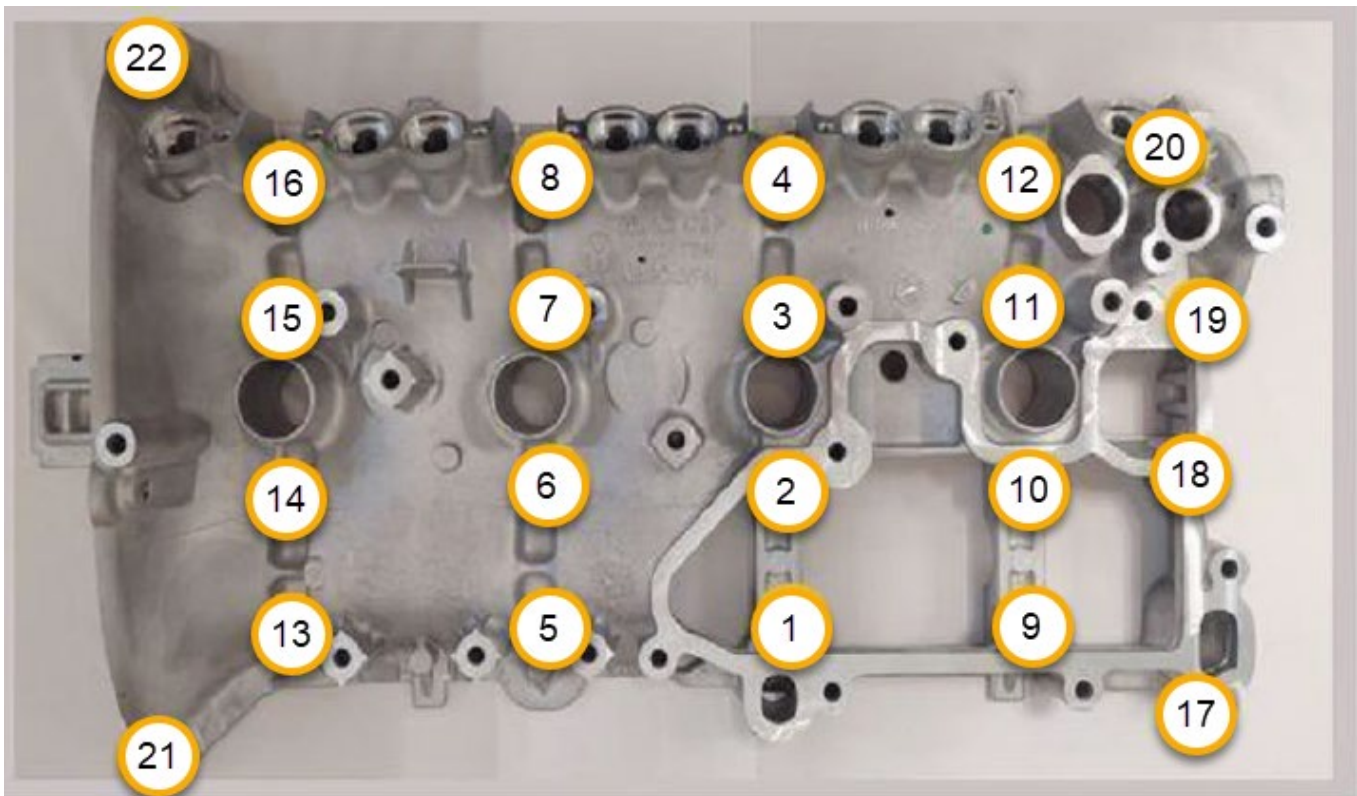
- Check all 22-cylinder head cover bolts.
- Check that the bolts are tightened to a torque of 14 Nm in the order shown below.

- Replace any loose bolts.
- Tighten the new bolt(s) to a torque of 8 Nm + 90°.
- If several bolts are affected, do not loosen them at the same time (i.e. several at once). Please remove, replace, and tighten the bolts one by one in order shown in the image above.

If the specified torque of 14 Nm is not reached after turning torque wrench a quarter turn (90°), the affected bolt must be replaced.
