Safety Recall

Code: 15ZK

Subject Cylinder Head Cover Screws

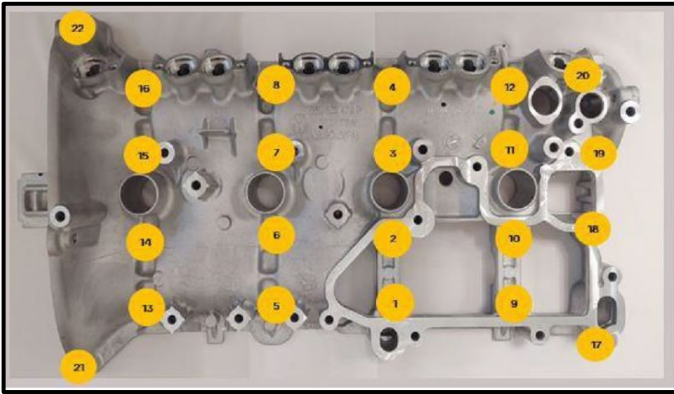
Repair Overview

Over time, the cylinder head cover screw(s) may loosen. If this occurs, engine oil may leak from the cylinder head cover screw hole(s). If the engine oil were to come into contact with certain hot parts of the engine, increasing the risk of a fire.

- Check torque on all cylinder head cover bolts, and replace bolts, if necessary.

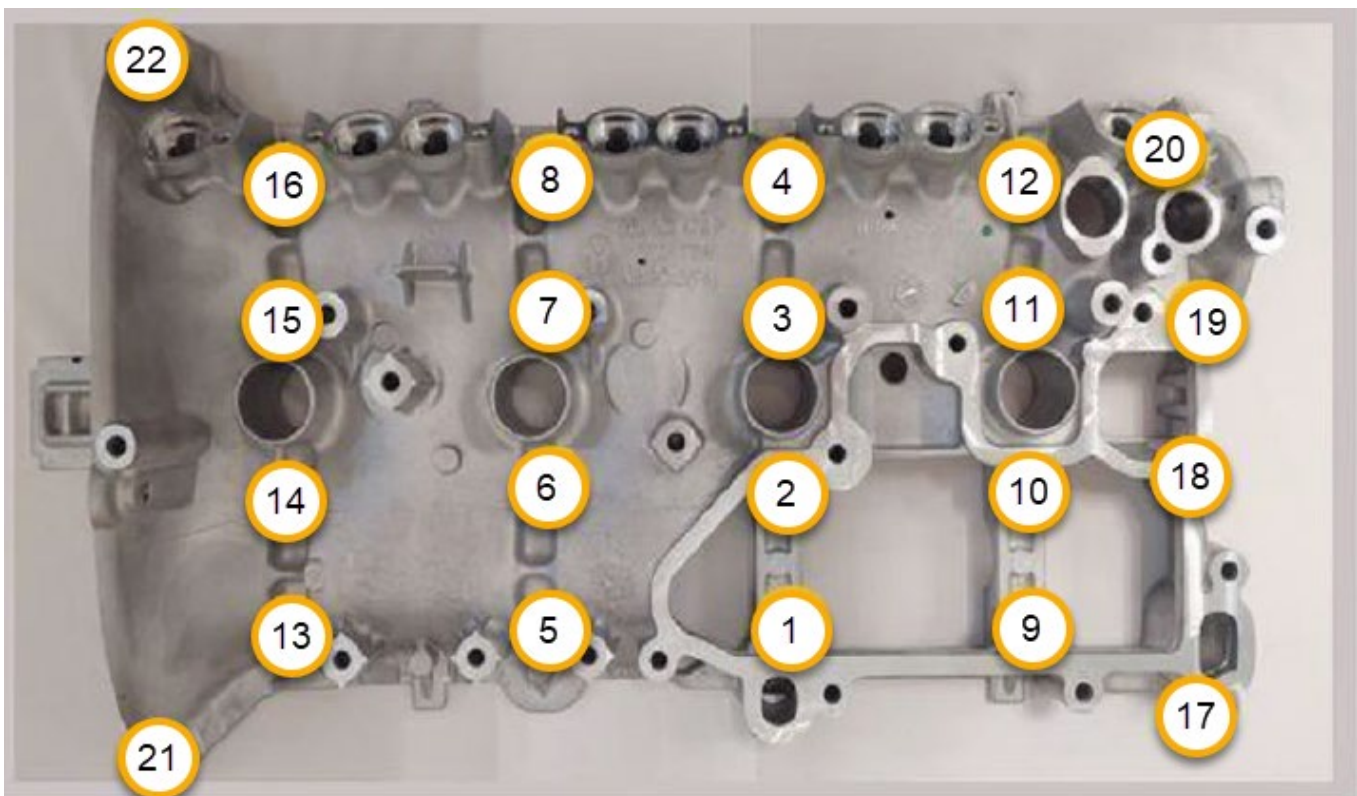
- Check all 22-cylinder head cover bolts.
- Check that the bolts are tightened to a torque of 14 Nm in the order shown below.

If the specified torque of 14 Nm is not reached on the original bolts after turning torque wrench a quarter turn (90°), the affected bolt must be replaced.

- Replace any loose bolts.
- Tighten the new bolt(s) to a torque of 8 Nm + 90°.
- If several bolts are affected, do not loosen them at the same time (i.e. several at once). Please remove, replace, and tighten the bolts one by one in order shown in the image above.

- When replacing the new bolt, it must be tightened to a torque of 8 Nm + 90°. If several bolts are affected, do not loosen them at the same time (i.e. several at once). Please remove, replace, and tighten the bolts one by one.
- When re-tightening the bolt(s), the maximum torque of 14 Nm must not be exceeded.
