## RECALL ACTION

Reference number:	RA-18-2044	Issue Number: 1	Issued: 07 May, 2025
Subject:	Replace the Rear Fuse Box Closing Panel Screws		
Model(s):	Valkyrie, Valkyrie Spider		
VIN range:	Please refer to the separately published list of Vehicle Information Numbers (VINs)		
Applicable to:	All US Dealers		
Distribute to:	Head of Business After Sales Manager Service Manager Sales Manager	Warranty Staff Technician(s) Parts Staff

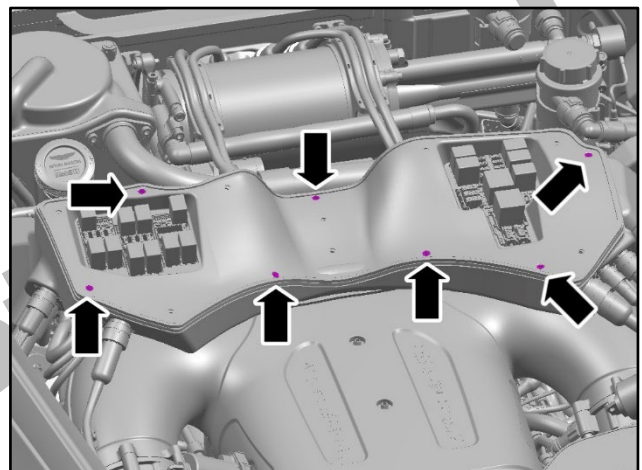
Figure 7

Incorrect length screws were used to attach the rear fuse box closing panel in some vehicles. The incorrect screws may be able to clash with the wiring harness.

On the affected vehicles it is necessary to replace all the screws for the fuse box closing panel with 9.53 mm screws.

7. Remove and discard the seven screws (refer to Figure 7).

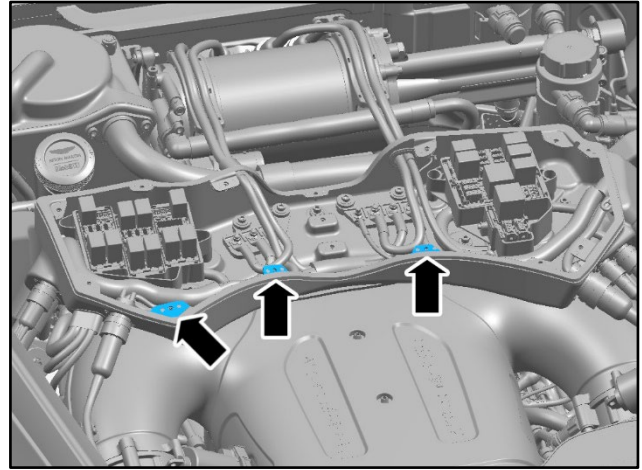
Figure 9

- 9. Examine the bolted joint areas that are near to fuse box harness (refer to Figure 9).

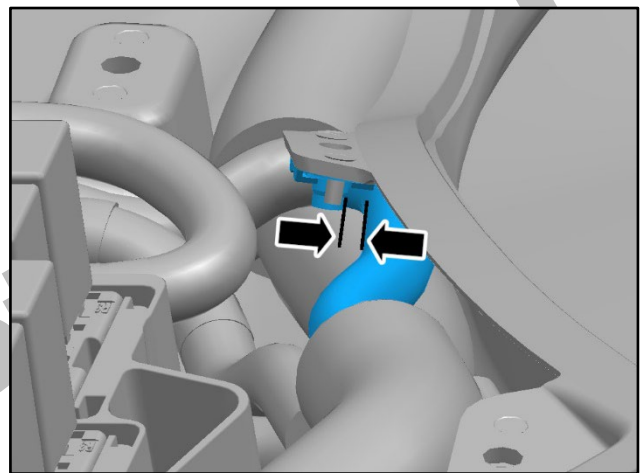
Figure 10

- 10. Confirm the clearance between the captive nut for the bolted joint and fuse box harness is at least 3.0 mm (refer to Figure 10).

If the clearance is less than 3.0 mm, submit a report to the Valkyrie Aftersales team. This report should contain the VIN, mileage, and images of the area of concern.

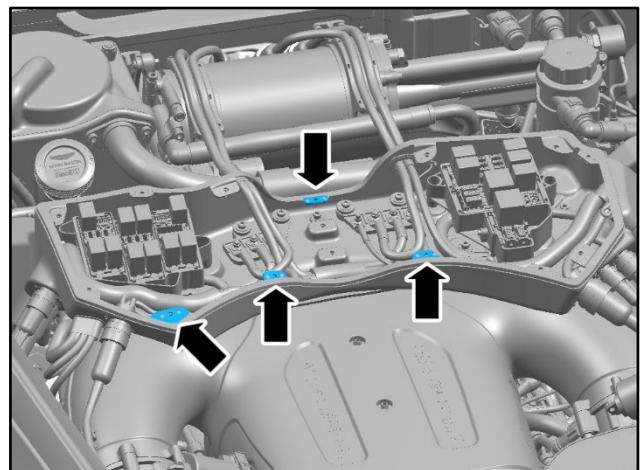
Figure 11

- 11. Examine the fuse box for any damage in the indicated areas below the bolted joints (refer to Figure 11).

If any damage is discovered, submit a report to the Valkyrie Aftersales team. This report should contain the VIN, mileage, and images of the damage.
