# SAFETY RECALL

## Side Curtain Airbag

Reference: 54C / NHTSA 25V-302

2022-2025 (RU) Chrysler Pacifica  
2022-2025 (RU) Chrysler Voyager

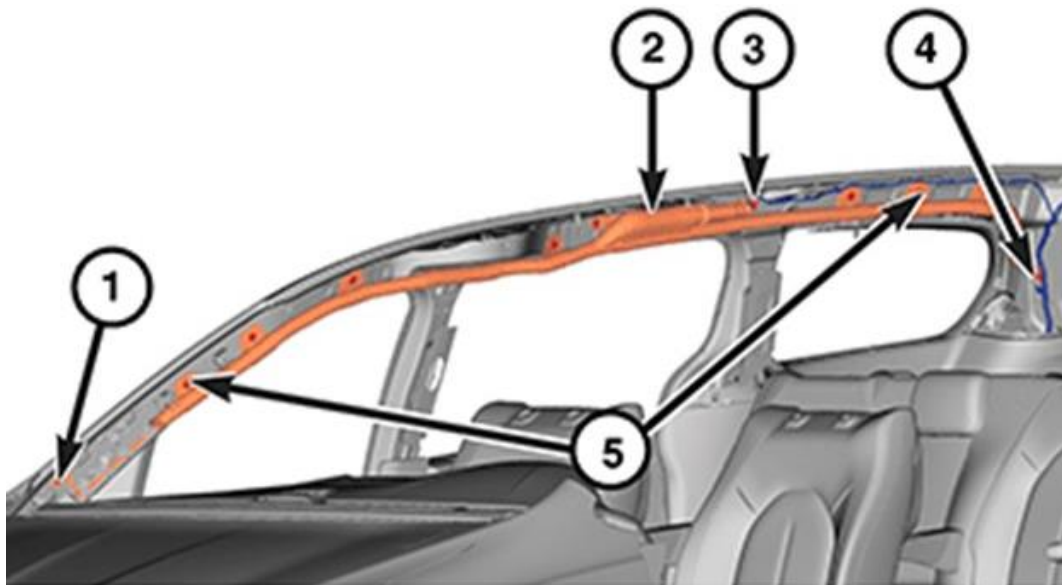
**Figure 25 – Side Curtain Airbag (CAB)**

55. Disconnect the body wire harness connector for the CAB from the connector receptacle of the inflator above the front door opening (Figure 25).
56. Remove the fastener that secures the airbag front tether to the A-pillar (Figure 25).
57. Remove the fastener that secures the airbag rear tether to the D-pillar (Figure 25).
58. Remove the fasteners that secure the CAB to the inner roof rail (Figure 25).
59. Remove the CAB from the vehicle as a unit and **DISPOSE** of in a proper manner (Figure 25).

60. Obtain the **NEW** left side (driver side) CAB for the vehicle.
61. Clean the CAB mounting studs with mineral spirits, toluene, or equivalent (Figure 25).
62. Apply blue threadlocking compound Mopar Part Number 04318031AB (MS-90061) or equivalent to the CAB mounting studs (Figure 25).
63. Install the **NEW** CAB to the vehicle as a unit (Figure 25).
64. Engage the CAB to the weld studs of the inner roof side rail. Be certain that the CAB is not twisted.
65. Working from front to rear, install the fasteners that secure the CAB and the inflator bracket to the inner roof rail and tighten to 6 N·m (53 in. lbs.) (Figure 25).

66. Install the fastener that secures the airbag front tether to the A-pillar and tighten to 6 N·m (53 in. lbs.) (Figure 25).
67. Install the fastener that secures the airbag rear tether to the D-pillar and tighten to 6 N·m (53 in. lbs.) (Figure 25).
68. Connect the body wire harness connector for the SABIC to the connector receptacle of the inflator above the sliding door opening (Figure 25).

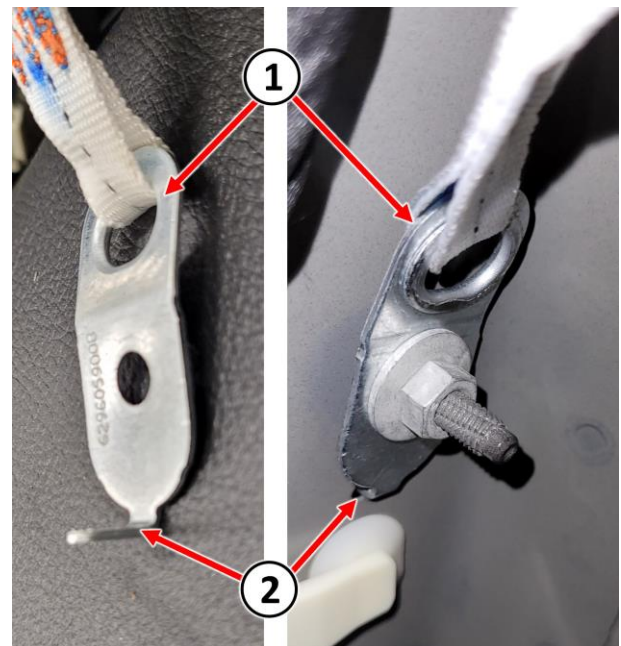
**Figure 26 – CAB Tether**

**NOTE: The CAB tether tab must be properly positioned in the corresponding hole. Failure to insert the tab in the corresponding hole could allow the tether end to rotate out of proper position while tightening the fastener (Figure 26).**
