# SAFETY RECALL

## Side Curtain Airbag

Reference: 06C / NHTSA 25V-302

FCA US LLC

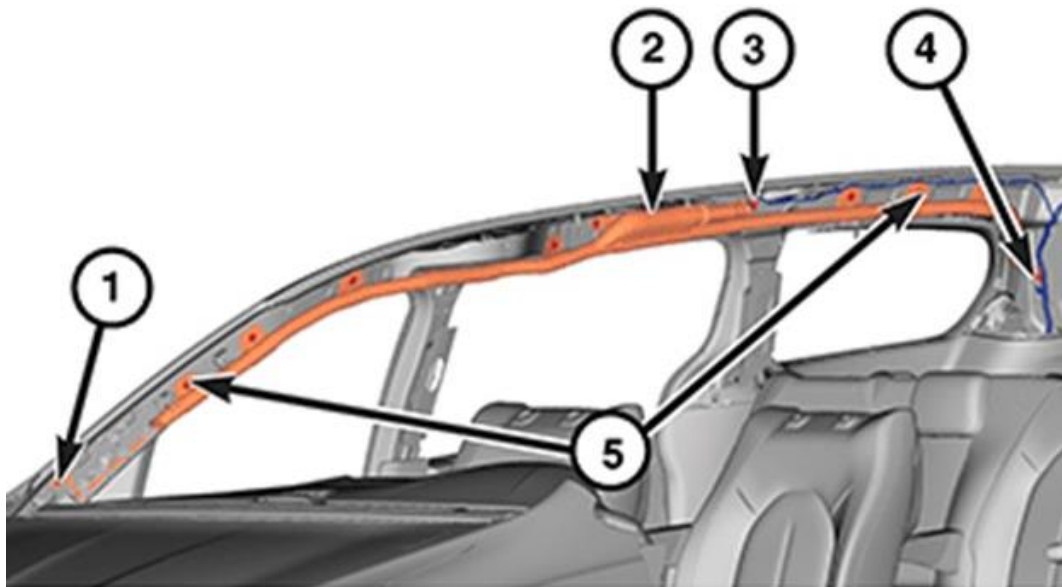
**Figure 25 – Side Curtain Airbag (CAB)**

The Curtain Airbag (CAB) on about 174,897 of the above vehicles may not retain sufficient pressure during deployment. CABs that do not sufficiently limit head excursion can increase the risk of injury to occupants in certain crashes.

The condition above fails to comply with the requirements of Federal Motor Vehicle Safety Standard (FMVSS) 571.226 S4.2.1 requires that "When propel[led] ... into the impact target locations ... the most outboard surface of the ... headform must not displace more than 100 millimeters beyond the zero displacement plane." Suspect CABs may not retain sufficient pressure to prevent headform displacement of more than 100mm.

55. Disconnect the body wire harness connector for the CAB from the connector receptacle of the inflator above the front door opening (Figure 25).
56. Remove the fastener that secures the airbag front tether to the A-pillar (Figure 25).
57. Remove the fastener that secures the airbag rear tether to the D-pillar (Figure 25).
58. Remove the fasteners that secure the CAB to the inner roof rail (Figure 25).
59. Remove the CAB from the vehicle as a unit and **DISPOSE** of in a proper manner (Figure 25).

60. Obtain the **NEW** CABs for each side of the vehicle.
61. Clean the CAB mounting studs with mineral spirits, toluene, or equivalent (Figure 25).
62. Apply blue threadlocking compound Mopar Part Number 04318031AB (MS-90061) or equivalent to the CAB mounting studs (Figure 25).
63. Install the **NEW** CAB to the vehicle as a unit (Figure 25).
64. Engage the CAB to the weld studs of the inner roof side rail. Be certain that the CAB is not twisted.
65. Working from front to rear, install the fasteners that secure the CAB and the inflator bracket to the inner roof rail and tighten to 6 N·m (53 in. lbs.) (Figure 25).

66. Install the fastener that secures the airbag front tether to the A-pillar and tighten to 6 N·m (53 in. lbs.) (Figure 25).
67. Install the fastener that secures the airbag rear tether to the D-pillar and tighten to 6 N·m (53 in. lbs.) (Figure 25).
68. Connect the body wire harness connector for the SABIC to the connector receptacle of the inflator above the sliding door opening (Figure 25).
