**SAFETY RECALL**  
NORTH AMERICA  
**Side Curtain Airbag**

Reference: 55C / NHTSA 25V-302

FCA US LLC

2024-2025 (RU) Chrysler Pacifica  
2024-2025 (RU) Chrysler Voyager

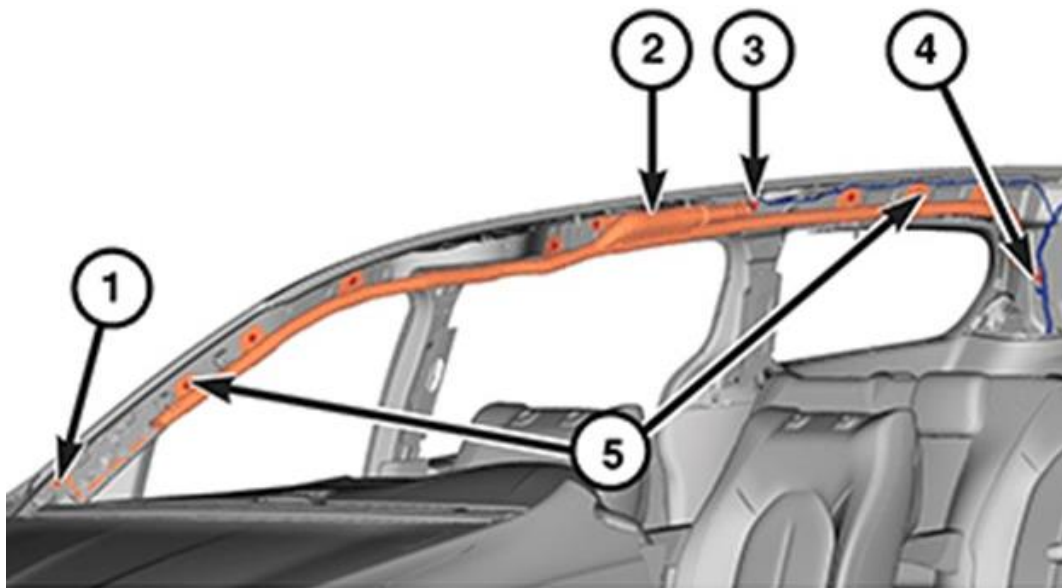
**Figure 25 – Side Curtain Airbag (CAB)**

The Curtain Airbag (CAB) on about 37,745 of the above vehicles may not retain sufficient pressure during deployment. CABs that do not sufficiently limit head excursion can increase the risk of injury to occupants in certain crashes.

The condition above fails to comply with the requirements of Federal Motor Vehicle Safety Standard (FMVSS) 571.226 S4.2.1 requires that "When propel[led] ... into the impact target locations ... the most outboard surface of the ... headform must not displace more than 100 millimeters beyond the zero displacement plane." Suspect CABs may not retain sufficient pressure to prevent headform displacement of more than 100mm.

55. Disconnect the body wire harness connector for the CAB from the connector receptacle of the inflator above the front door opening (Figure 25).
56. Remove the fastener that secures the airbag front tether to the A-pillar (Figure 25).
57. Remove the fastener that secures the airbag rear tether to the D-pillar (Figure 25).
58. Remove the fasteners that secure the CAB to the inner roof rail (Figure 25).
59. Remove the CAB from the vehicle as a unit and **DISPOSE** of in a proper manner (Figure 25).

60. Obtain the **NEW** CAB for right side of the vehicle.
61. Clean the CAB mounting studs with mineral spirits, toluene, or equivalent (Figure 25).
62. Apply blue threadlocking compound Mopar Part Number 04318031AB (MS-90061) or equivalent to the CAB mounting studs (Figure 25).
63. Install the **NEW** CAB to the vehicle as a unit (Figure 25).
64. Engage the CAB to the weld studs of the inner roof side rail. Be certain that the CAB is not twisted.
65. Working from front to rear, install the fasteners that secure the CAB and the inflator bracket to the inner roof rail and tighten to 6 N·m (53 in. lbs.) (Figure 25).

66. Install the fastener that secures the airbag front tether to the A-pillar and tighten to 6 N·m (53 in. lbs.) (Figure 25).
67. Install the fastener that secures the airbag rear tether to the D-pillar and tighten to 6 N·m (53 in. lbs.) (Figure 25).
68. Connect the body wire harness connector for the SABIC to the connector receptacle of the inflator above the sliding door opening (Figure 25).
