Safety Recall

Date	Number	Release	Page
06.2025	SC0478	01	1(6)

MMD Bench Seat Center Seat Belt Incorrect Routing MD6, MD7

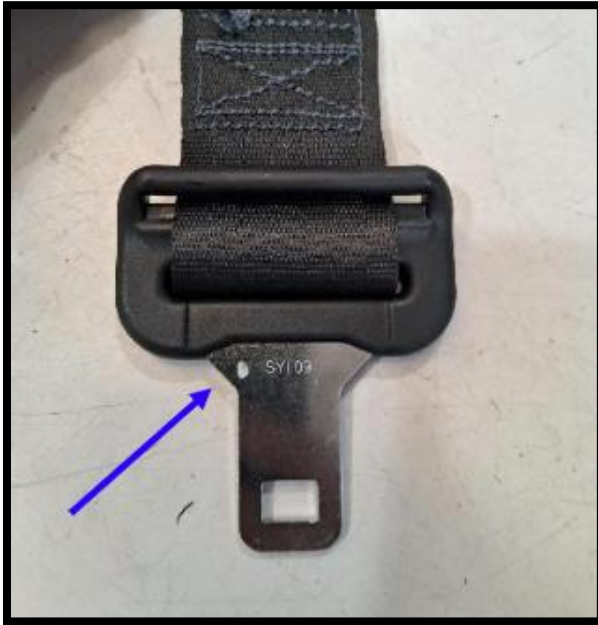
Correct routing

6. Locate and inspect the seatbelt for proper routing. If routing is **correct**, release truck for service. If routing is **incorrect**, proceed to step 7.

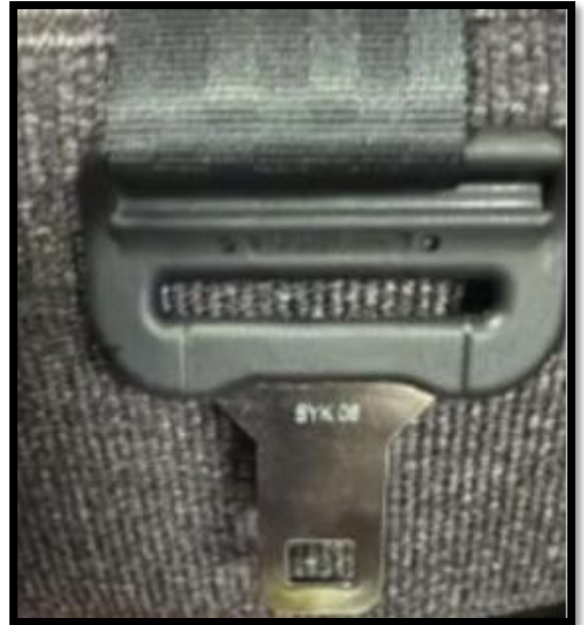
Mack Trucks has determined that certain model year 2026 Mack Medium Duty (“MMD”) vehicles could have been manufactured with seatbelts where the belt routing is incorrect on the tongue (latch plate) assembly. This would prevent the seat belt from performing correctly.

In the event of a crash, the incorrectly routed seatbelt would not perform as designed and this could increase the risk of an injury.

Incorrect routing
