# Safety Recall

## N252500680 Instrument Panel Display May Go Blank

**Release Date:** May 2025

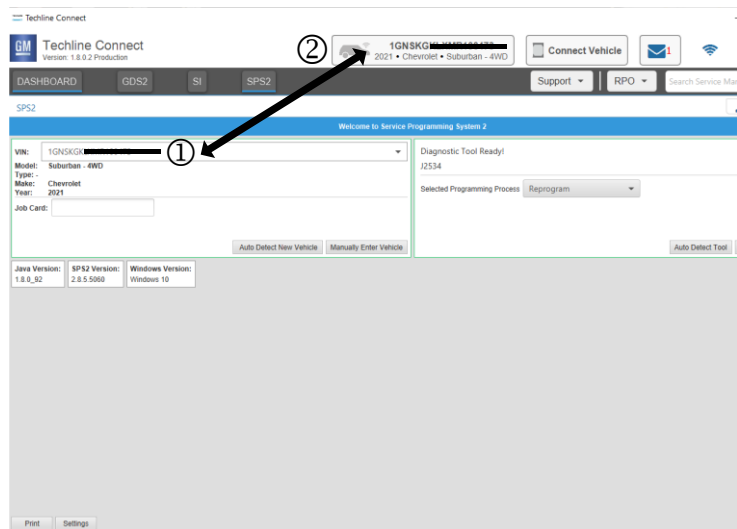
**Caution:** Be sure the VIN selected in the drop down menu (1) is the same as the vehicle connected (2) before beginning programming.

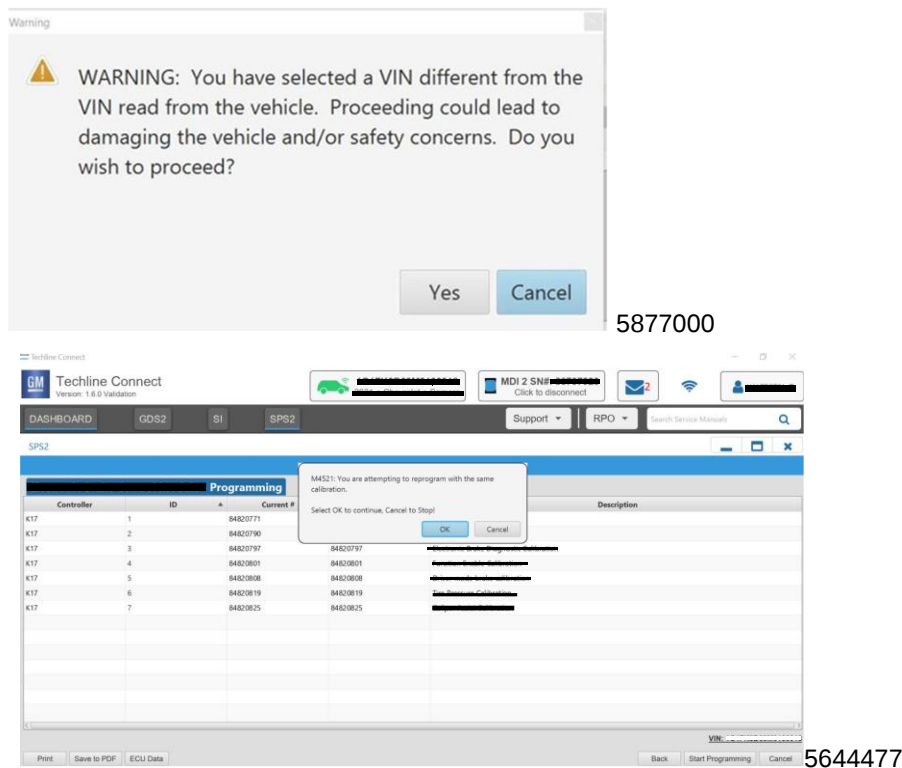
**Important:** If the vehicle VIN DOES NOT match, the message below will be shown.

**Important:** Techline Connect screens shown above.

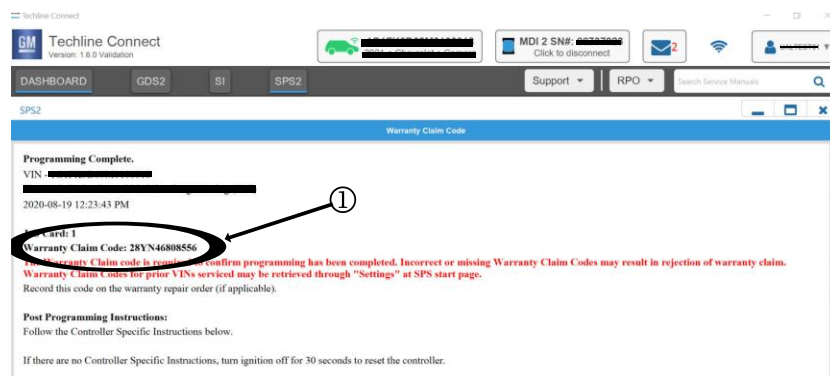
5644478

**Note:** The screenshot above is an example of module programming and may not be indicative of the specific module that is being programmed. Module selection and VIN information have been blacked out.

**Important:** To avoid warranty transaction rejections, you **MUST** record the warranty claim code provided on the Warranty Claim Code (WCC) screen shown above on the job card. Refer to callout 1 above for the location of the WCC on the screen.
