Tesla, Inc.
Service Bulletin

Inspect Windshield Wiper Arm Elbow Connectors

SB-25-17-006
June 25, 2025

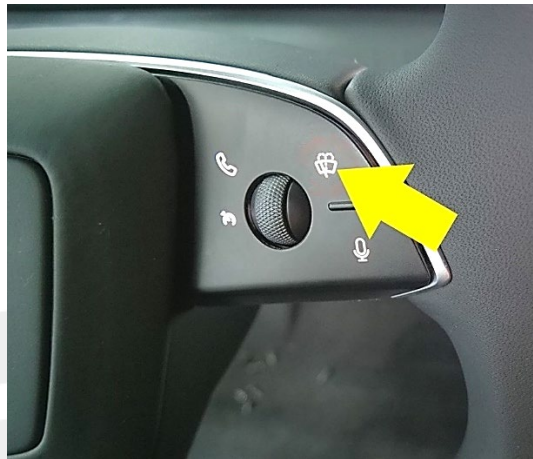
Figure 1

1. Press and hold the windshield washer button on the steering wheel to spray washer fluid onto the windshield, and then inspect the streams of washer fluid from the LH and RH washer arms (Figure 1).

- If the washer fluid sprays in a steady stream from the LH and RH windshield wiper washer jets, skip to step 9.
 - If the washer fluid does not spray in a steady stream from the LH or RH windshield wiper washer jet, the affected wiper arm elbow connector must be replaced. Skip to step 2.
 - If the washer fluid does not spray in a steady stream from the LH and RH windshield wiper washer jets, both wiper arm elbow connectors must be replaced. Continue to step 2.
2. Open the hood.
 3. Carefully disconnect the affected wiper arm elbow connector from the cowl fitting (Figures 2 and 3).
