SAFETY RECALL

Rearview Camera Bluescreen or Inoperative

Reference: 34C / NHTSA 25V-388

Remedy available for
2023 (RU) Chrysler Pacifica/Voyager

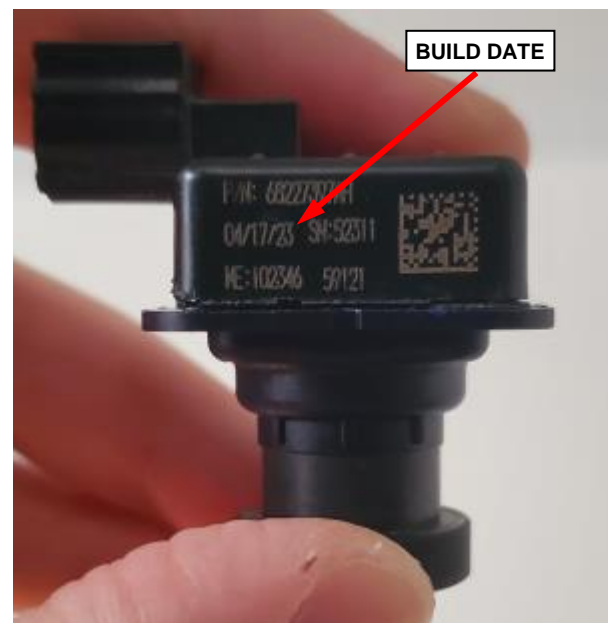
Figure 7 – Inspect Build Date

The rearview camera on about 160 of the above vehicles may contain a solder void between the circuit board and an image signal processing chip which may prevent the rearview image from displaying during a backing event. The vehicle operator may notice that the rearview image is not displayed if attempting to reference the image while backing. A rearview camera image that does not display reduces the driver's visibility of what is behind the vehicle and if not heeded, increases the risk of a crash.

2. Inspect the build date on the RVC (Figure 7).
 - Build date 04/17/23 or 04/18/23, replace the camera.
 - All other build dates, re-install camera.
