# Safety Recall

## N242482680 Brake Pressure Switch Connector Fire

**Release Date:** October 2025

**Revision:** 02

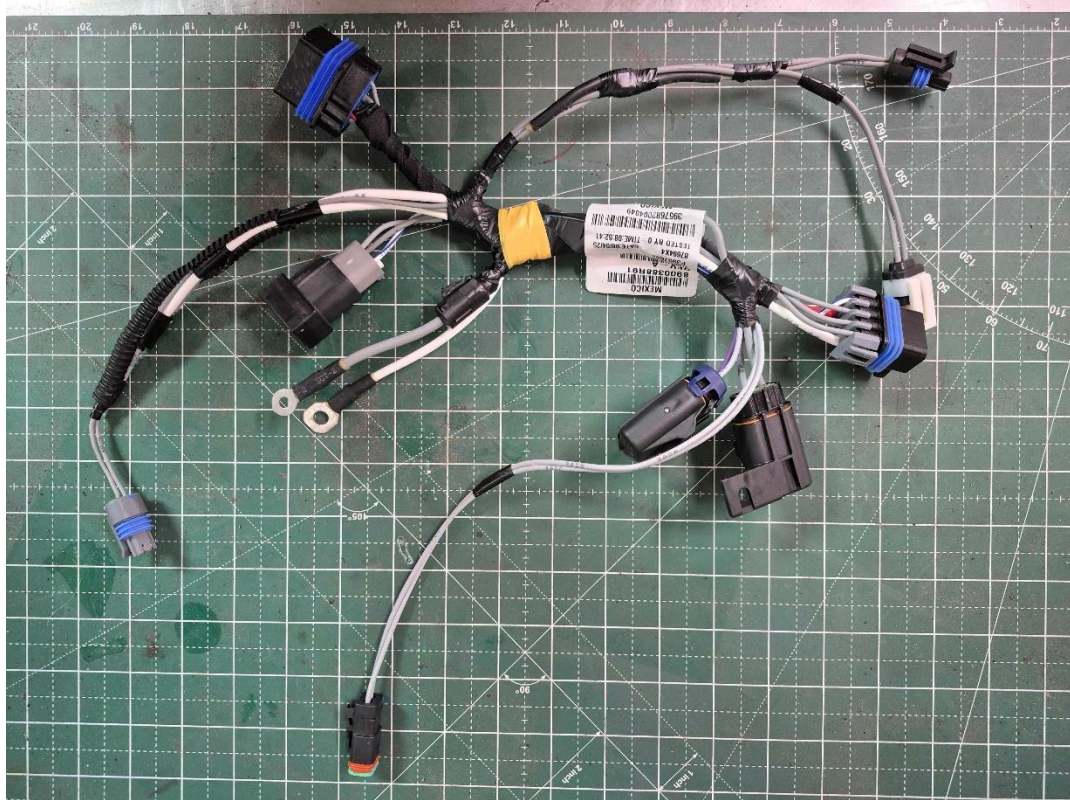
7006748

**IMPORTANT:** Harness part number 19410082 will require the harness to have electrical harness tap installed, if not already fully taped. This tape is to prevent abrasion to the harness from other components.

8. Verify the replacement harness is fully taped.
9. If the harness is not fully taped (as above) proceed to step 11 to wrap the harness.
10. If the harness IS fully taped, proceed to step 14.

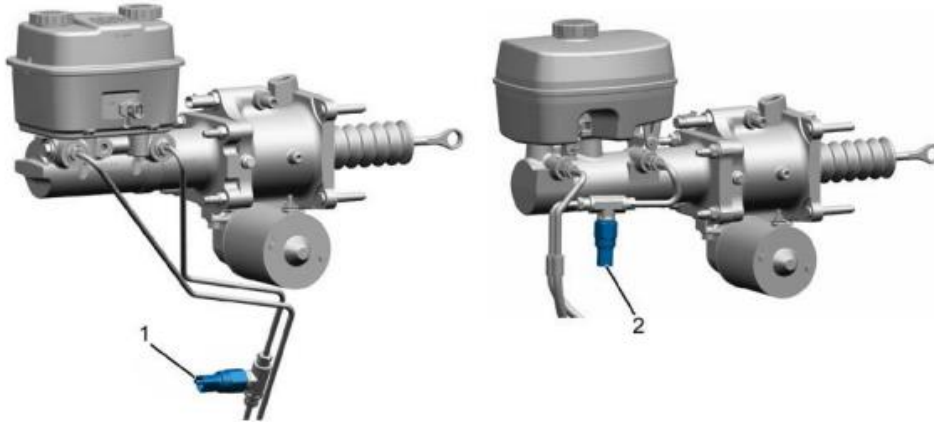
**Figure 1. Brake Pressure Switch Placement**

1. Built 11/30/2020 and prior
2. Built 12/01/2020 and after

**NOTE: Placement of the brake pressure switch is different for vehicles built 11/30/2020 and prior and vehicles built 12/01/2020 and after (Figure 1, Items 1 and 2).**

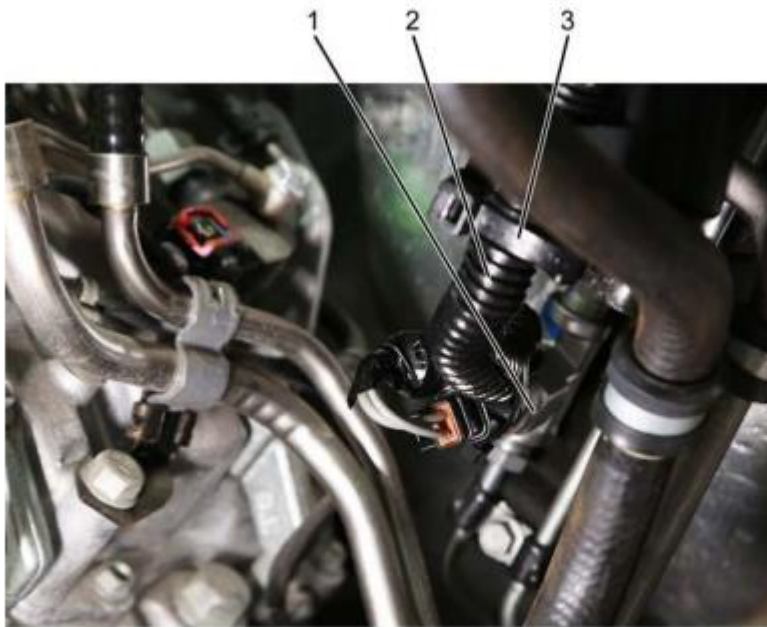
**Figure 2. Brake Pressure Switch Connector Location**

1. Brake pressure switch connector
2. Harness
3. Cable wire tie

14. Locate the brake booster pressure switch connector (Figure 1, Item 1) located near the vehicle master cylinder.
15. Disconnect the harness connector (Figure 2, Item 2) from the hydraulic brake pressure switch (Figure 2, Item 1).

36. Connect brake hydraulic switch connector to the brake hydraulic switch.
37. Using a cable tie strap (Figure 2, Item 2), secure brake hydraulic switch connector harness to it's clipping point (Figure 2, Item 2).

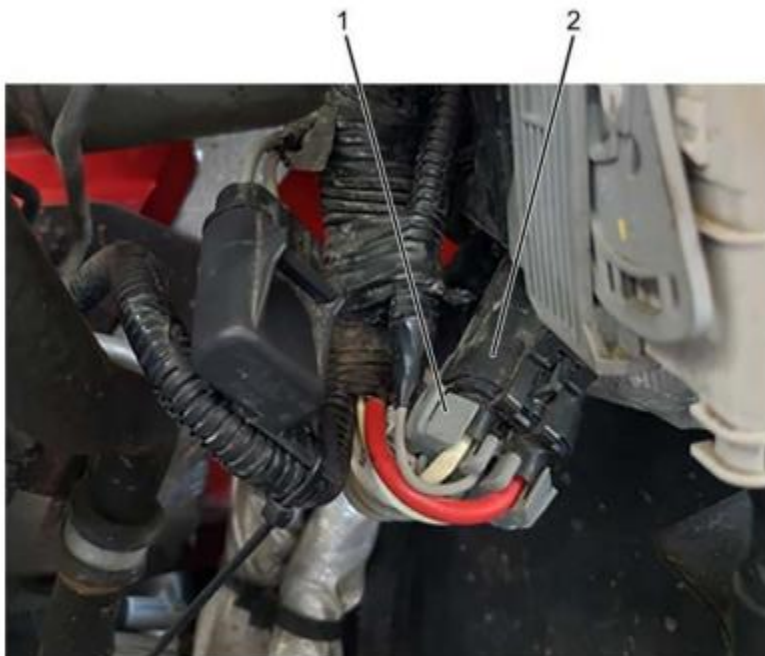
**Figure 3. Booster Pump Motor Jumper Harness Connector**

1. Booster pump motor jumper harness connector
2. Center chassis harness connector

16. Disconnect the backup booster pump motor jumper harness connector (Figure 3, Item 1) from the center chassis harness connector (Figure 3, Item 2).

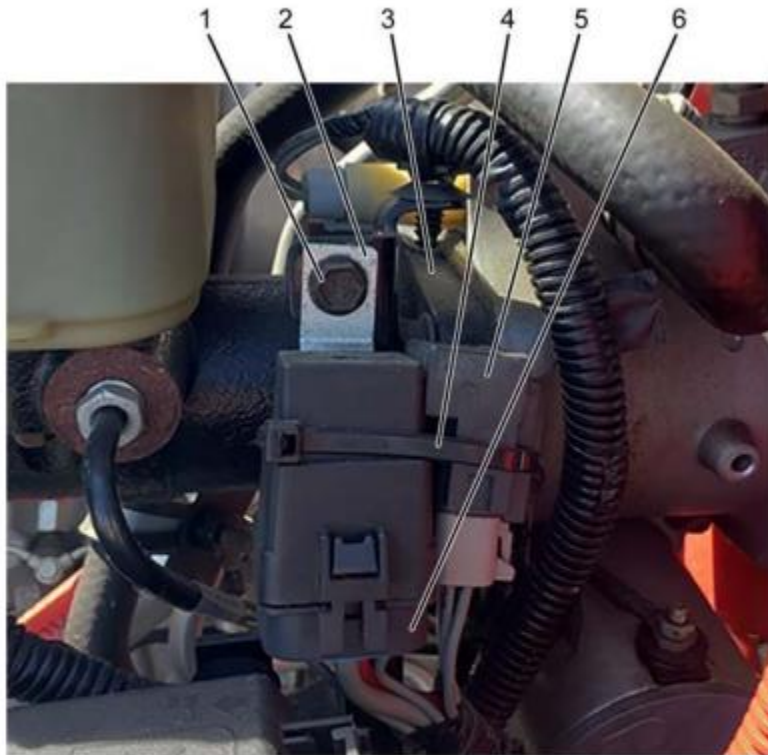
**Figure 4. Relay Mount**

1. Bolt
2. Relay mounting bracket
3. Master cylinder
4. Cable tie strap
5. Diode
6. Relay connector

17. Cut and discard cable tie strap (Figure 4, Item 4) connecting diode (Figure 4, item 5) to relay mounting bracket (Figure 4, Item 2). Disconnect relay connector (Figure 4, Item 6).
18. If the vehicle you are working on was built 11/30/2020 and prior, perform step 18a. If the vehicle you are working on was built 12/01/2020 and after, perform step 18b.
  - a) For vehicles built 11/30/2020 and prior, Disconnect master cylinder fluid level sensor mounted on brake fluid reservoir, low-pressure brake switch connector mounted on master cylinder, and brake booster flow switch mounted on the Hydromax booster.
  - b) For vehicles built 12/01/2020 and after, disconnect master cylinder fluid level sensor mounted on brake fluid reservoir and brake booster flow switch mounted on the Hydromax booster.

34. Using cable tie strap, secure both fuse holders to brake jumper harness.
35. Using cable tie strap, secure diode (Figure 4, Item 5) to relay mounting bracket (Figure 4, Item 2).

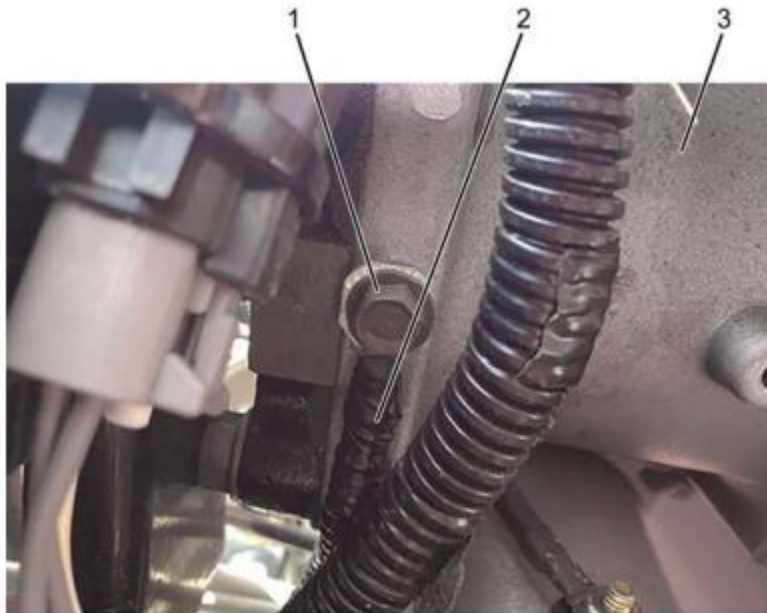
**Figure 5. Hydromax Brake Booster**

1. Bolt
2. Ground wire
3. Hydromax brake booster

19. Remove bolt (Figure 5, Item 1) securing ground wire (Figure 5, Item 2) to the Hydromax Brake Booster (Figure 5, Item 3). Reposition ground wire and save bolt for reuse.

28. Position ground bolt (Figure 5, Item 1) through ring terminal eyelet of the ground wire (Figure 5, Item 2) and into the Hydromax Brake Booster.
29. Using torque wrench, tighten ground bolt to 102 lb-in (11.5N-m).

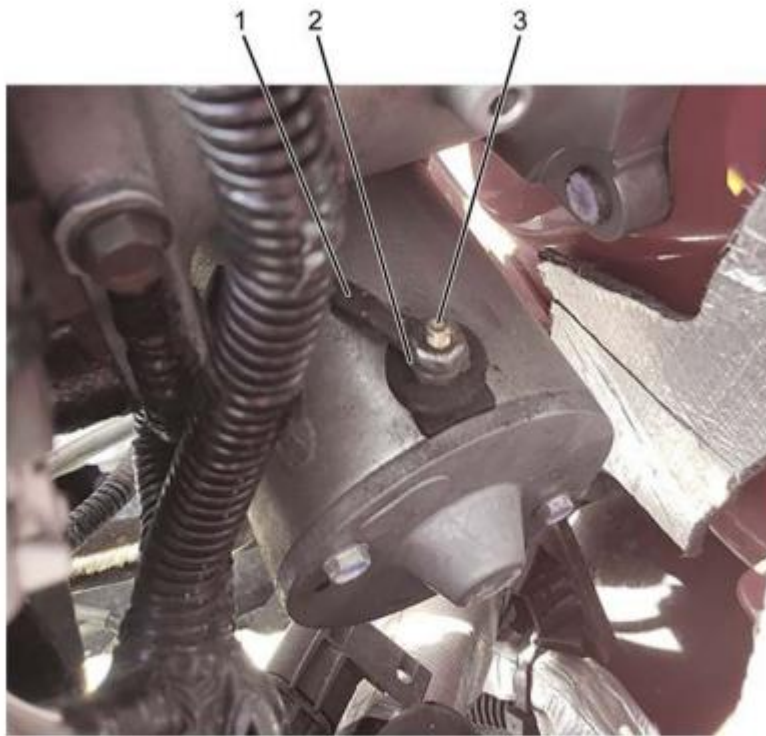
**Figure 6. Booster Pump**

1. Power wire
2. Nut and lock washer
3. Booster pump motor terminal

20. Remove nut and lock washer (Figure 6, Item 2) securing power wire (Figure 6, Item 1) to booster pump motor terminal (Figure 6, Item 3). Reposition power wire and save nut and lock washer for reuse.

24. Position ring terminal of power wire (Figure 6, Item 1) over booster pump motor terminal (Figure 6, Item 3). Install lock washer and nut removed in Step 13 (Figure 6, Item 2).

25. Using torque wrench, tighten booster pump motor terminal nut to 17 lb-in (2 N-m).  
**Caution: To prevent damage to property, ensure even application of dielectric grease to backup pump power terminal nut and booster pump ground bolt. Failure to do so can result in damage to property.**

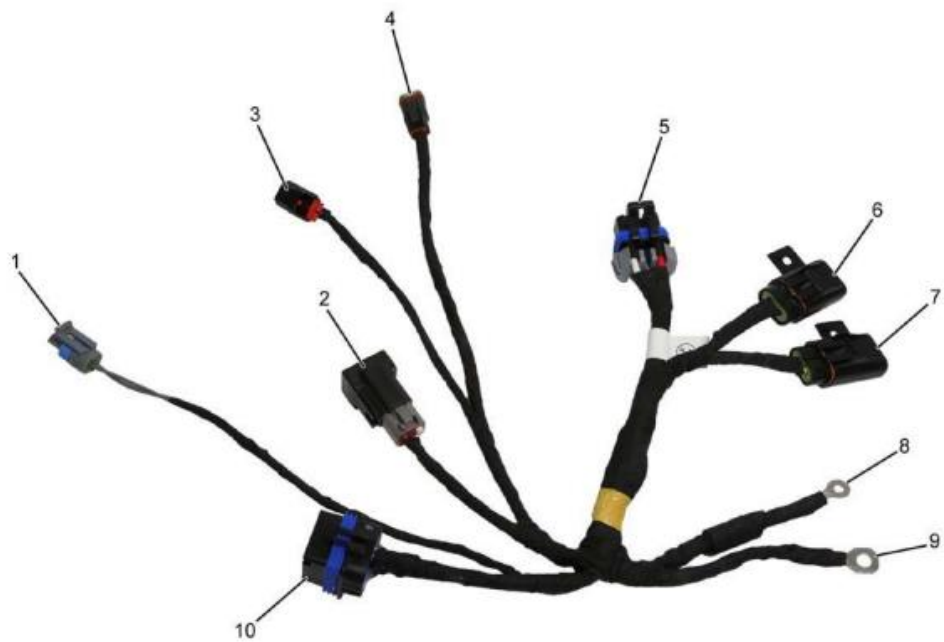
**Figure 7. Brake Jumper Harness for 12/01/2020 and later**

1. Brake booster flow switch connector
2. Diode
3. Brake fluid level sensor connector
4. Brake pressure switch connector
5. Booster pump motor jumper harness connector
6. 5-amp fuse
7. 5-amp fuse
8. Power terminal
9. Ground terminal
10. Relay connector

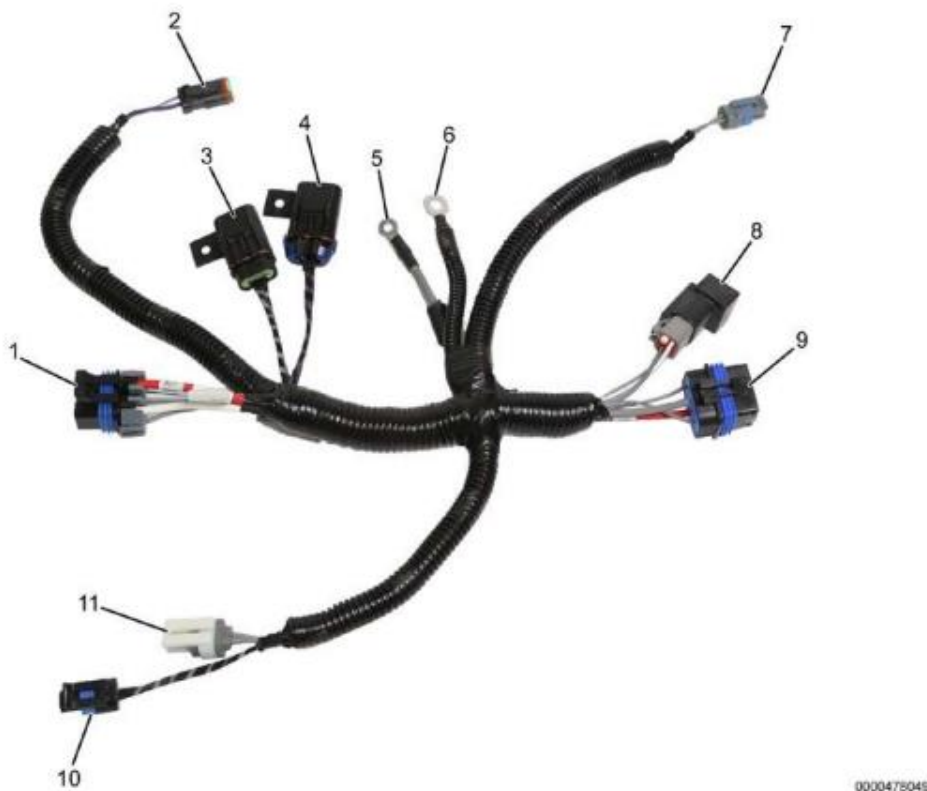
**Figure 8. Brake Jumper Harness for 11/30/2020 and earlier**

1. Booster pump motor jumper harness connector
2. Brake pressure switch connector
3. 5-amp fuse
4. 5-amp fuse
5. Power terminal
6. Ground terminal
7. Brake booster flow switch connector
8. Diode
9. Relay connector
10. Master fluid level sensor
11. Low pressure flow switch connector

21. Record harness routing and location of cable wire ties and clipping saddles.
22. Cut and discard cable ties securing harness and remove harness from vehicle. Discard harness.

**Caution: To prevent damage to property, use caution when routing harness. Failure to do so can lead to damage to harness.**
23. Using previously recorded routing and clipping locations, route new harness as noted in Step 21.
