# Safety Recall

## N242482680 Brake Pressure Switch Connector Fire

Release Date: August 2025

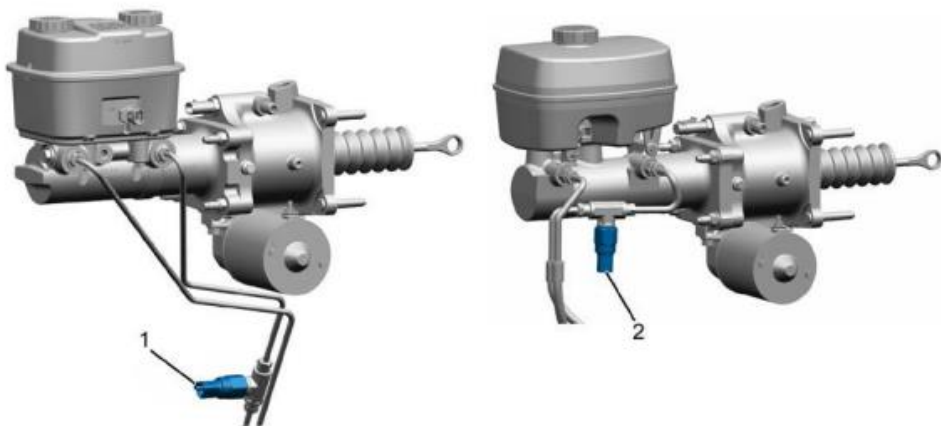
**Figure 1. Brake Pressure Switch Placement**

1. Built 11/30/2020 and prior
2. Built 12/01/2020 and after

**NOTE: Placement of the brake pressure switch is different for vehicles built 11/30/2020 and prior and vehicles built 12/01/2020 and after (Figure 1, Items 1 and 2).**

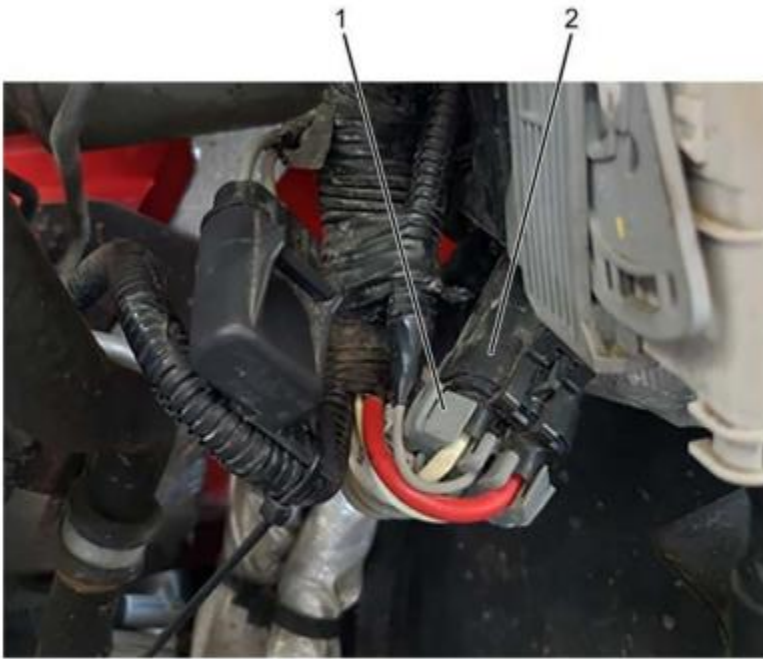
**Figure 3. Booster Pump Motor Jumper Harness Connector**

1. Booster pump motor jumper harness connector
2. Center chassis harness connector

10. Disconnect the backup booster pump motor jumper harness connector (Figure 3, Item 1) from the center chassis harness connector (Figure 3, Item 2).

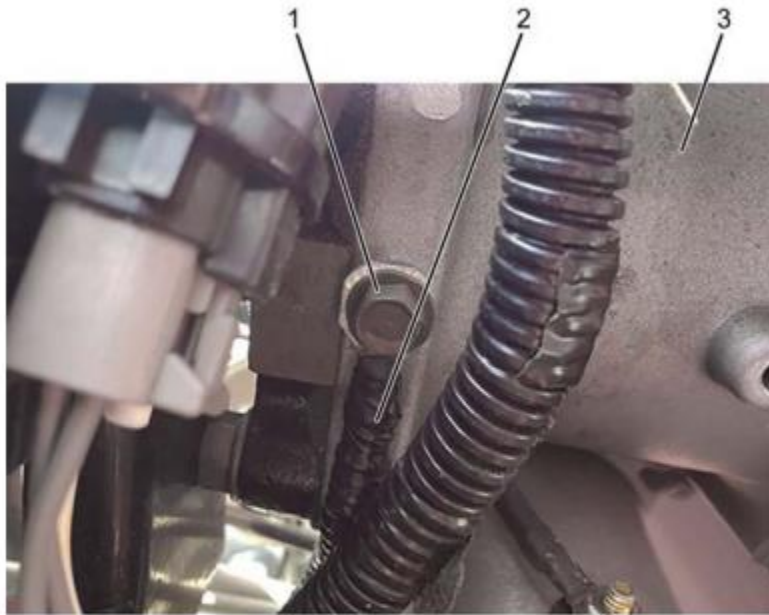
**Figure 5. Hydromax Brake Booster**

1. Bolt
2. Ground wire
3. Hydromax brake booster

13. Remove bolt (Figure 5, Item 1) securing ground wire (Figure 5, Item 2) to the Hydromax Brake Booster (Figure 5, Item 3). Reposition ground wire and save bolt for reuse.

22. Position ground bolt (Figure 5, Item 1) through ring terminal eyelet of the ground wire (Figure 5, Item 2) and into the Hydromax Brake Booster.
23. Using torque wrench, tighten ground bolt to 102 lb-in (11.5N-m).
