# Safety Recall

## N242482680 Brake Pressure Switch Connector Fire

**Release Date:** August 2025

**Revision:** 01

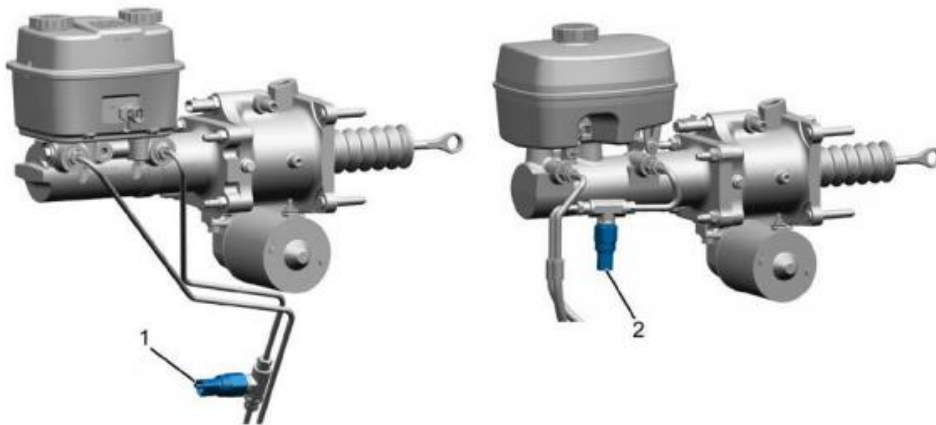
**Figure 1. Brake Pressure Switch Placement**

1. Built 11/30/2020 and prior
2. Built 12/01/2020 and after

**NOTE: Placement of the brake pressure switch is different for vehicles built 11/30/2020 and prior and vehicles built 12/01/2020 and after (Figure 1, Items 1 and 2).**

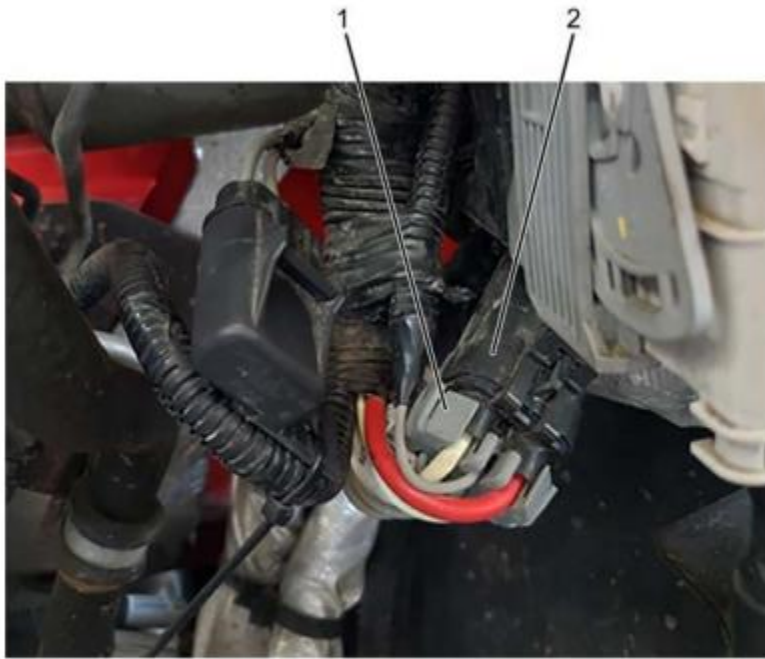
**Figure 3. Booster Pump Motor Jumper Harness Connector**

1. Booster pump motor jumper harness connector
2. Center chassis harness connector

10. Disconnect the backup booster pump motor jumper harness connector (Figure 3, Item 1) from the center chassis harness connector (Figure 3, Item 2).

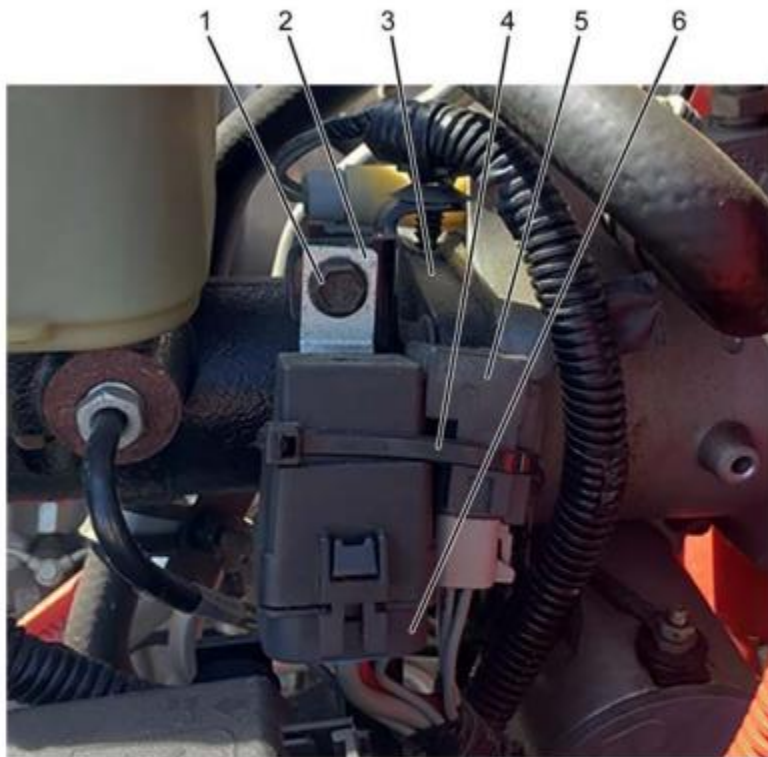
**Figure 4. Relay Mount**

1. Bolt
2. Relay mounting bracket
3. Master cylinder
4. Cable tie strap
5. Diode
6. Relay connector

11. Cut and discard cable tie strap (Figure 4, Item 4) connecting diode (Figure 4, item 5) to relay mounting bracket (Figure 4, Item 2). Disconnect relay connector (Figure 4, Item 6).
12. If the vehicle you are working on was built 11/30/2020 and prior, perform step 12a. If the vehicle you are working on was built 12/01/2020 and after, perform step 12b.
  - a. For vehicles built 11/30/2020 and prior, Disconnect master cylinder fluid level sensor mounted on brake fluid reservoir, low-pressure brake switch connector mounted on master cylinder, and brake booster flow switch mounted on the Hydromax booster.
  - b. For vehicles built 12/01/2020 and after, disconnect master cylinder fluid level sensor mounted on brake fluid reservoir and brake booster flow switch mounted on the Hydromax booster.

28. Using cable tie strap, secure both fuse holders to brake jumper harness.
29. Using cable tie strap, secure diode (Figure 4, Item 5) to relay mounting bracket (Figure 4, Item 2).

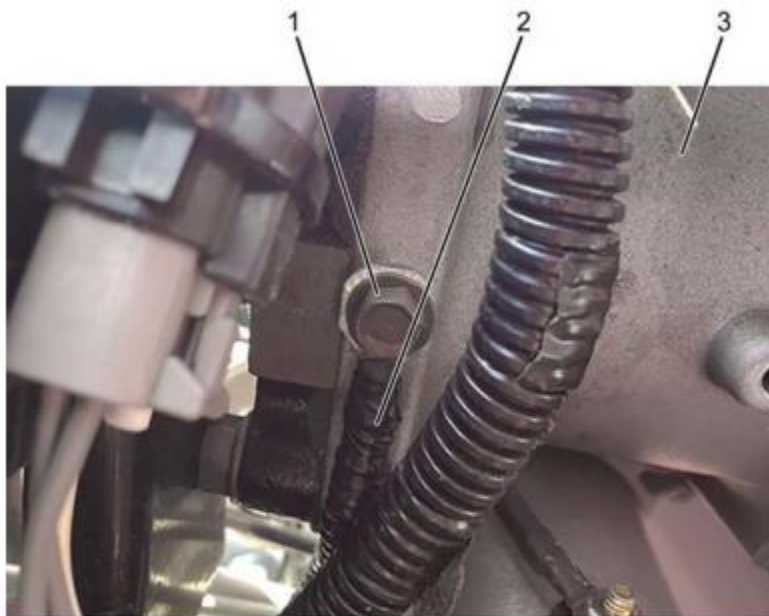
**Figure 5. Hydromax Brake Booster**

1. Bolt
2. Ground wire
3. Hydromax brake booster

13. Remove bolt (Figure 5, Item 1) securing ground wire (Figure 5, Item 2) to the Hydromax Brake Booster (Figure 5, Item 3). Reposition ground wire and save bolt for reuse.

22. Position ground bolt (Figure 5, Item 1) through ring terminal eyelet of the ground wire (Figure 5, Item 2) and into the Hydromax Brake Booster.
23. Using torque wrench, tighten ground bolt to 102 lb-in (11.5N-m).

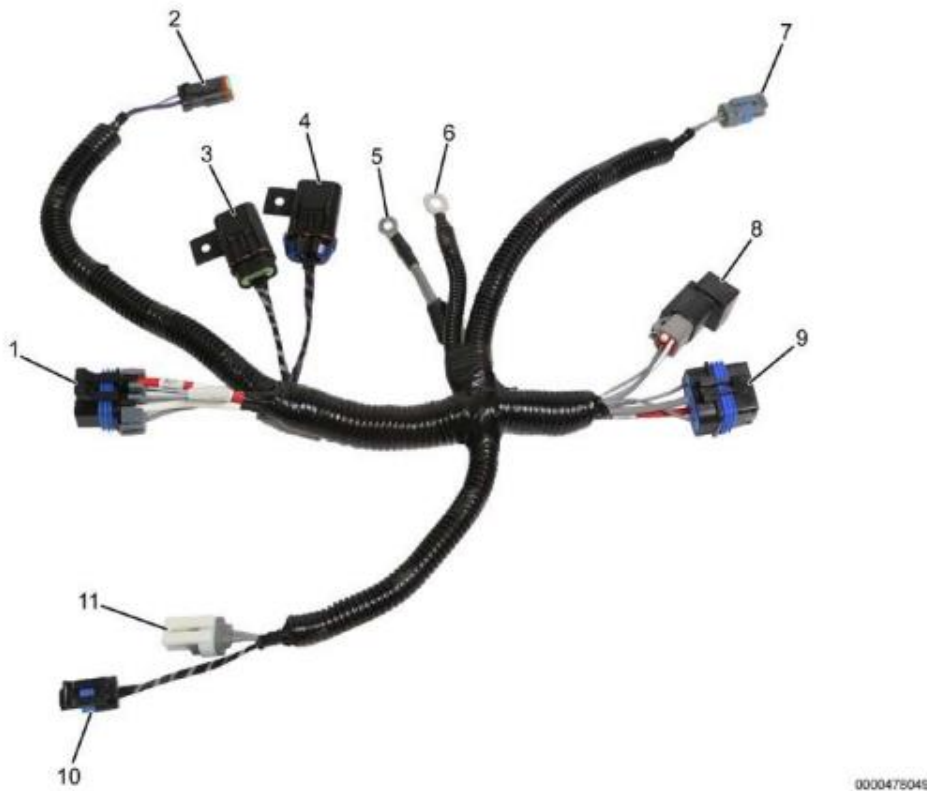
**Figure 8. Brake Jumper Harness for 11/30/2020 and earlier**

1. Booster pump motor jumper harness connector
2. Brake pressure switch connector
3. 5-amp fuse
4. 5-amp fuse
5. Power terminal
6. Ground terminal
7. Brake booster flow switch connector
8. Diode
9. Relay connector
10. Master fluid level sensor
11. Low pressure flow switch connector
