NHTSA: 25V-408

Winnebago Towable: CAM0000043

SUBJECT: Cooktop Flame May Invert Due to Furnace

Safety Recall:
 Cooktop Flame May Invert Due to Furnace

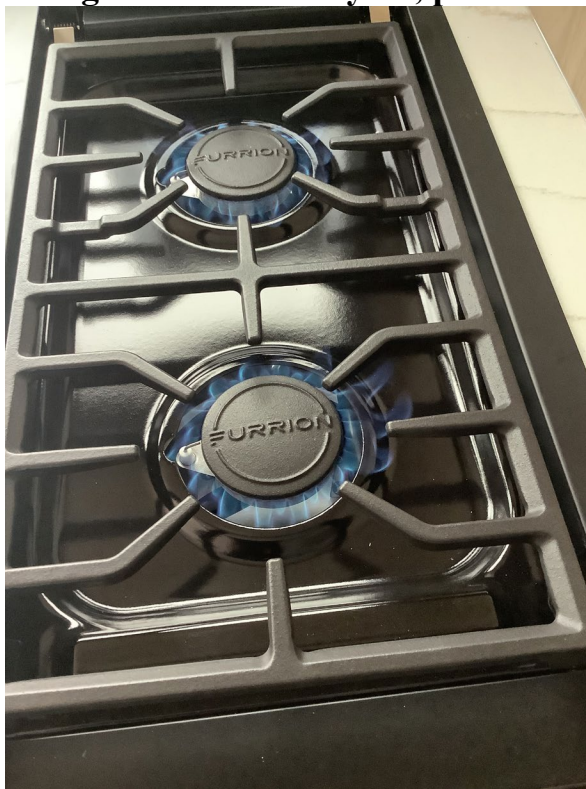
1. Turn on both burners for the range
2. Turn on the furnace
3. Inspect for flames being inverted. If they do, please follow the instructions below.
