Tesla, Inc.
Service Bulletin

Inspect 1st Row Seatback Fastener Torque

SB-25-13-003
June 25, 2025

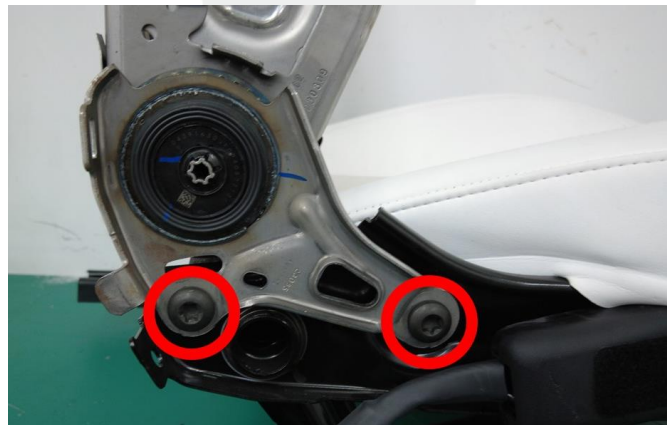
Some Model 3 and Model Y vehicles may have been built with improperly torqued fasteners that attach the 1st row seatback to the seat cushion.

Figure 1 – LH and RH seats similar; inboard and outboard bolts similar

1. Remove the LH 1st row seat assembly and place it on a clean and stable working surface. Refer to Service Manual procedures:
 - Model 3: [1304010022](#)
 - Model Y: [1304010402](#)
2. Remove the inboard and outboard side shields from the front seat assembly that was removed:
 - Model 3
 - Inboard Side Shield: Service Manual procedure [1307010132](#)
 - Outboard Side Shield: Service Manual procedure [1307010122](#)
 - Model Y
 - Inboard Side Shield: Service Manual procedure [1307010302](#)
 - Outboard Side Shield: Service Manual procedure [1307010502](#)
3. Remove the inboard and outboard side shield carriers from the front seat assembly that was removed (refer to Service Manual procedure 1307010022; [Model 3](#), [Model Y](#)).
4. Perform a torque check on the inboard and outboard bolts (**x4 total**) that attach the seatback to the seat cushion (torque 43 Nm) (Figure 1).

- If a bolt is already properly torqued, take note.
- If a bolt is under-torqued, remove and discard the bolt, and then replace it with a new bolt. Take note of this action.

⚠ CAUTION: Replace all under-torqued bolts. DO NOT re-use any under-torqued bolts.
